COMMERCIAL WINDSTORM MITIGATION INSPECTION REPORT (OIR-B1-1802)

Windrush Bay Condominium Association, Inc.

501-508 Windrush Bay Dr (Building E)

As of 10/5/2015

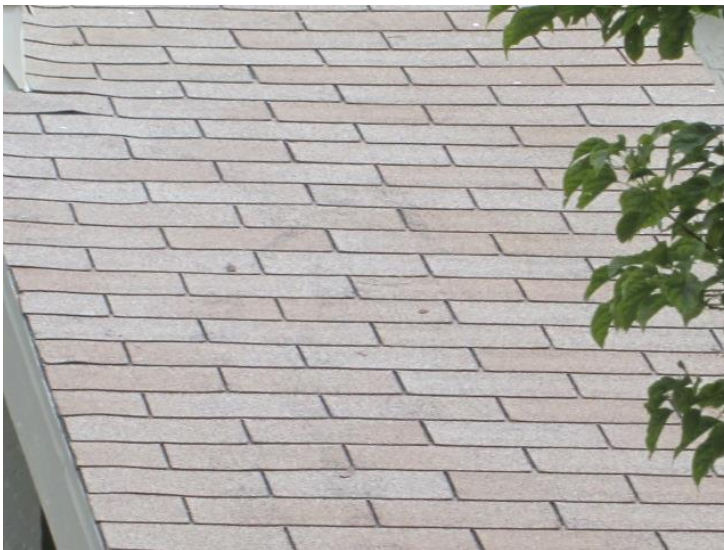
Roof Covering (Section 2)

Comments: | No roof coverings meet the minimum requirements
The roof covering was replaced in 2001. The roof permit was confirmed and the permit number is 01-360. This roof was verified as not meeting the building code requirements outlined on the mitigation affidavit. |

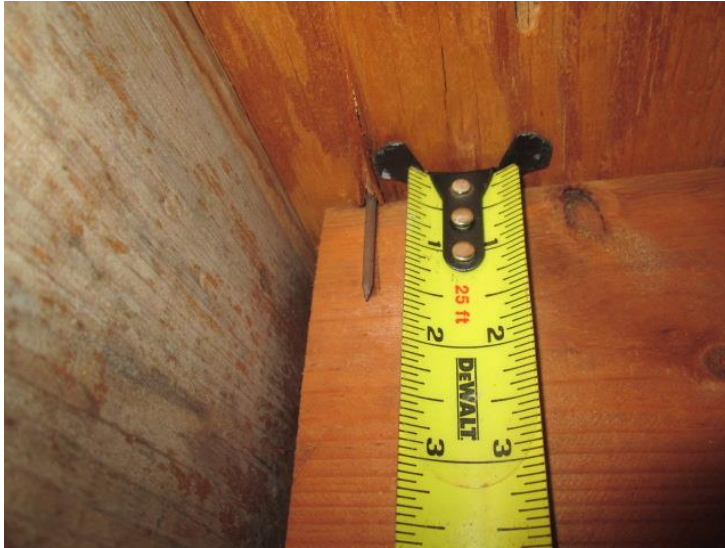
Roof Deck Attachment
(Section 3)

Comments: | Level A
Inspection verified 1/2" plywood roof deck attached with 6d nails at a minimum of 6" on the edge & 12" in the field. |

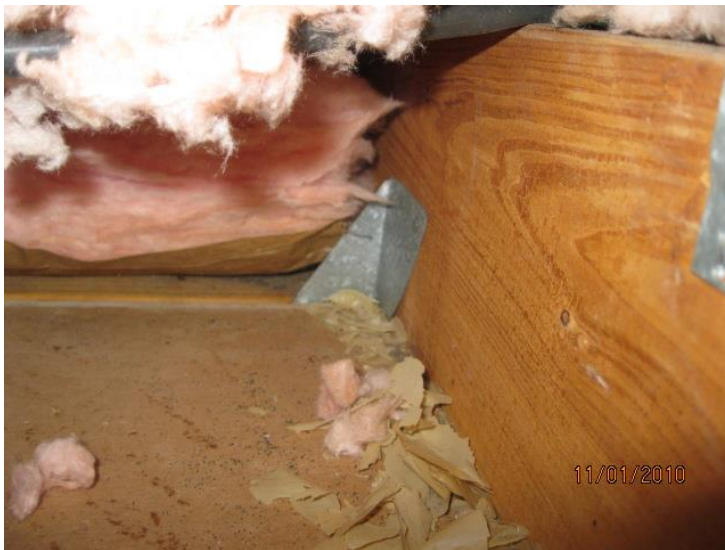
Roof to Wall Attachment
(Section 4)

Comments: | Clips
Inspection verified hurricane clips fastened with a minimum of three nails. |

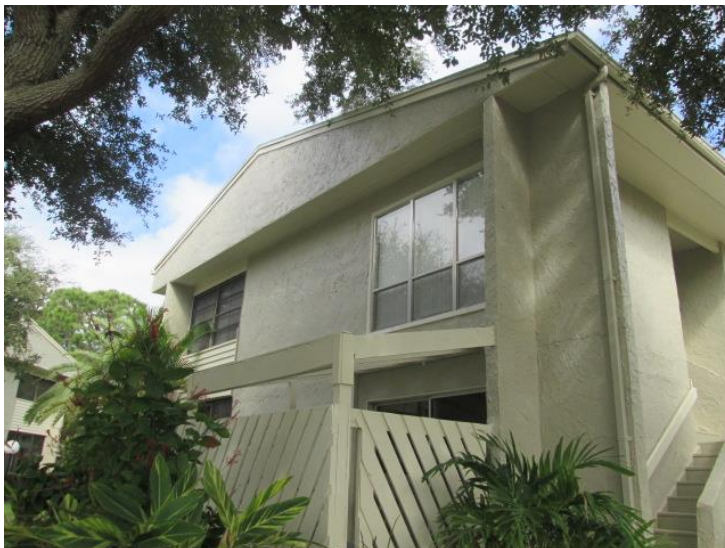
Roof Shape (Section 5)

Comments: | Other Roof
Inspection verified a gable roof shape. |
