COMMERCIAL WINDSTORM MITIGATION INSPECTION REPORT (OIR-B1-1802)

Windrush Bay Condominium Association, Inc.

509-516 Windrush Bay Dr (Building F)

RECAPITULATION OF MITIGATION FEATURES
For 509-516 Windrush Bay Dr (Building F)

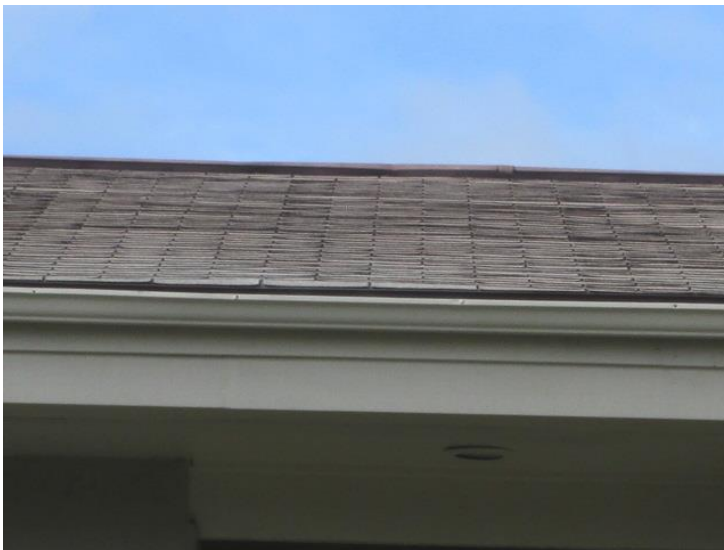
Roof Covering (Section 2)

Comments: | No roof coverings meet the minimum requirements
The roof covering was replaced in 2001. The roof permit was confirmed and the permit number is 01-361. This roof was verified as not meeting the building code requirements outlined on the mitigation affidavit. |

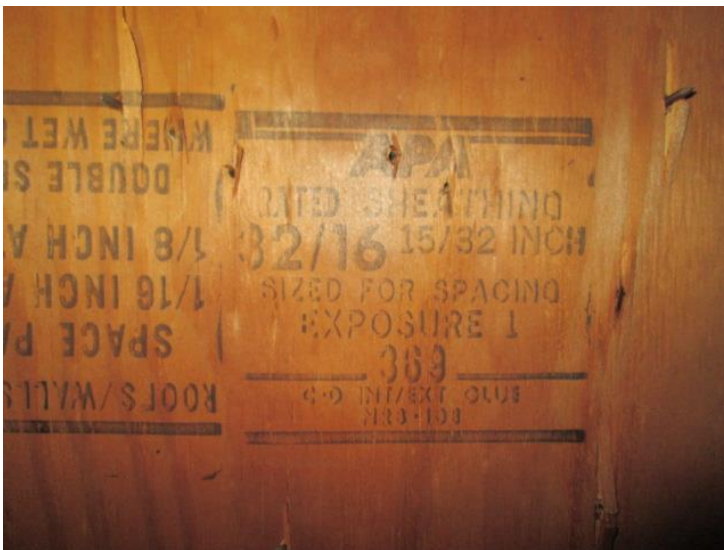
Roof Deck Material (Section 3)

Comments: | Level A
Inspection verified 1/2" plywood roof deck attached with 6d nails at a minimum of 6" on the edge & 12" in the field. |

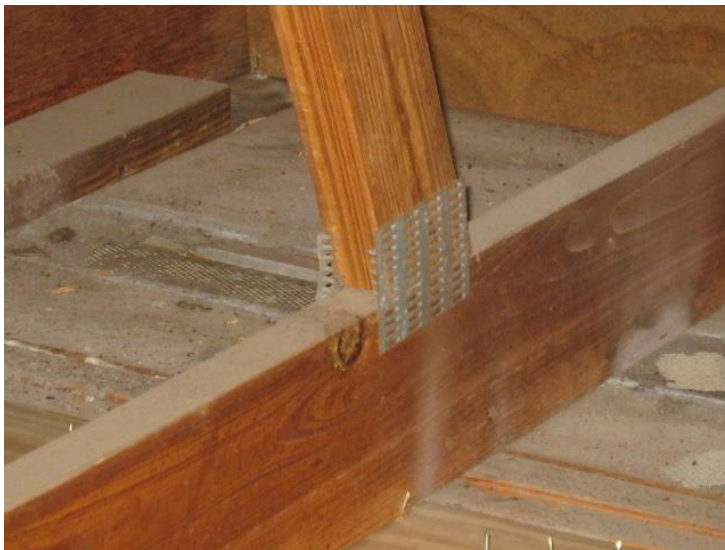
Roof to Wall Attachment
(Section 4)

Comments: | Toe Nails
Toe nails were verified during our attic inspection as the roof wall connection. |

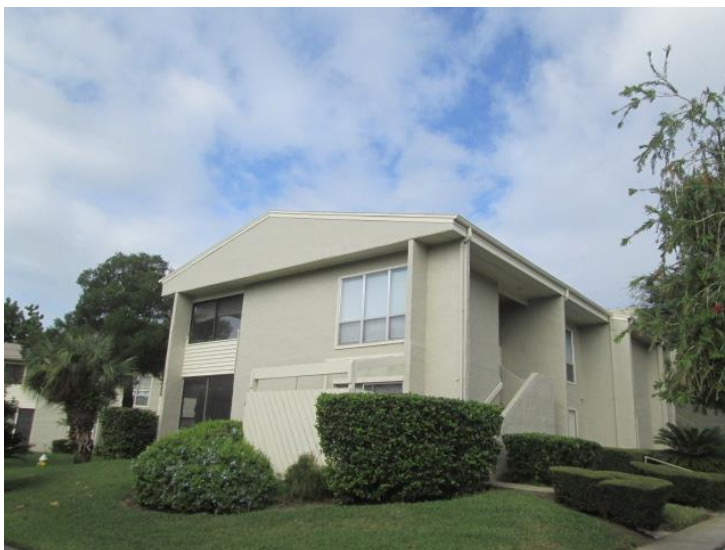
Roof Shape (Section 5)

Comments: | Other Roof
Inspection verified a gable roof shape. |
