## COMMERCIAL WINDSTORM MITIGATION INSPECTION REPORT (OIR-B1-1802)

Windrush Bay Condominium Association, Inc.

649-656 Windrush Bay Dr (Building 0)

As of 10/5/2015

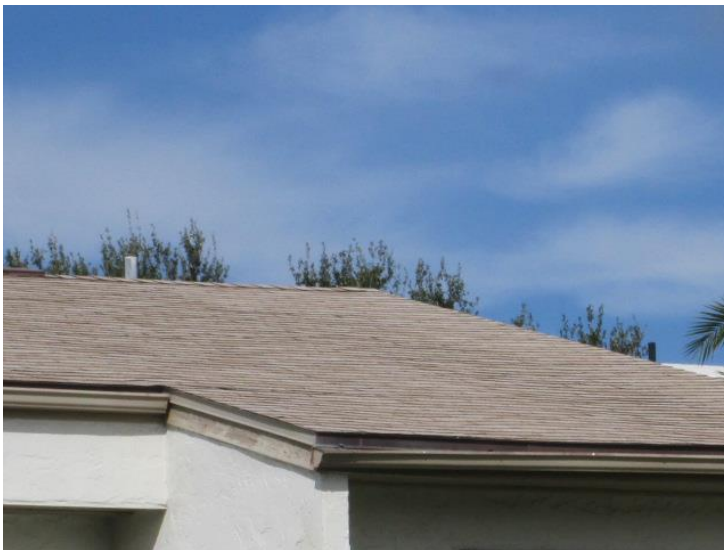
Roof Covering (Section 2)

| <b>2. <u>Roof Covering:</u></b><br>Comments: | <b>No roof coverings meet the minimum requirements</b><br>The roof covering was replaced in 2001. The roof permit was confirmed and the permit number is 01-2286. This roof was verified as not meeting the building code requirements outlined on the mitigation affidavit. |

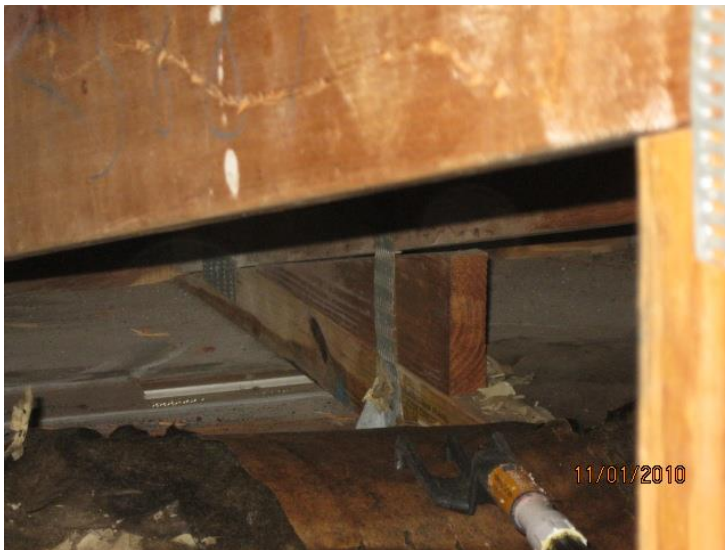
Roof to Wall Attachment  
(Section 4)

| <b>4. <u>Roof to Wall Attachment:</u></b><br>Comments: | <b>Clips</b><br>Inspection verified hurricane clips fastened with a minimum of three nails. |

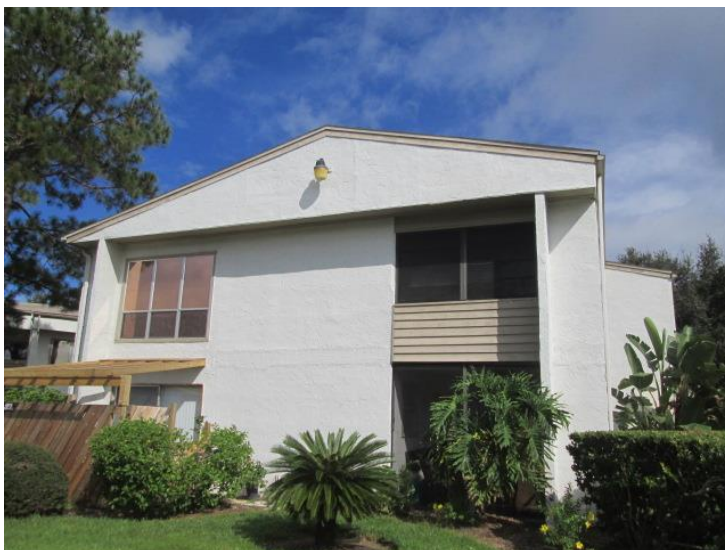
Roof Shape (Section 5)

| <b>5. <u>Roof Geometry:</u></b><br>Comments: | <b>Other Roof</b><br>Inspection verified a gable roof shape. |
