COMMERCIAL WINDSTORM MITIGATION INSPECTION REPORT (OIR-B1-1802)

Windrush Bay Condominium Association, Inc.

10 Windrush Bay Dr
Tarpon Springs, FL 34689

As of 10/5/2015

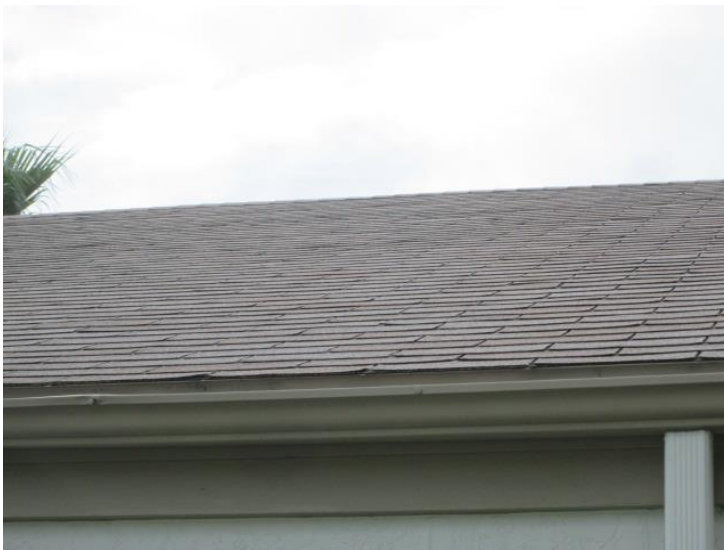
Roof Covering (Section 2)

Comments: | FBC Equivalent
The roof covering was replaced in 2003. The roof permit was confirmed and the permit number is 03-107. This roof was verified as meeting the building code requirements outlined on the mitigation affidavit. |

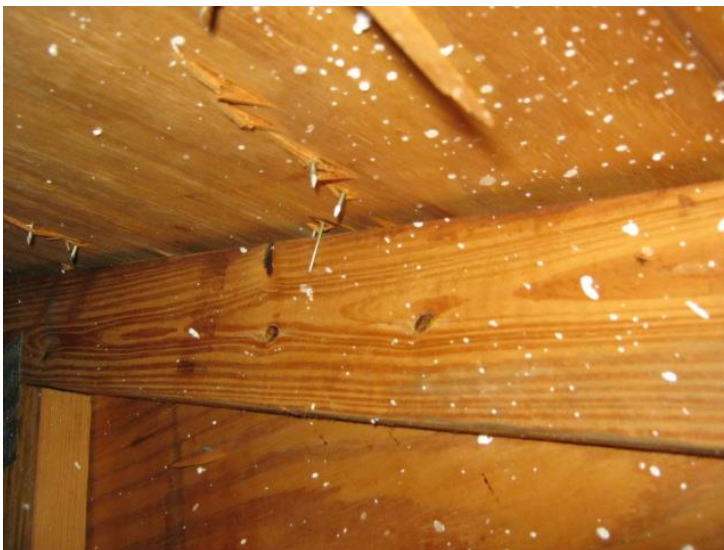
Roof Deck Attachment
(Section 3)

Comments: | Level A
Inspection verified 1/2" plywood roof deck attached with staples at a minimum of 6" on the edge & 12" in the field. |

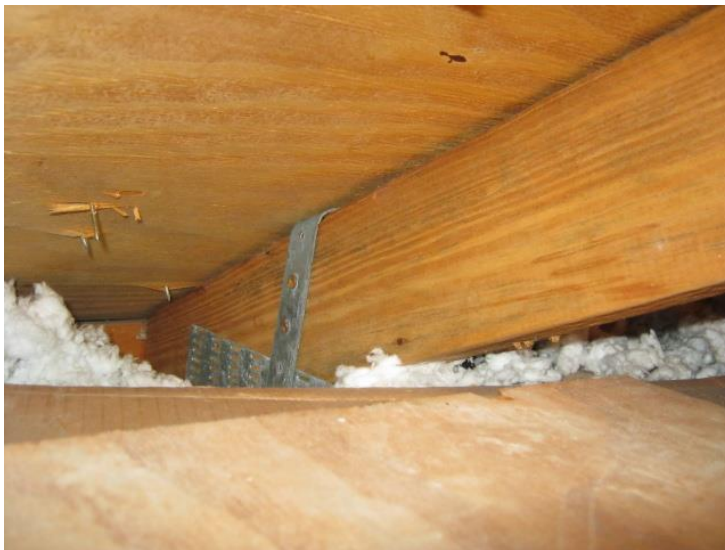
Roof to Wall Attachment (Section 4)

Comments: | Clips
Inspection verified embedded straps fastened with a minimum of three nails. |

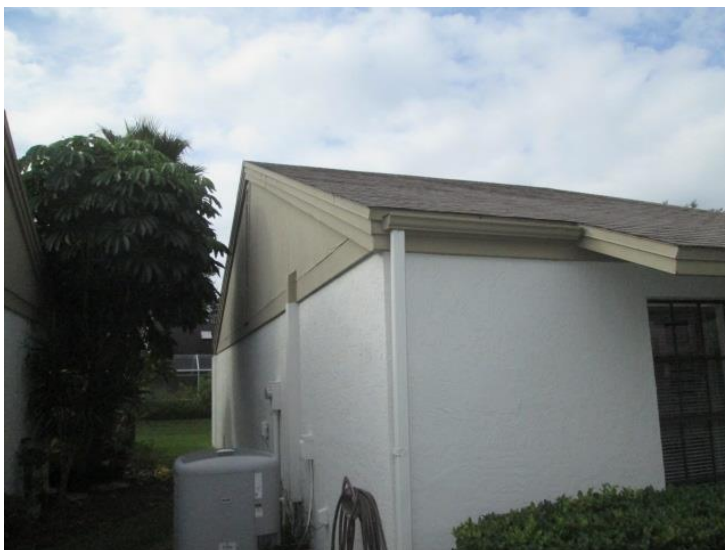
Roof Shape (Section 5)

Comments: | Other Roof
Inspection verified a gable roof shape. |
