## COMMERCIAL WINDSTORM MITIGATION INSPECTION REPORT (OIR-B1-1802)

Windrush Bay Condominium Association, Inc.

12 Windrush Bay Dr  
Tarpon Springs, FL 34689

As of 10/5/2015

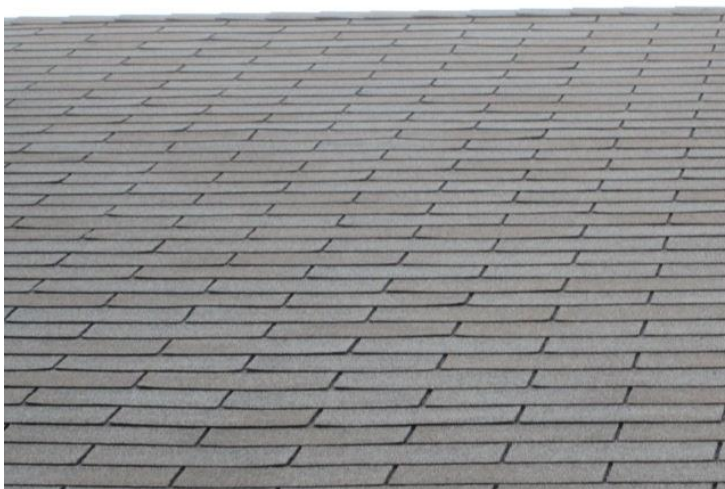
Roof Covering (Section 2)

| <b>2. <u>Roof Covering:</u></b><br>Comments: | <b>FBC Equivalent</b><br>The roof covering was replaced in 2003. The roof permit was confirmed and the permit number is 03-109. This roof was verified as meeting the building code requirements outlined on the mitigation affidavit. |

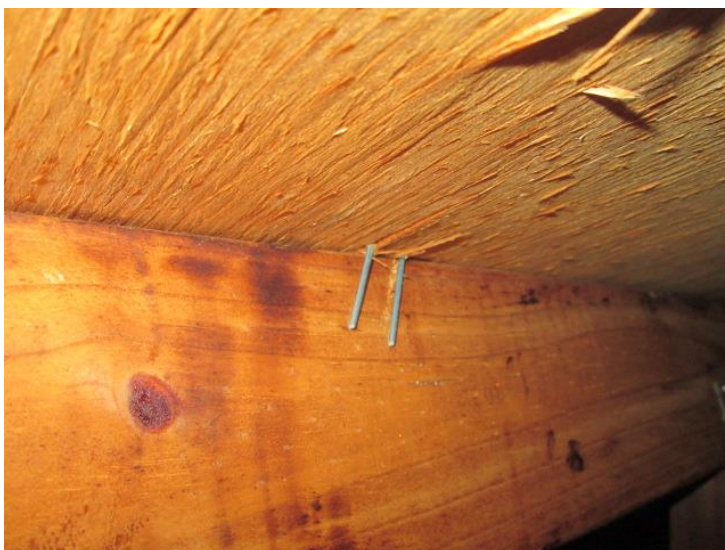
Roof Deck Attachment  
(Section 3)

| <b>3. <u>Roof Deck Attachment:</u></b><br>Comments: | <b>Level A</b><br>Inspection verified 1/2" plywood roof deck attached with staples at a minimum of 6" on the edge & 12" in the field. |

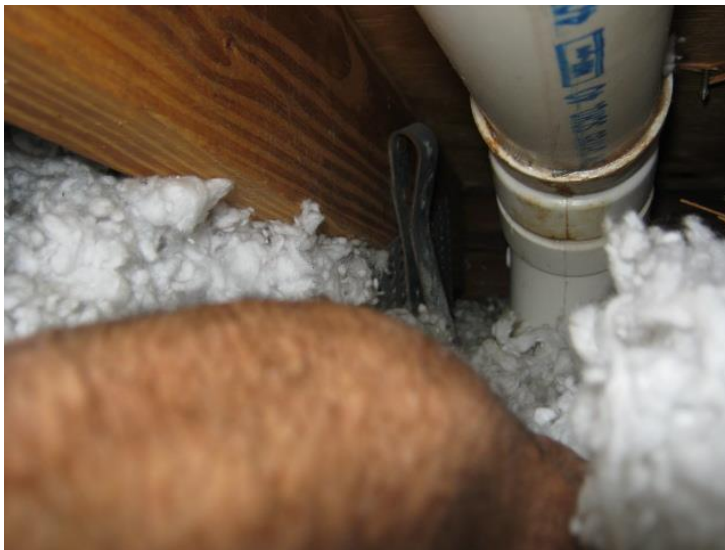
Roof to Wall Attachment (Section 4)

| <b>4. <u>Roof to Wall Attachment:</u></b><br>Comments: | <b>Clips</b><br>Inspection verified embedded straps fastened with a minimum of three nails. |

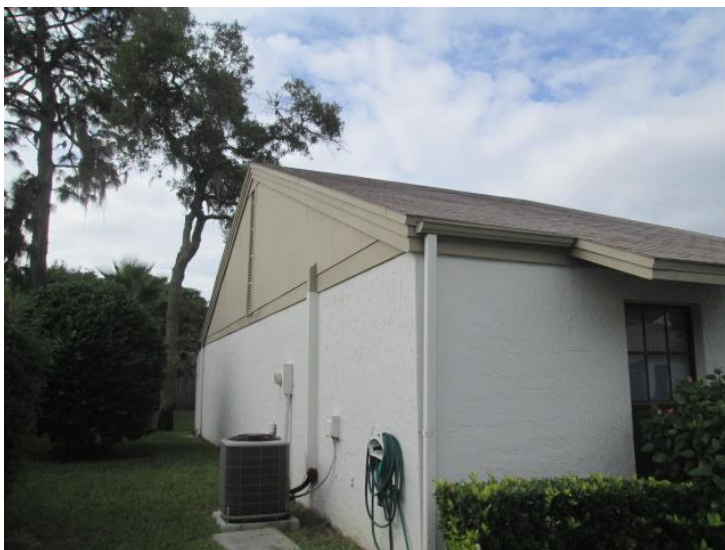
Roof Shape (Section 5)

| <b>5. <u>Roof Geometry:</u></b><br>Comments: | <b>Other Roof</b><br>Inspection verified a gable roof shape. |
