COMMERCIAL WINDSTORM MITIGATION INSPECTION REPORT (OIR-B1-1802)

Windrush Bay Condominium Association, Inc.

13 Windrush Bay Dr
Tarpon Springs, FL 34689

As of 10/5/2015

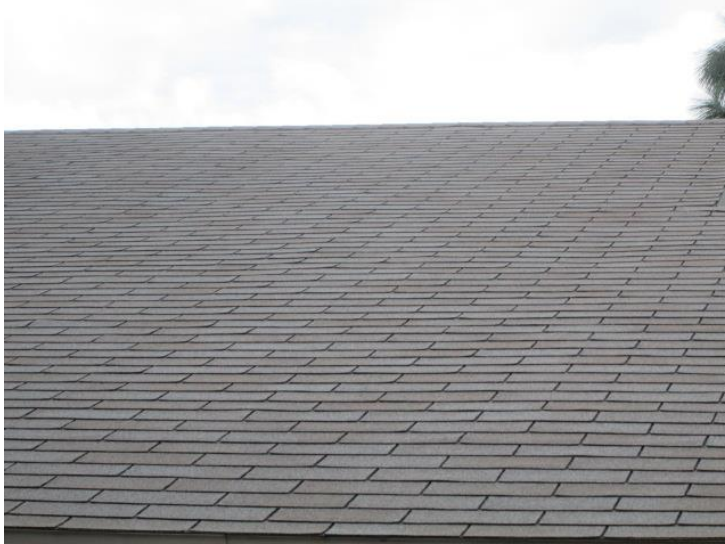
Roof Covering (Section 2)

| 2. <u>Roof Covering:</u> Comments: | FBC Equivalent The roof covering was replaced in 2003. The roof permit was confirmed and the permit number is 03-110. This roof was verified as meeting the building code requirements outlined on the mitigation affidavit. |

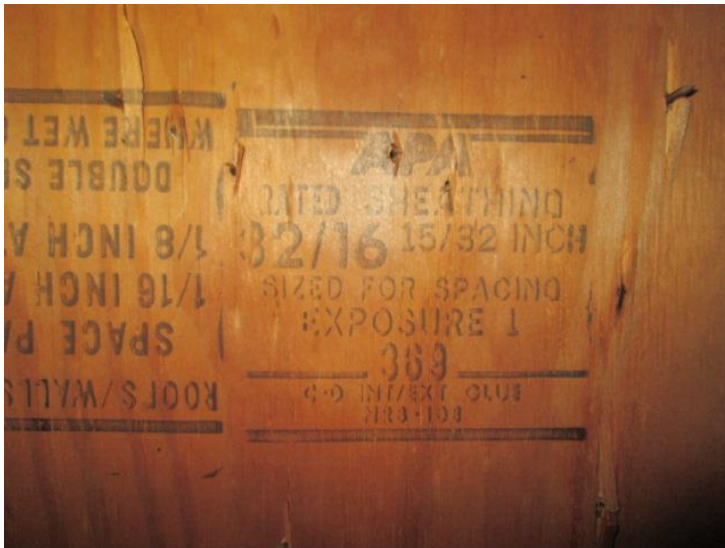
Roof Deck Material (Section 3)

| 3. <u>Roof Deck Attachment:</u> Comments: | Level A Inspection verified 1/2" plywood roof deck attached with staples at a minimum of 6" on the edge & 12" in the field. |

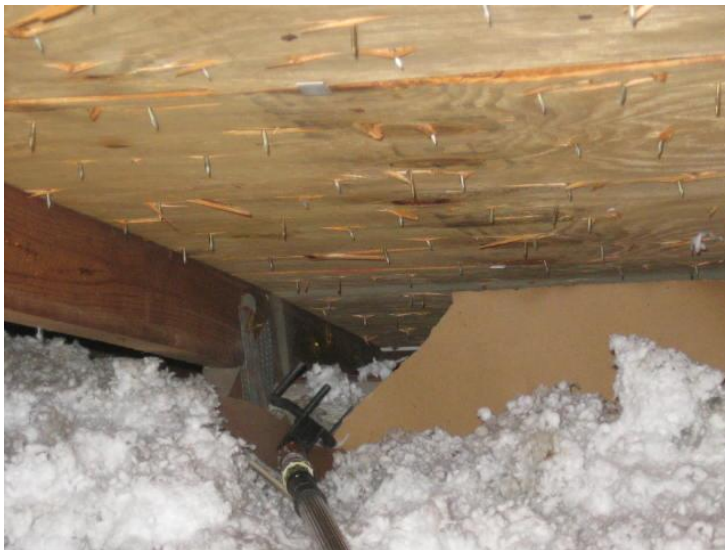
Roof to Wall Attachment
(Section 4)

| 4. <u>Roof to Wall Attachment:</u> Comments: | Clips Inspection verified embedded straps fastened with a minimum of three nails. |

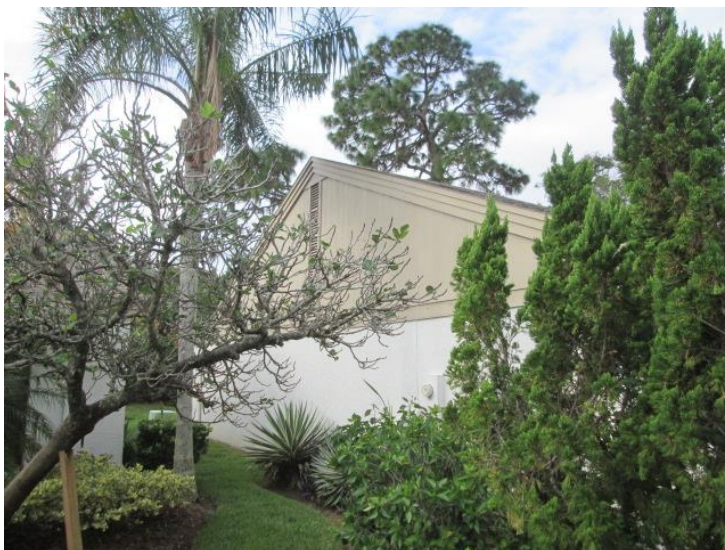
Roof Shape (Section 5)

| 5. <u>Roof Geometry:</u> Comments: | Other Roof Inspection verified a gable roof shape. |
