COMMERCIAL WINDSTORM MITIGATION INSPECTION REPORT (OIR-B1-1802)

Windrush Bay Condominium Association, Inc.

14 Windrush Bay Dr
Tarpon Springs, FL 34689

As of 10/5/2015

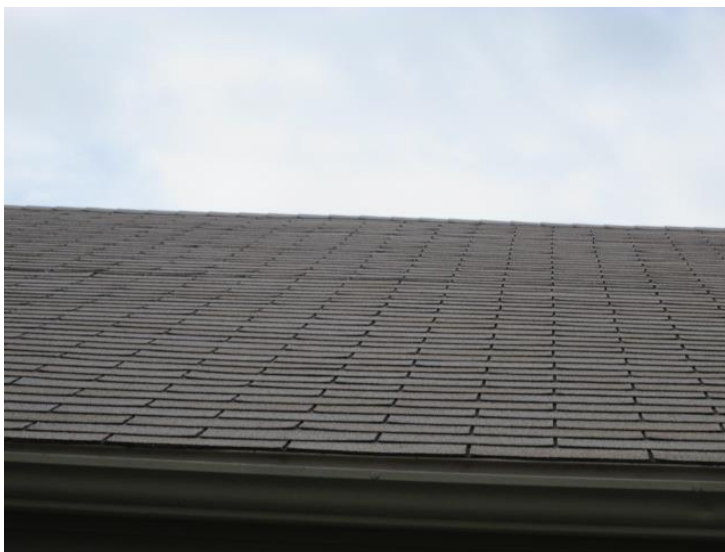
Roof Covering (Section 2)

Comments: | FBC Equivalent
The roof covering was replaced in 2003. The roof permit was confirmed and the permit number is 03-111. This roof was verified as meeting the building code requirements outlined on the mitigation affidavit. |

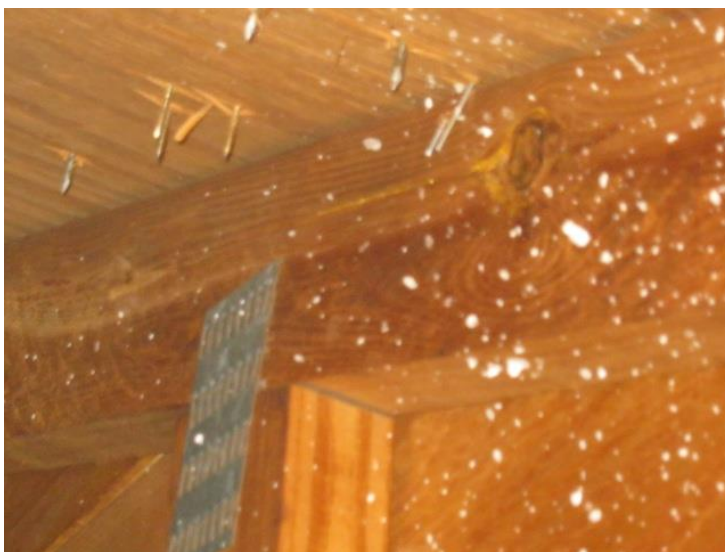
Roof Deck Attachment
(Section 3)

Comments: | Level A
Inspection verified 1/2" plywood roof deck attached with staples at a minimum of 6" on the edge & 12" in the field. |

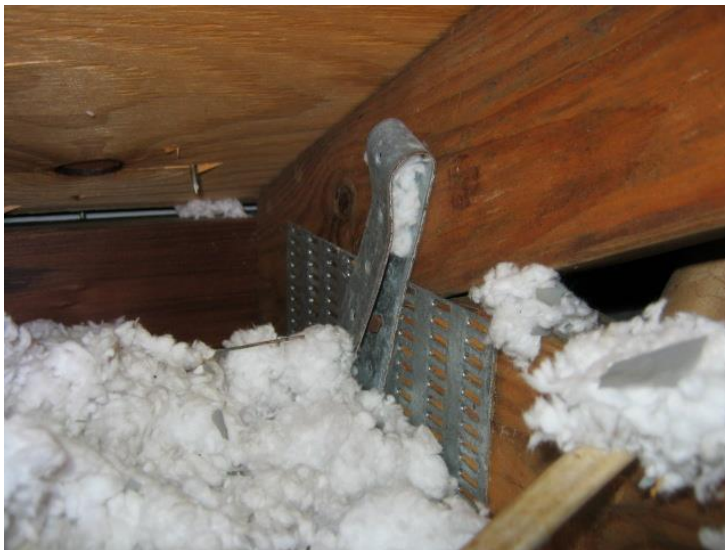
Roof to Wall Attachment (Section 4)

Comments: | Clips
Inspection verified embedded straps fastened with a minimum of three nails. |

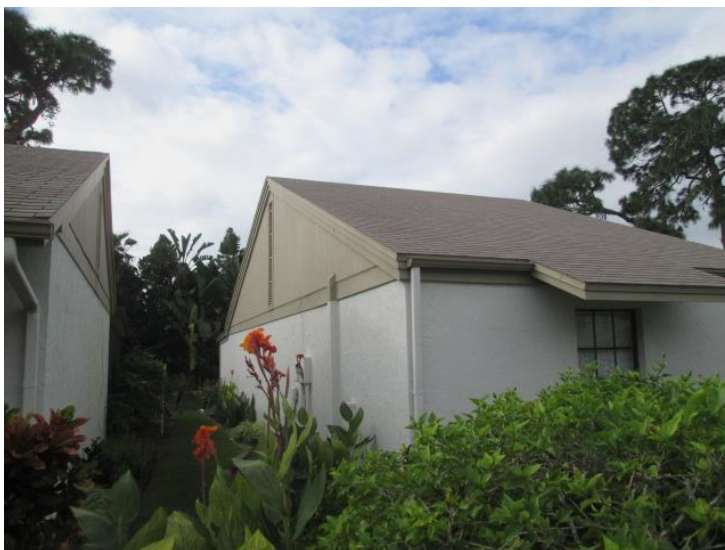
Roof Shape (Section 5)

Comments: | Other Roof
Inspection verified a gable roof shape. |
