COMMERCIAL WINDSTORM MITIGATION INSPECTION REPORT (OIR-B1-1802)

Windrush Bay Condominium Association, Inc.

18 Windrush Bay Dr
Tarpon Springs, FL 34689

As of 10/5/2015

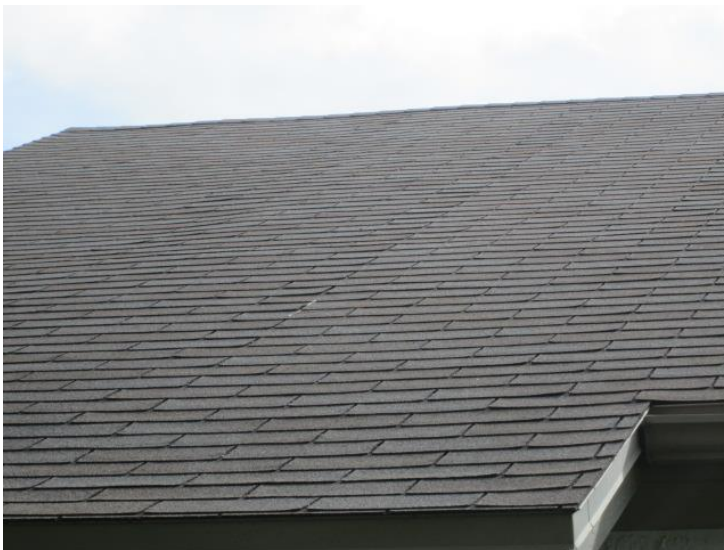
Roof Covering (Section 2)

Comments: | FBC Equivalent
The roof covering was replaced in 2003. The roof permit was confirmed and the permit number is 03-115. This roof was verified as meeting the building code requirements outlined on the mitigation affidavit. |

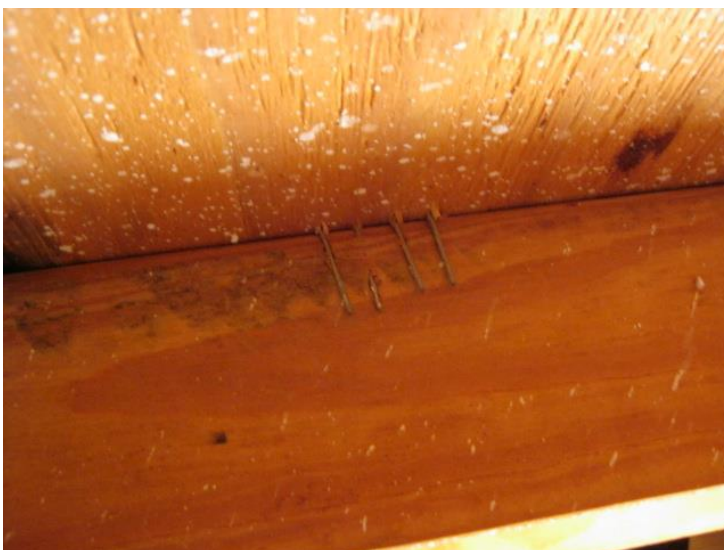
Roof Deck Attachment
(Section 3)

Comments: | Level A
Inspection verified 1/2" plywood roof deck attached with staples at a minimum of 6" on the edge & 12" in the field. |

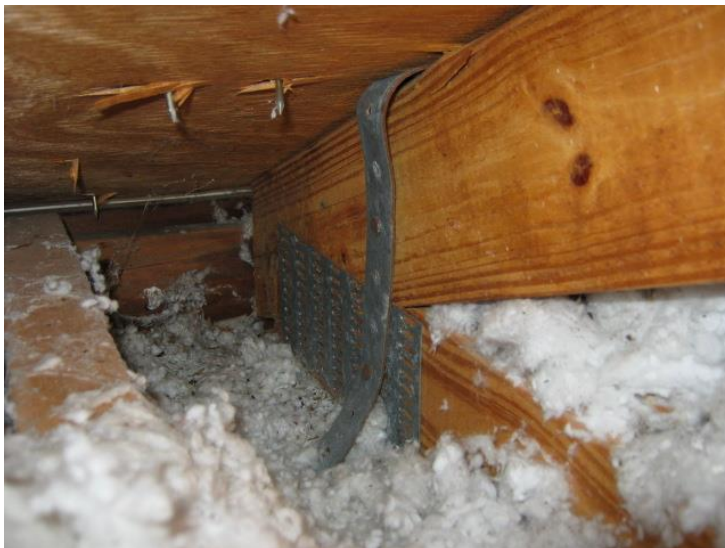
Roof to Wall Attachment (Section 4)

Comments: | Clips
Inspection verified embedded straps fastened with a minimum of three nails. |

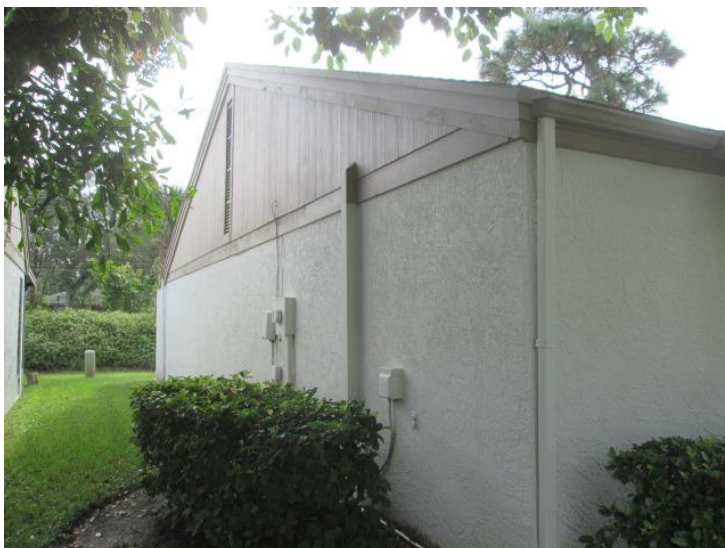
Roof Shape (Section 5)

Comments: | Other Roof
Inspection verified a gable roof shape. |
