COMMERCIAL WINDSTORM MITIGATION INSPECTION REPORT (OIR-B1-1802)

Windrush Bay Condominium Association, Inc.

2 Windrush Bay Dr
Tarpon Springs, FL 34689

As of 10/5/2015

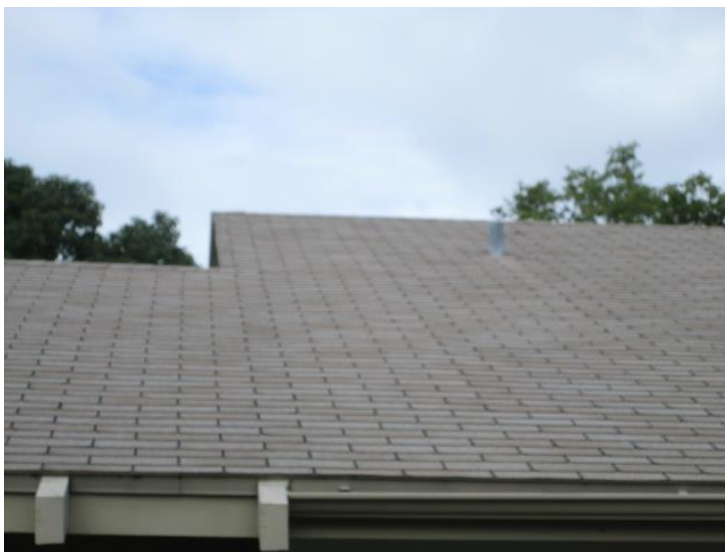
Roof Covering (Section 2)

Comments: | FBC Equivalent
The roof covering was replaced in 2003. The roof permit was confirmed and the permit number is 03-98. This roof was verified as meeting the building code requirements outlined on the mitigation affidavit. |

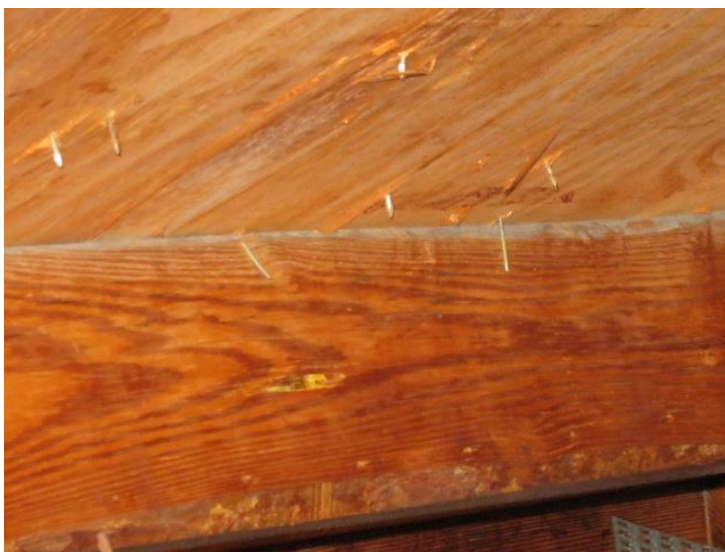
Roof Deck Attachment
(Section 3)

Comments: | Level A
Inspection verified 1/2" plywood roof deck attached with staples at a minimum of 6" on the edge & 12" in the field. |

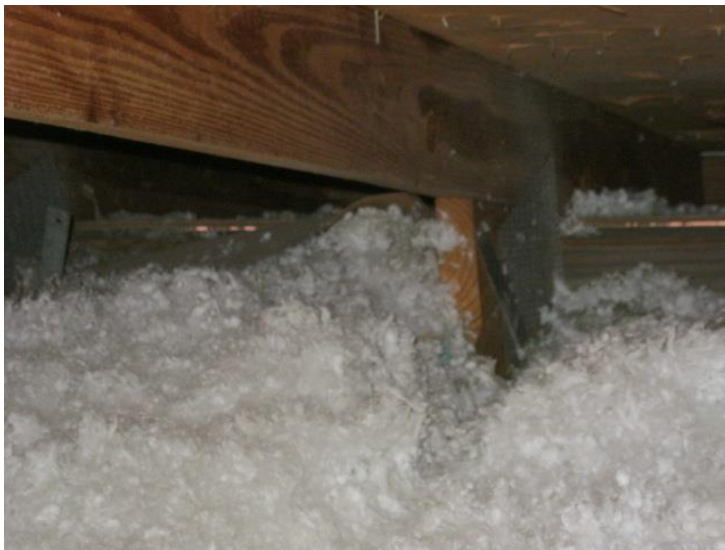
Roof to Wall Attachment (Section 4)

Comments: | Clips
Inspection verified embedded straps fastened with a minimum of three nails. |

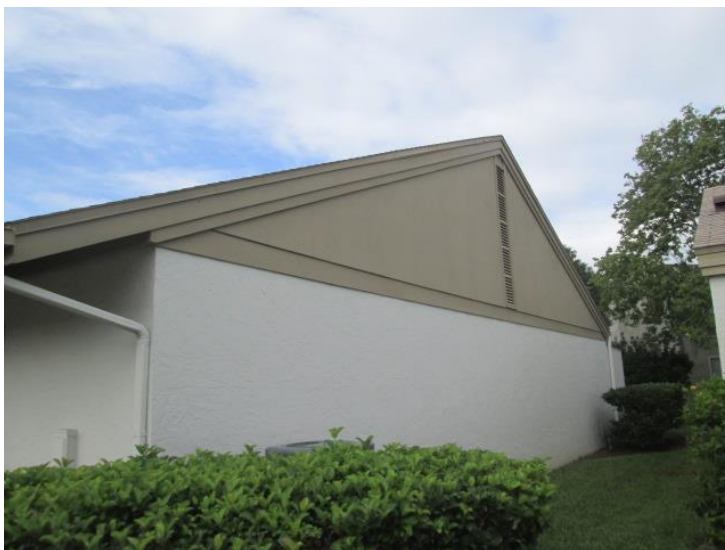
Roof Shape (Section 5)

Comments: | Other Roof
Inspection verified a gable roof shape. |
