COMMERCIAL WINDSTORM MITIGATION INSPECTION REPORT (OIR-B1-1802)

Windrush Bay Condominium Association, Inc.

20 Windrush Bay Dr
Tarpon Springs, FL 34689

As of 10/5/2015

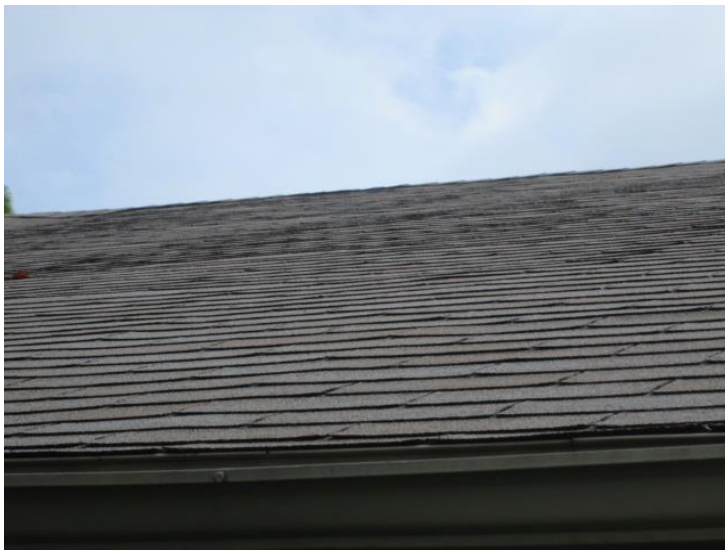
Roof Covering (Section 2)

Comments: | FBC Equivalent
The roof covering was replaced in 2003. The roof permit was confirmed and the permit number is 03-117. This roof was verified as meeting the building code requirements outlined on the mitigation affidavit. |

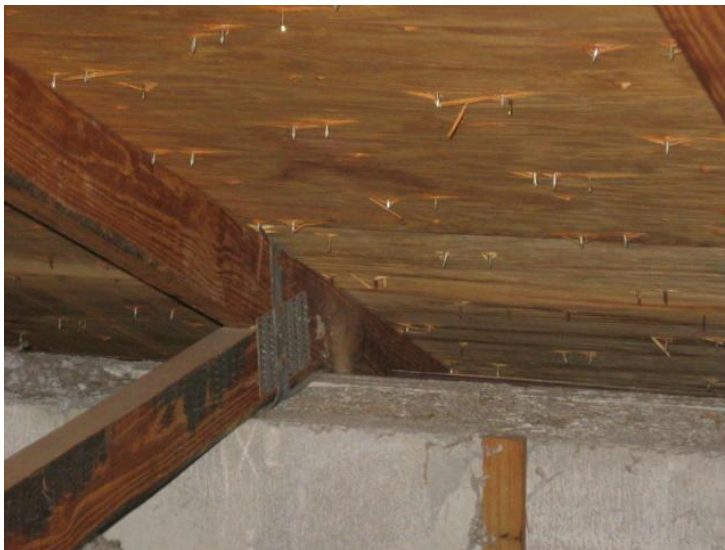
Roof to Wall Attachment
(Section 4)

Comments: | Clips
Inspection verified embedded straps fastened with a minimum of three nails. |

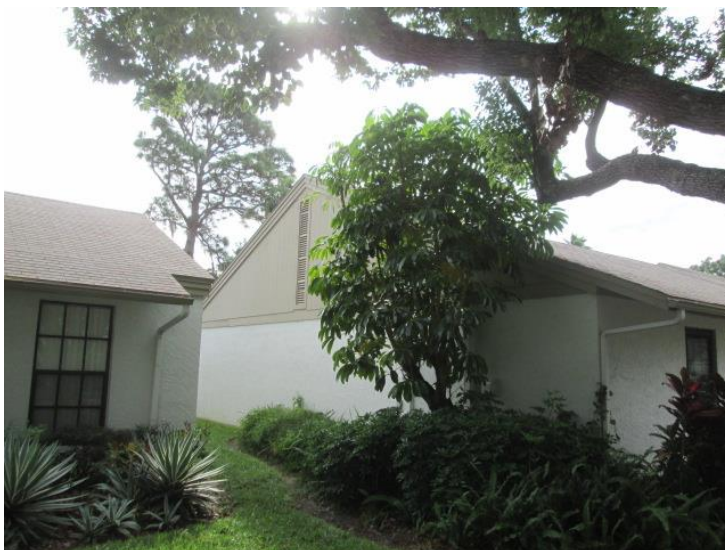
Roof Shape (Section 5)

Comments: | Other Roof
Inspection verified a gable roof shape. |
