COMMERCIAL WINDSTORM MITIGATION INSPECTION REPORT (OIR-B1-1802)

Windrush Bay Condominium Association, Inc.

21 Windrush Bay Dr
Tarpon Springs, FL 34689

As of 10/5/2015

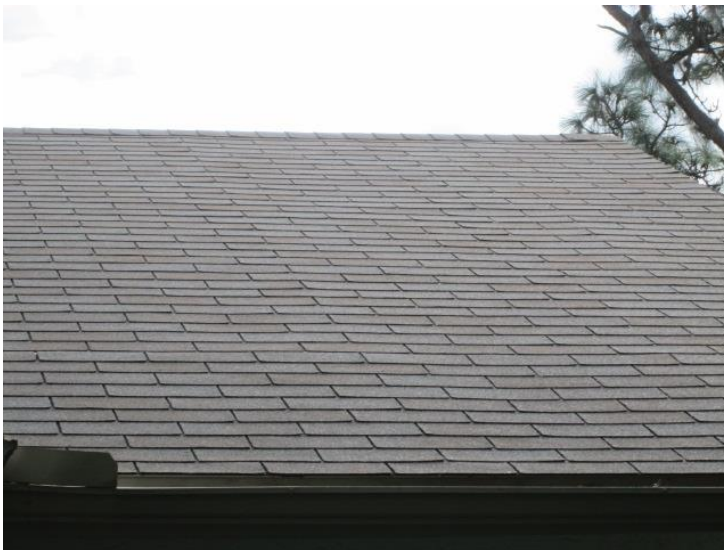
Roof Covering (Section 2)

| 2. <u>Roof Covering:</u> Comments: | FBC Equivalent The roof covering was replaced in 2003. The roof permit was confirmed and the permit number is 03-118. This roof was verified as meeting the building code requirements outlined on the mitigation affidavit. |

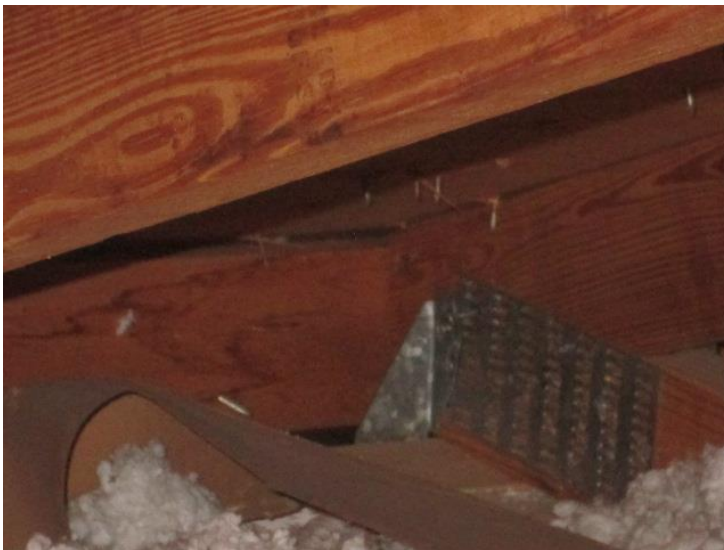
Roof to Wall Attachment
(Section 4)

| 4. <u>Roof to Wall Attachment:</u> Comments: | Clips Inspection verified hurricane clips fastened with a minimum of three nails. |

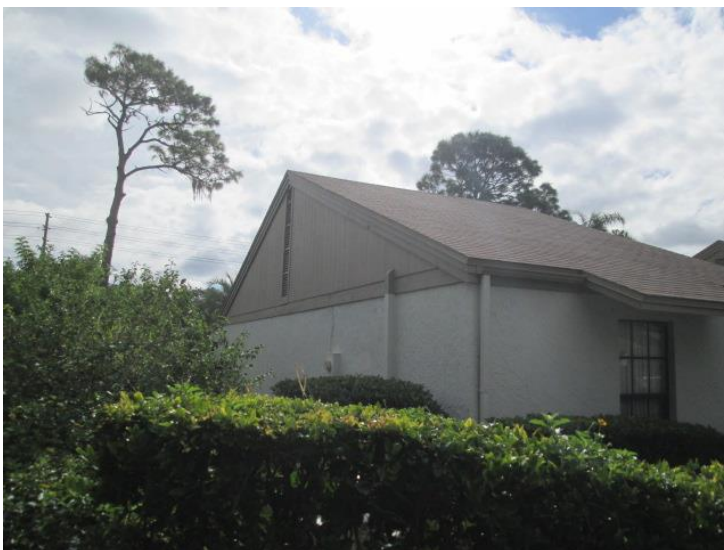
Roof Shape (Section 5)

| 5. <u>Roof Geometry:</u> Comments: | Other Roof Inspection verified a gable roof shape. |
