COMMERCIAL WINDSTORM MITIGATION INSPECTION REPORT (OIR-B1-1802)

Windrush Bay Condominium Association, Inc.

22 Windrush Bay Dr
Tarpon Springs, FL 34689

As of 10/5/2015

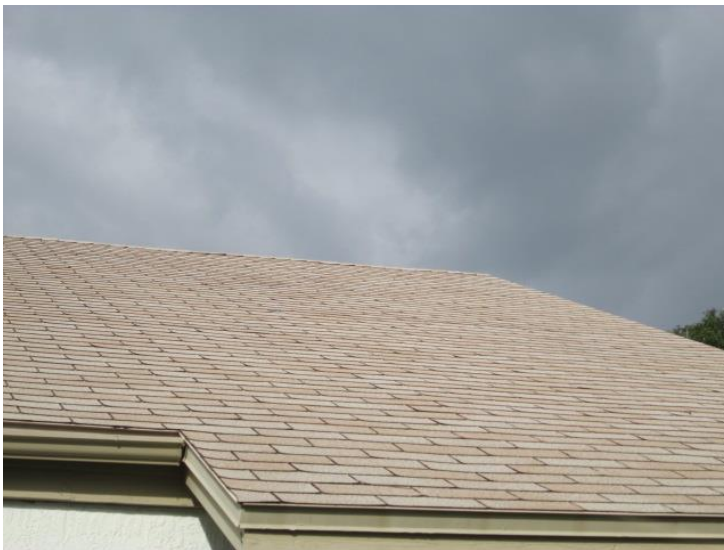
Roof Covering (Section 2)

Comments: | FBC Equivalent
The roof covering was replaced in 2003. The roof permit was confirmed and the permit number is 03-119. This roof was verified as meeting the building code requirements outlined on the mitigation affidavit. |

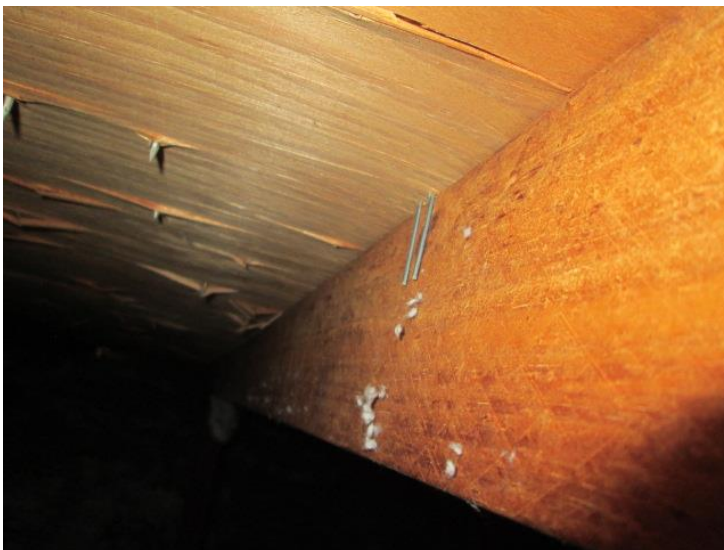
Roof Deck Attachment
(Section 3)

Comments: | Level A
Inspection verified 1/2" plywood roof deck attached with staples at a minimum of 6" on the edge & 12" in the field. |

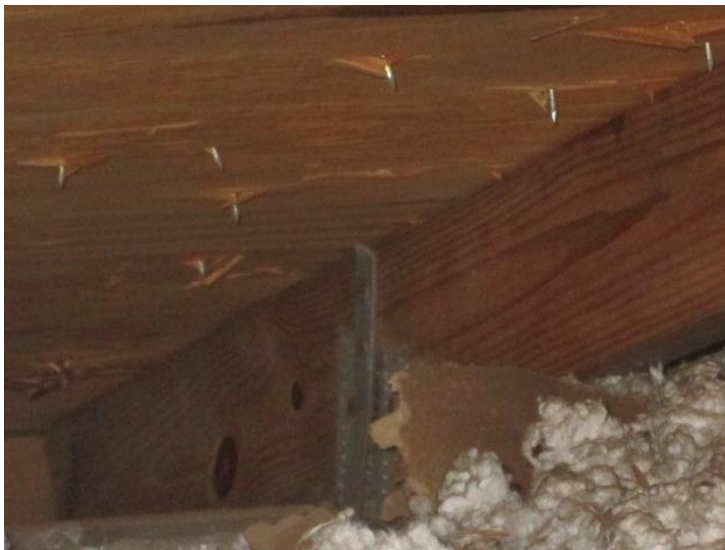
Roof to Wall Attachment (Section 4)

Comments: | Clips
Inspection verified embedded straps fastened with a minimum of three nails. |

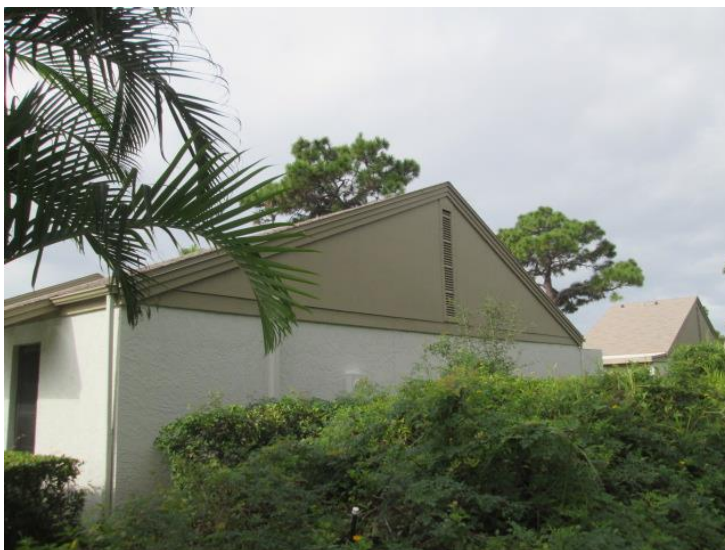
Roof Shape (Section 5)

Comments: | Other Roof
Inspection verified a gable roof shape. |
