COMMERCIAL WINDSTORM MITIGATION INSPECTION REPORT (OIR-B1-1802)

Windrush Bay Condominium Association, Inc.

25 Windrush Bay Dr
Tarpon Springs, FL 34689

As of 10/5/2015

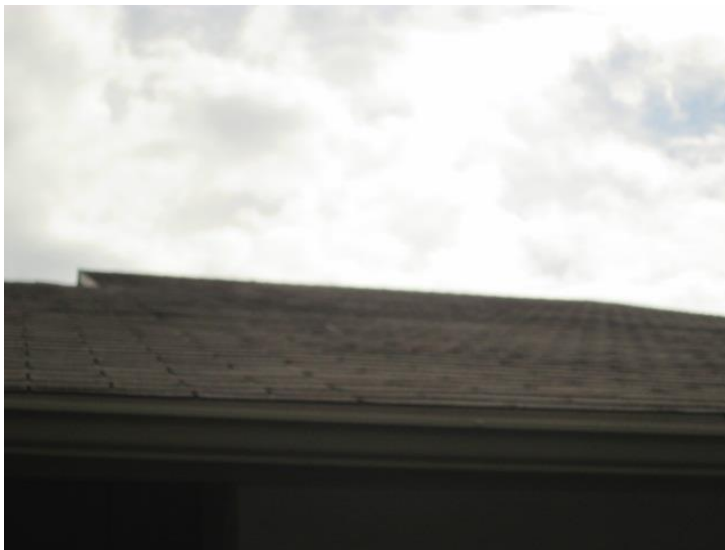
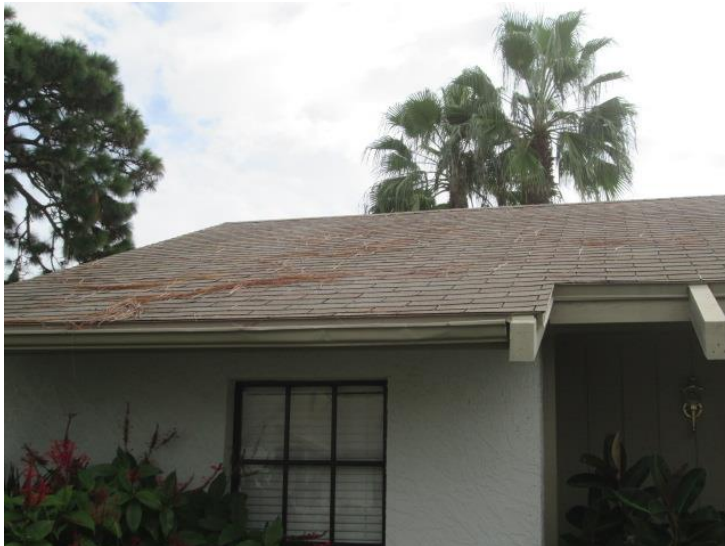
Roof Covering (Section 2)

Comments: | FBC Equivalent
The roof covering was replaced in 2003. The roof permit was confirmed and the permit number is 03-122. This roof was verified as meeting the building code requirements outlined on the mitigation affidavit. |

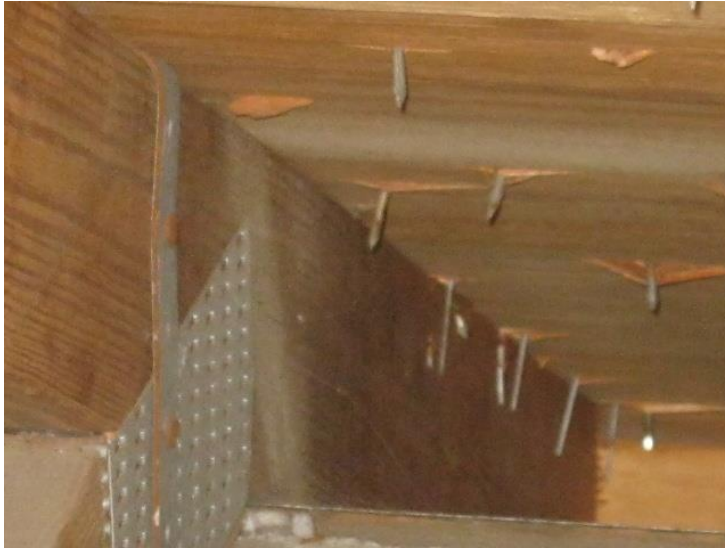
Roof Deck Attachment &
Roof-Wall
Attachment (Section 3 & 4)

Comments: | Level A
Inspection verified 1/2" plywood roof deck attached with staples at a minimum of 6" on the edge & 12" in the field. |

Comments: | Clips
Inspection verified embedded straps fastened with a minimum of three nails. |

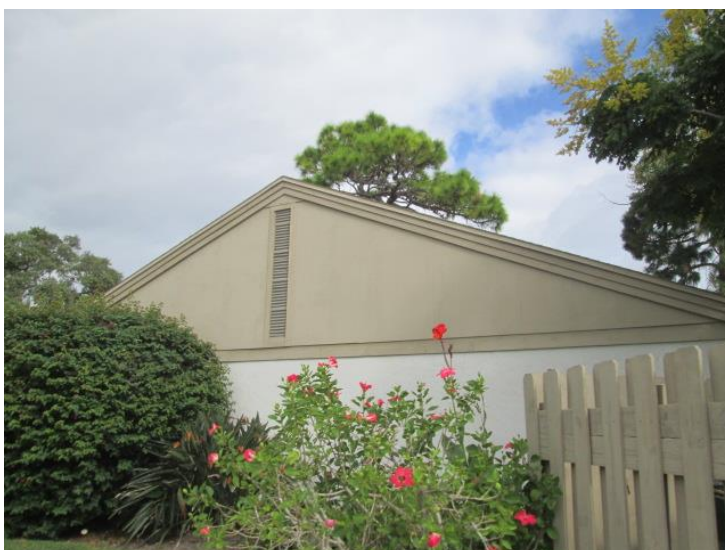
Roof Shape (Section 5)

Comments: | Other Roof
Inspection verified a gable roof shape. |
