COMMERCIAL WINDSTORM MITIGATION INSPECTION REPORT (OIR-B1-1802)

Windrush Bay Condominium Association, Inc.

27 Windrush Bay Dr
Tarpon Springs, FL 34689

RECAPITULATION OF MITIGATION FEATURES
For 27 Windrush Bay Dr

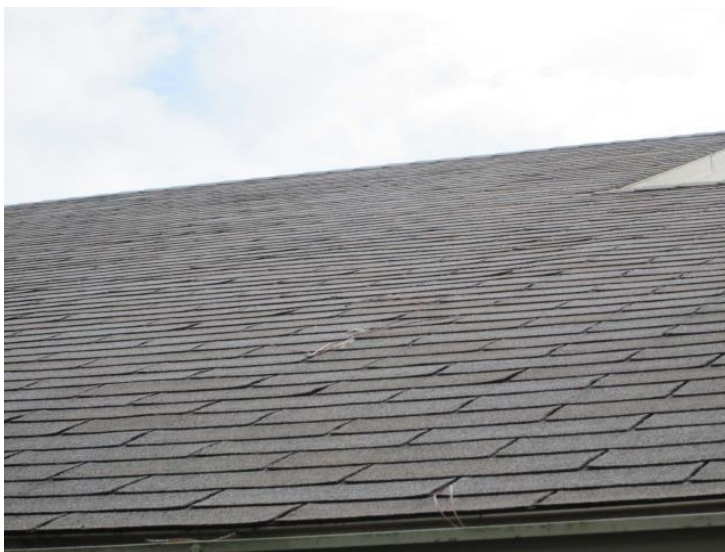
Roof Covering (Section 2)

Comments: | FBC Equivalent
The roof covering was replaced in 2003. The roof permit was confirmed and the permit number is 03-124. This roof was verified as meeting the building code requirements outlined on the mitigation affidavit. |

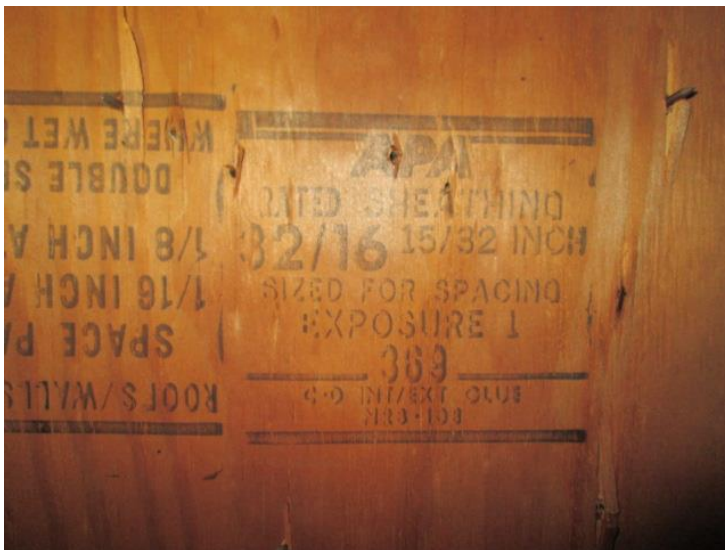
Roof Deck Material (Section 3)

Comments: | Level A
Inspection verified 1/2" plywood roof deck attached with staples at a minimum of 6" on the edge & 12" in the field. |

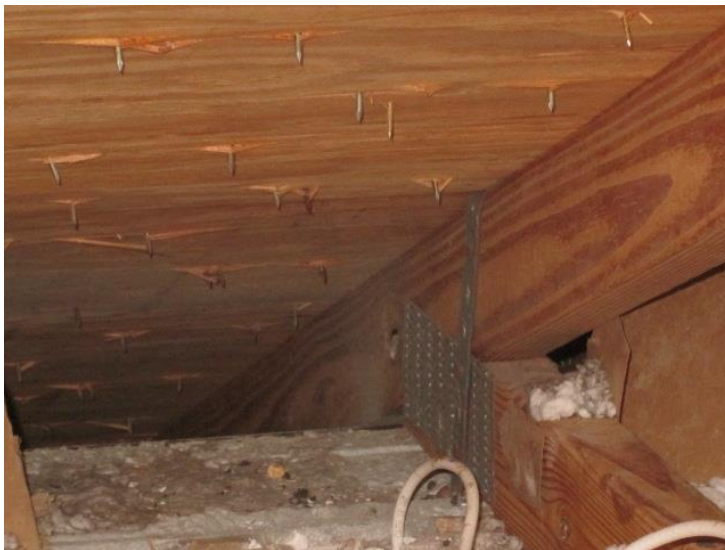
Roof to Wall Attachment
(Section 4)

Comments: | Clips
Inspection verified embedded straps fastened with a minimum of three nails. |

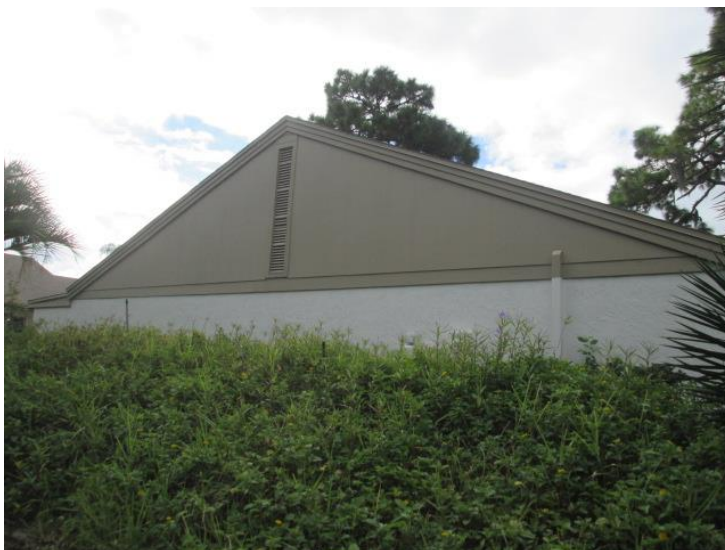
Roof Shape (Section 5)

Comments: | Other Roof
Inspection verified a gable roof shape. |
