COMMERCIAL WINDSTORM MITIGATION INSPECTION REPORT (OIR-B1-1802)

Windrush Bay Condominium Association, Inc.

29 Windrush Bay Dr
Tarpon Springs, FL 34689

As of 10/5/2015

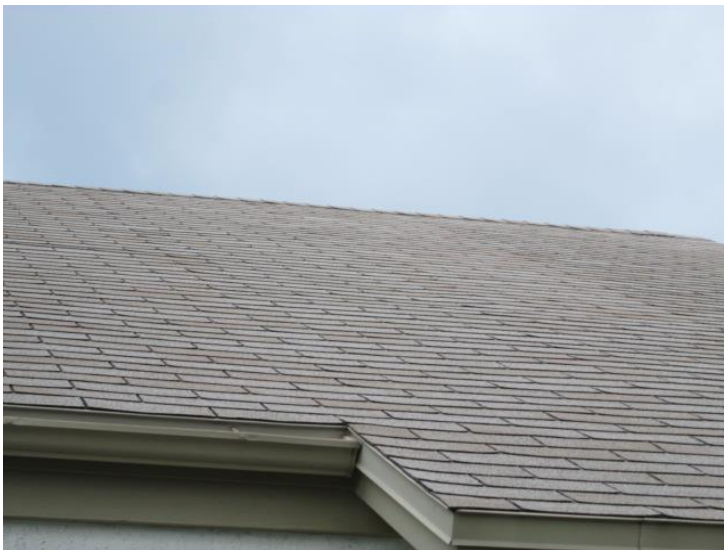
Roof Covering (Section 2)

Comments: | FBC Equivalent
The roof covering was replaced in 2003. The roof permit was confirmed and the permit number is 03-126. This roof was verified as meeting the building code requirements outlined on the mitigation affidavit. |

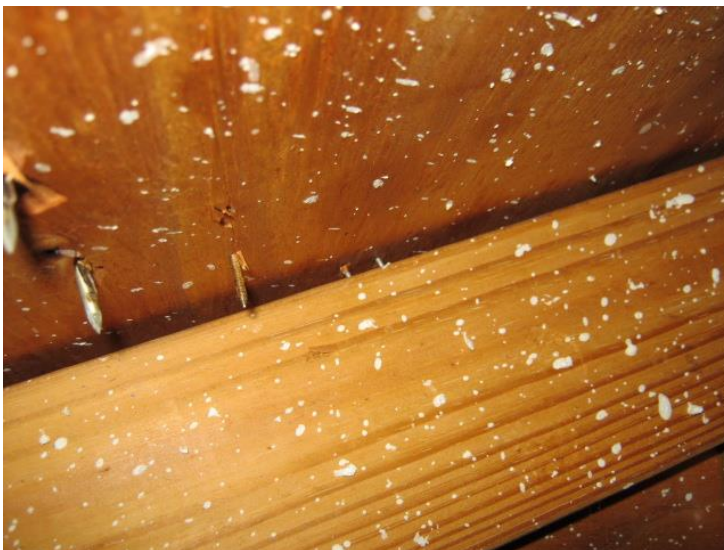
Roof Deck Attachment
(Section 3)

Comments: | Level A
Inspection verified 1/2" plywood roof deck attached with staples at a minimum of 6" on the edge & 12" in the field. |

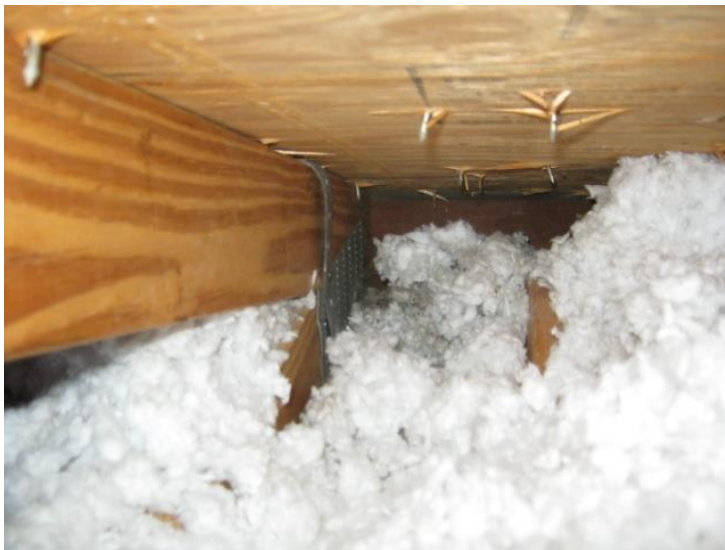
Roof to Wall Attachment (Section 4)

Comments: | Clips
Inspection verified embedded straps fastened with a minimum of three nails. |

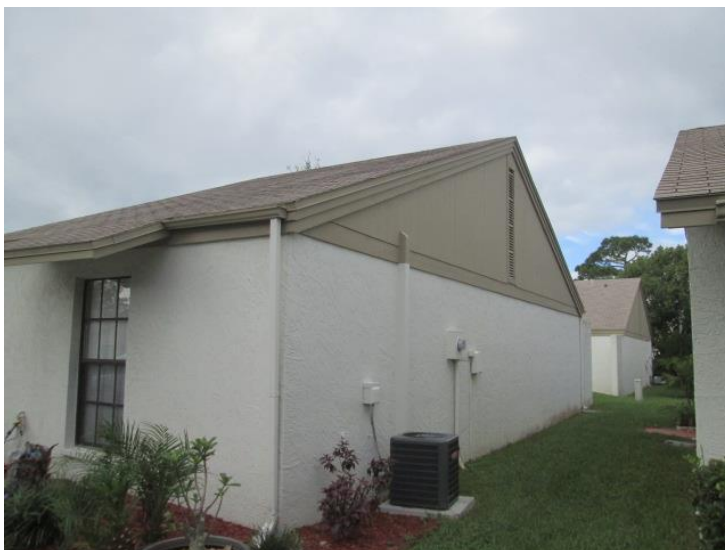
Roof Shape (Section 5)

Comments: | Other Roof
Inspection verified a gable roof shape. |
