COMMERCIAL WINDSTORM MITIGATION INSPECTION REPORT (OIR-B1-1802)

Windrush Bay Condominium Association, Inc.

3 Windrush Bay Dr
Tarpon Springs, FL 34689

As of 10/5/2015

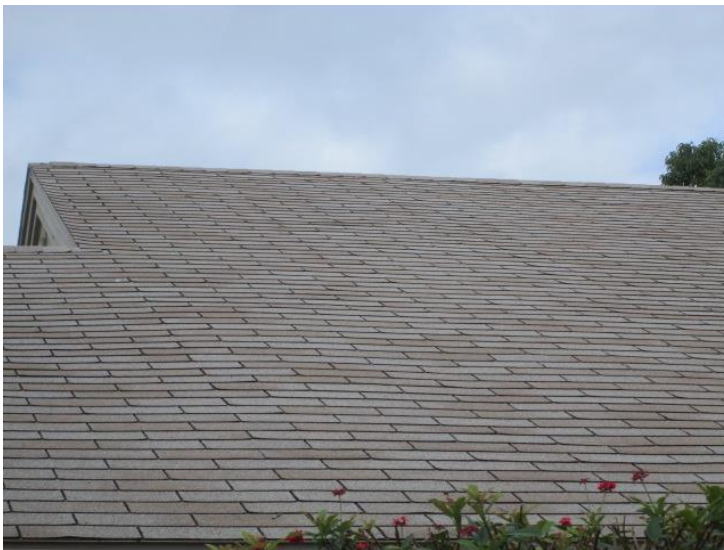
Roof Covering (Section 2)

Comments: | FBC Equivalent
The roof covering was replaced in 2003. The roof permit was confirmed and the permit number is 03-99. This roof was verified as meeting the building code requirements outlined on the mitigation affidavit. |

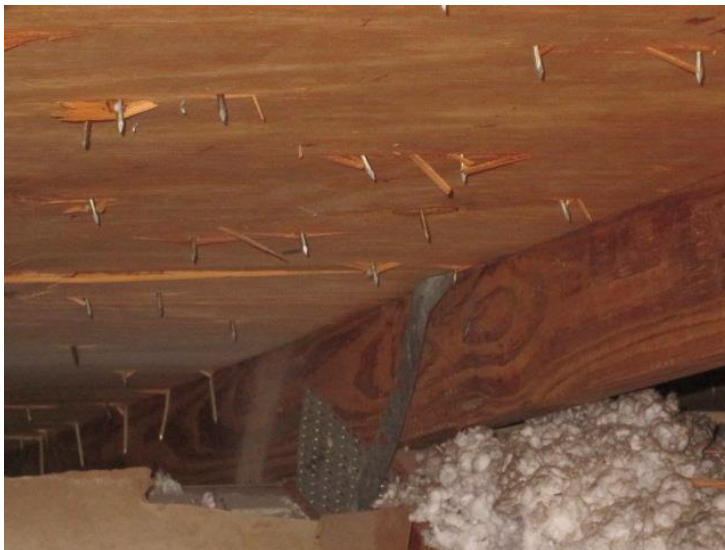
Roof to Wall Attachment
(Section 4)

Comments: | Clips
Inspection verified embedded straps fastened with a minimum of three nails. |

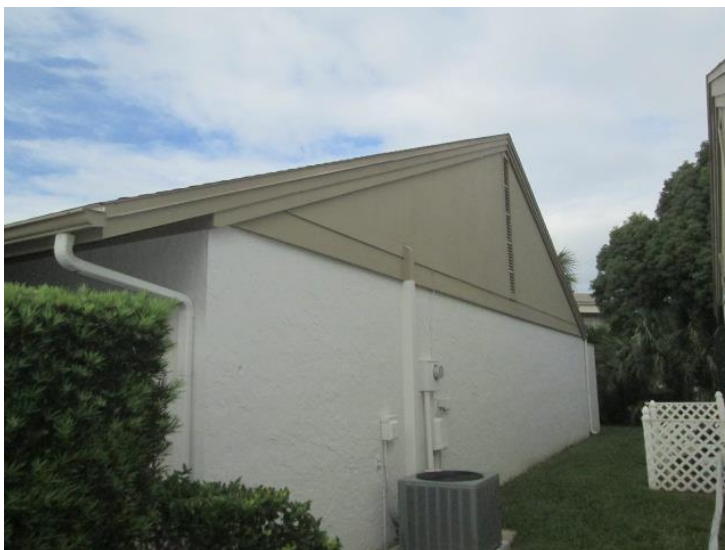
Roof Shape (Section 5)

Comments: | Other Roof
Inspection verified a gable roof shape. |
