## COMMERCIAL WINDSTORM MITIGATION INSPECTION REPORT (OIR-B1-1802)

Windrush Bay Condominium Association, Inc.

31 Windrush Bay Dr  
Tarpon Springs, FL 34689

As of 10/5/2015

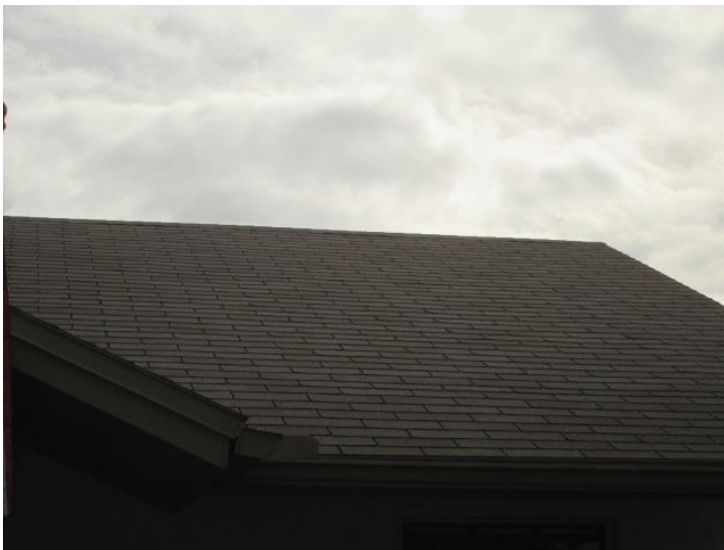
Roof Covering (Section 2)

| 2. <b><u>Roof Covering:</u></b><br>Comments: | <b>FBC Equivalent</b><br>The roof covering was replaced in 2003. The roof permit was confirmed and the permit number is 03-128. This roof was verified as meeting the building code requirements outlined on the mitigation affidavit. |

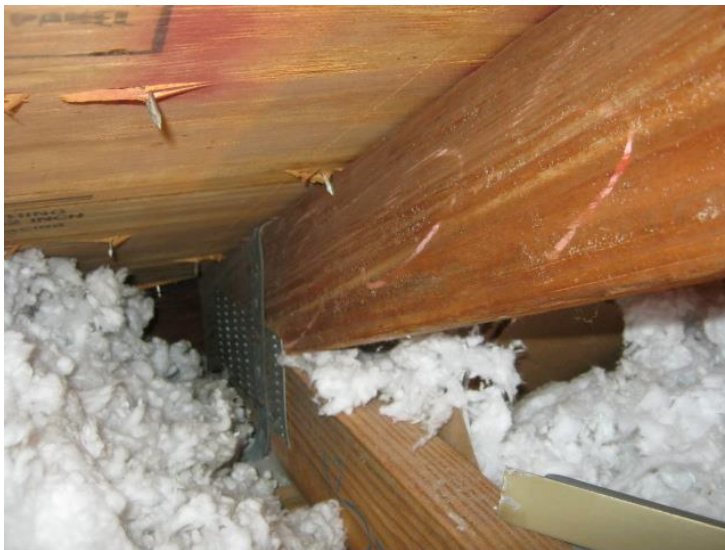
Roof to Wall Attachment (Section 4)

| 4. <b><u>Roof to Wall Attachment:</u></b><br>Comments: | <b>Clips</b><br>Inspection verified embedded straps fastened with a minimum of three nails. |

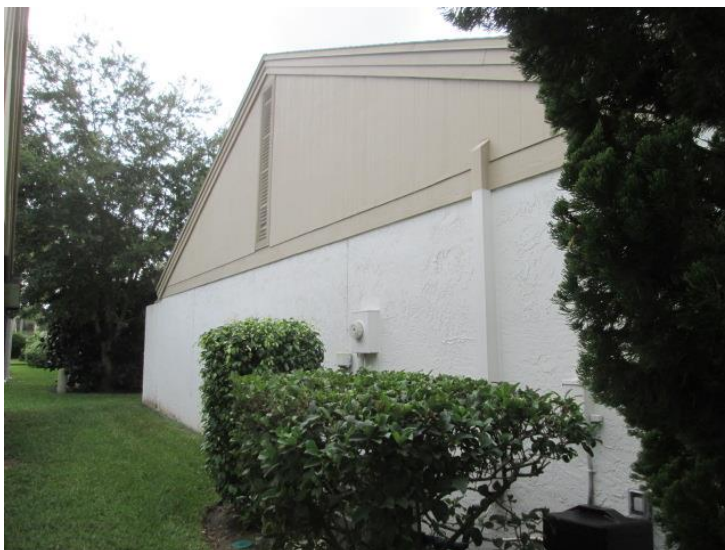
Roof Shape (Section 5)

| 5. <b><u>Roof Geometry:</u></b><br>Comments: | <b>Other Roof</b><br>Inspection verified a gable roof shape. |
