# COMMERCIAL WINDSTORM MITIGATION INSPECTION REPORT (OIR-B1-1802)

Windrush Bay Condominium Association, Inc.

32 Windrush Bay Dr  
Tarpon Springs, FL 34689

As of 10/5/2015

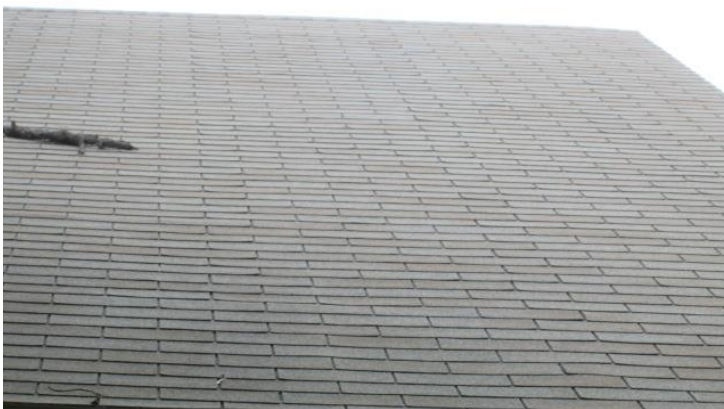
Roof Covering (Section 2)

| <b>2. <u>Roof Covering:</u></b><br>Comments: | <b>FBC Equivalent</b><br>The roof covering was replaced in 2003. The roof permit was confirmed and the permit number is 03-129. This roof was verified as meeting the building code requirements outlined on the mitigation affidavit. |

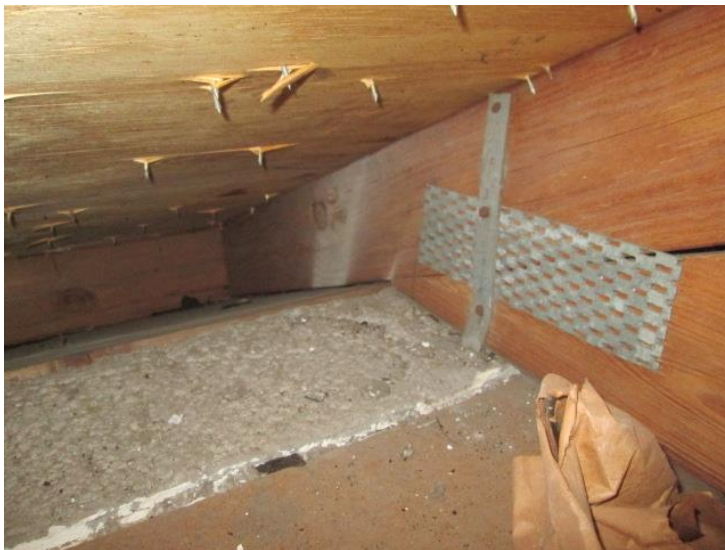
Roof to Wall Attachment  
(Section 4)

| <b>4. <u>Roof to Wall Attachment:</u></b><br>Comments: | <b>Clips</b><br>Inspection verified embedded straps fastened with a minimum of three nails. |

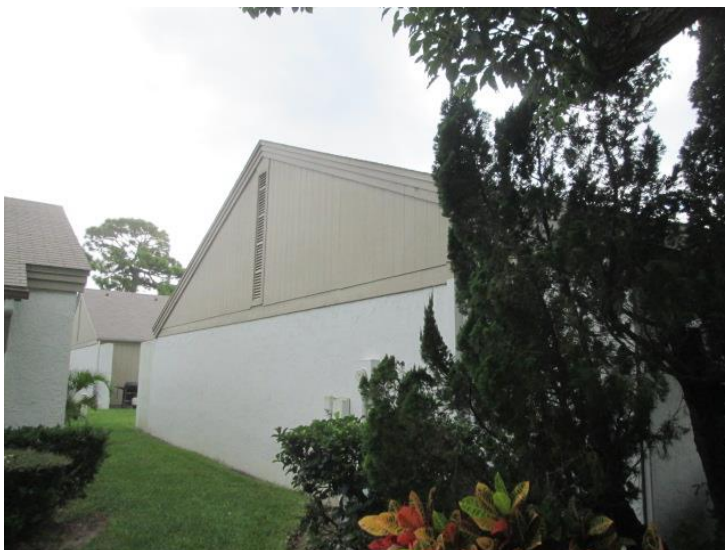
Roof Shape (Section 5)

| <b>5. <u>Roof Geometry:</u></b><br>Comments: | <b>Other Roof</b><br>Inspection verified a gable roof shape. |
