## COMMERCIAL WINDSTORM MITIGATION INSPECTION REPORT (OIR-B1-1802)

Windrush Bay Condominium Association, Inc.

33 Windrush Bay Dr  
Tarpon Springs, FL 34689

As of 10/5/2015

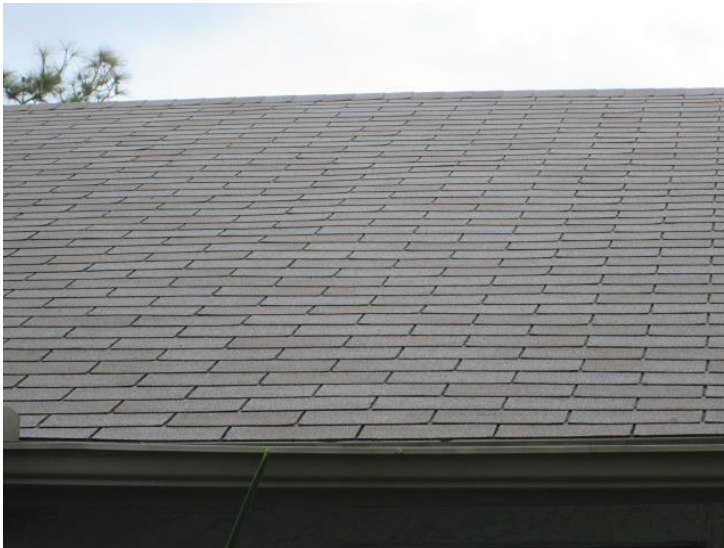
Roof Covering (Section 2)

| <b>2. <u>Roof Covering:</u></b><br>Comments: | <b>FBC Equivalent</b><br>The roof covering was replaced in 2003. The roof permit was confirmed and the permit number is 03-130. This roof was verified as meeting the building code requirements outlined on the mitigation affidavit. |

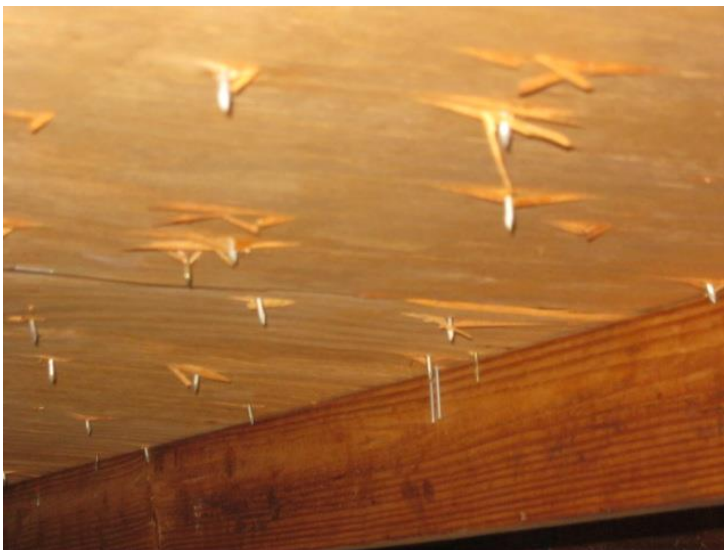
Roof Deck Attachment  
(Section 3)

| <b>3. <u>Roof Deck Attachment:</u></b><br>Comments: | <b>Level A</b><br>Inspection verified 1/2" plywood roof deck attached with staples at a minimum of 6" on the edge & 12" in the field. |

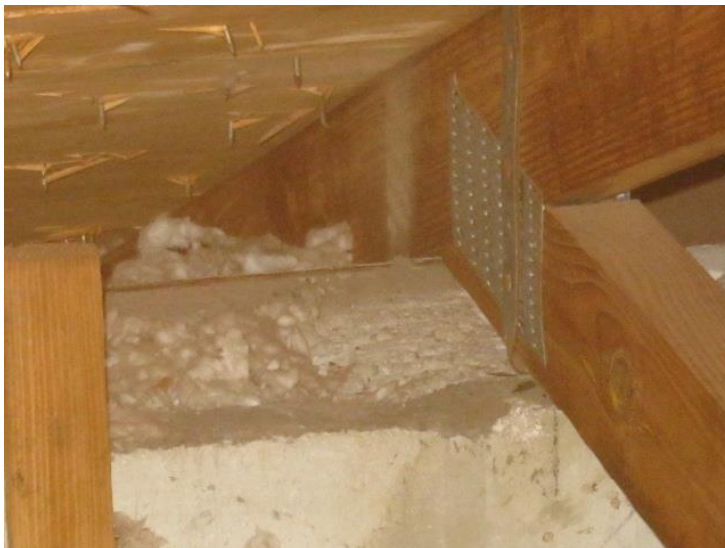
Roof to Wall Attachment (Section 4)

| <b>4. <u>Roof to Wall Attachment:</u></b><br>Comments: | <b>Clips</b><br>Inspection verified embedded straps fastened with a minimum of three nails. |

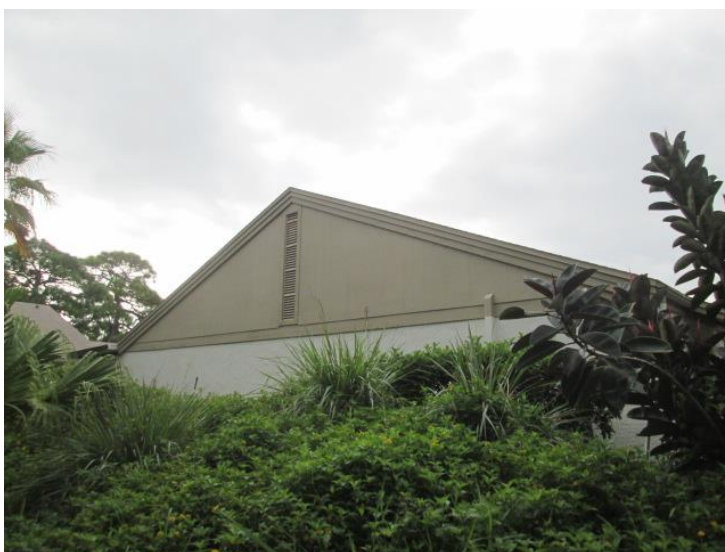
Roof Shape (Section 5)

| <b>5. <u>Roof Geometry:</u></b><br>Comments: | <b>Other Roof</b><br>Inspection verified a gable roof shape. |
