COMMERCIAL WINDSTORM MITIGATION INSPECTION REPORT (OIR-B1-1802)

Windrush Bay Condominium Association, Inc.

34 Windrush Bay Dr
Tarpon Springs, FL 34689

As of 10/5/2015

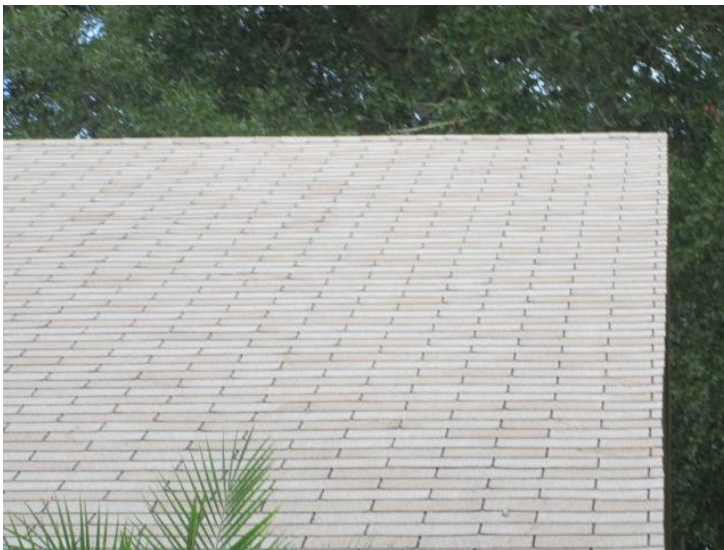
Roof Covering (Section 2)

Comments: | FBC Equivalent
The roof covering was replaced in 2003. The roof permit was confirmed and the permit number is 03-131. This roof was verified as meeting the building code requirements outlined on the mitigation affidavit. |

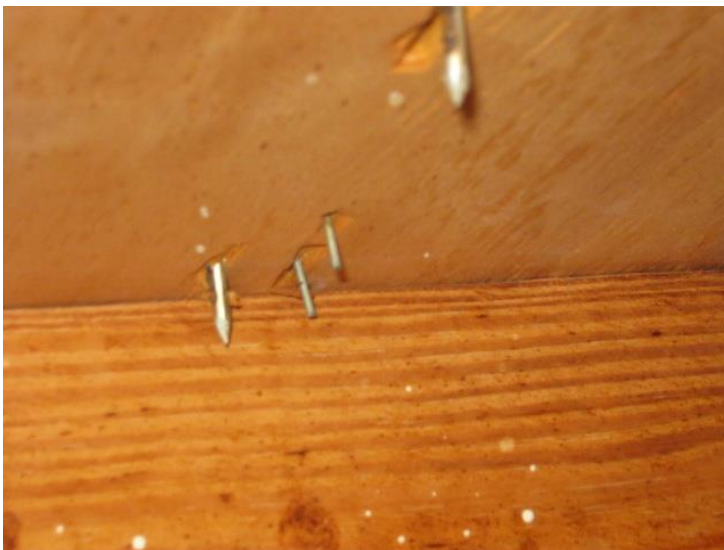
Roof Deck Attachment
(Section 3)

Comments: | Level A
Inspection verified 1/2" plywood roof deck attached with staples at a minimum of 6" on the edge & 12" in the field. |

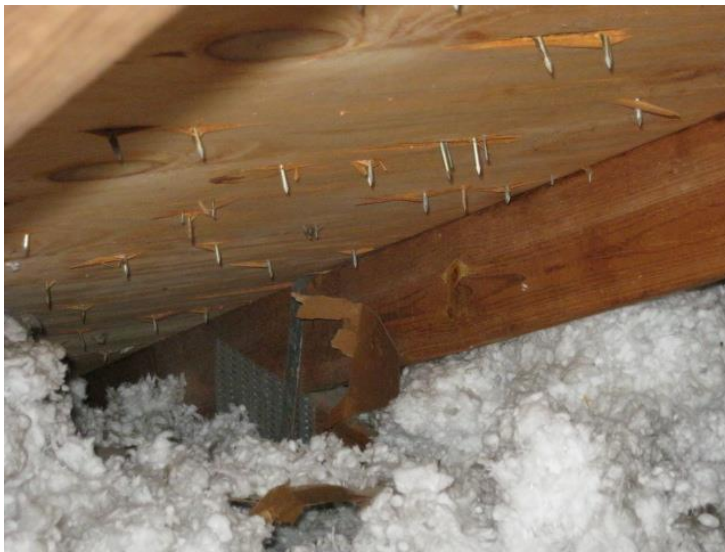
Roof to Wall Attachment (Section 4)

Comments: | Clips
Inspection verified embedded straps fastened with a minimum of three nails. |

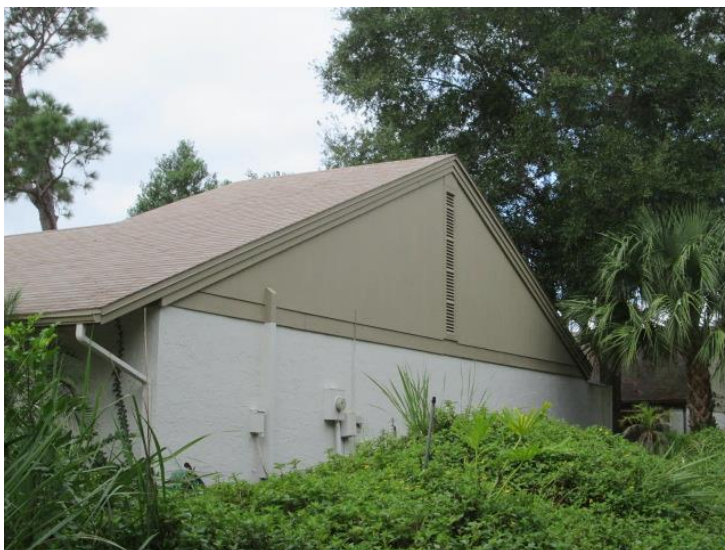
Roof Shape (Section 5)

Comments: | Other Roof
Inspection verified a gable roof shape. |
