COMMERCIAL WINDSTORM MITIGATION INSPECTION REPORT (OIR-B1-1802)

Windrush Bay Condominium Association, Inc.

5 Windrush Bay Dr
Tarpon Springs, FL 34689

As of 10/5/2015

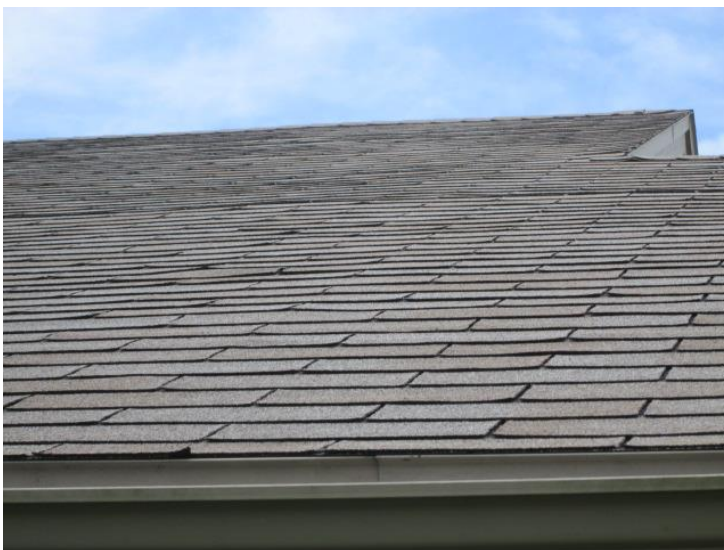
Roof Covering (Section 2)

Comments: | FBC Equivalent
The roof covering was replaced in 2003. The roof permit was confirmed and the permit number is 03-101. This roof was verified as meeting the building code requirements outlined on the mitigation affidavit. |

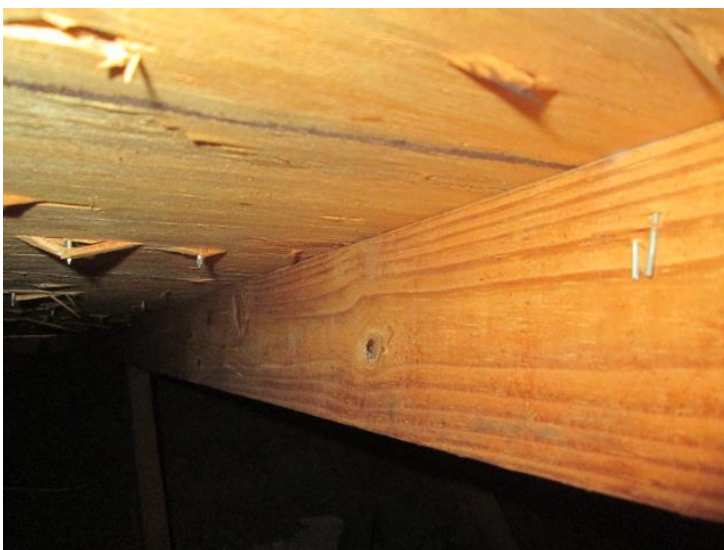
Roof Deck Attachment
(Section 3)

Comments: | Level A
Inspection verified 1/2" plywood roof deck attached with staples at a minimum of 6" on the edge & 12" in the field. |

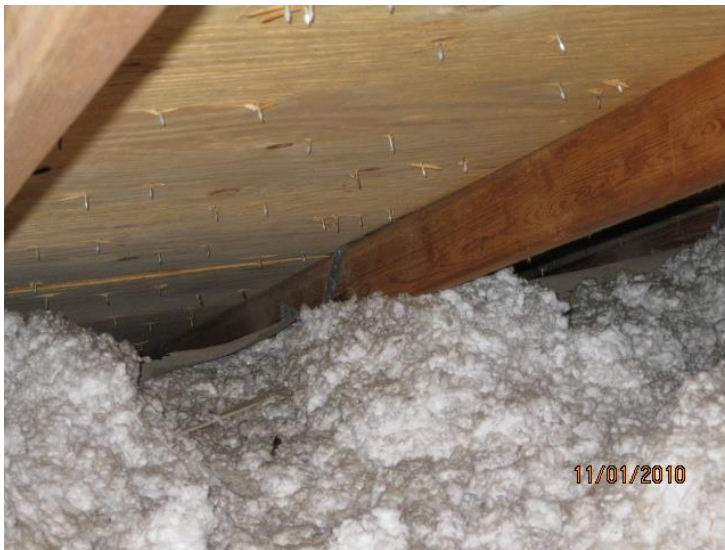
Roof to Wall Attachment (Section 4)

Comments: | Clips
Inspection verified embedded straps fastened with a minimum of three nails. |

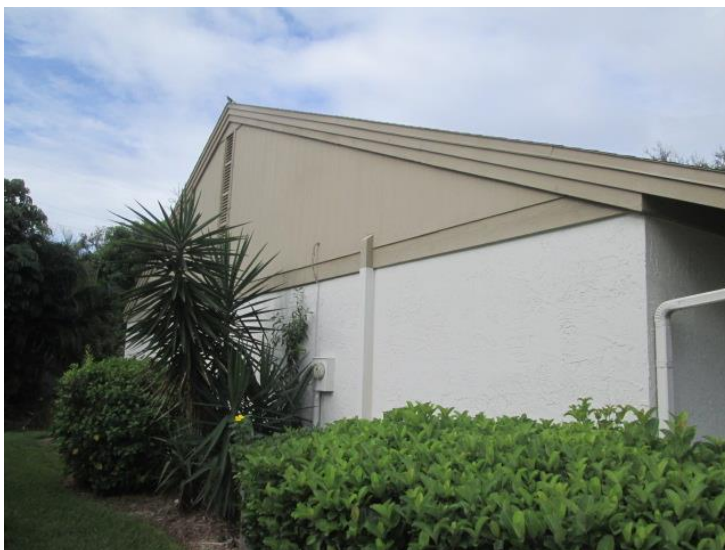
Roof Shape (Section 5)

Comments: | Other Roof
Inspection verified a gable roof shape. |
