## COMMERCIAL WINDSTORM MITIGATION INSPECTION REPORT (OIR-B1-1802)

Windrush Bay Condominium Association, Inc.

7 Windrush Bay Dr  
Tarpon Springs, FL 34689

As of 10/5/2015

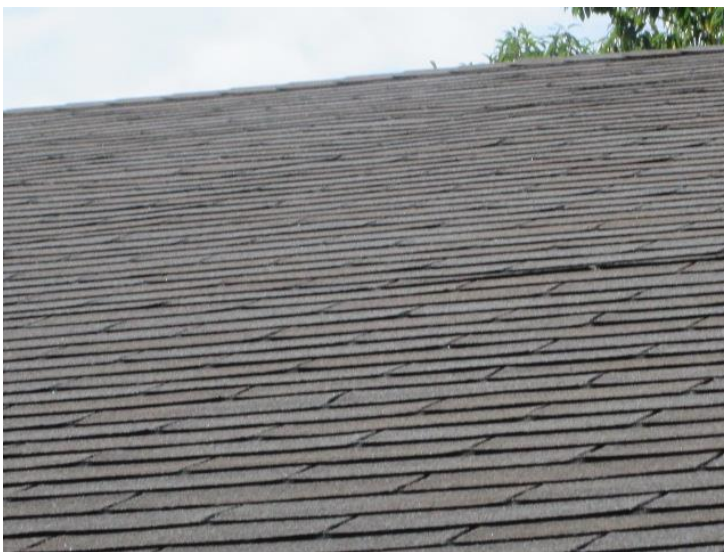
Roof Covering (Section 2)

| <b>2. <u>Roof Covering:</u></b><br>Comments: | <b>FBC Equivalent</b><br>The roof covering was replaced in 2003. The roof permit was confirmed and the permit number is 03-104. This roof was verified as meeting the building code requirements outlined on the mitigation affidavit. |

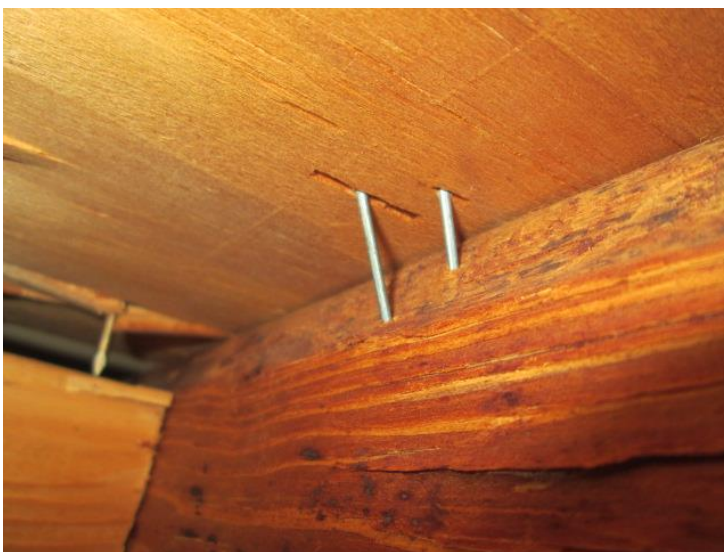
Roof Deck Attachment  
(Section 3)

| <b>3. <u>Roof Deck Attachment:</u></b><br>Comments: | <b>Level A</b><br>Inspection verified 1/2" plywood roof deck attached with staples at a minimum of 6" on the edge & 12" in the field. |

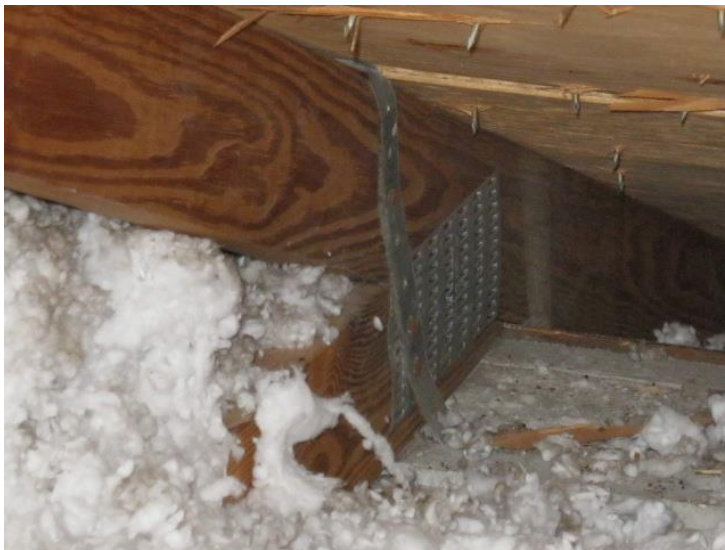
Roof to Wall Attachment (Section 4)

| <b>4. <u>Roof to Wall Attachment:</u></b><br>Comments: | <b>Clips</b><br>Inspection verified embedded straps fastened with a minimum of three nails. |

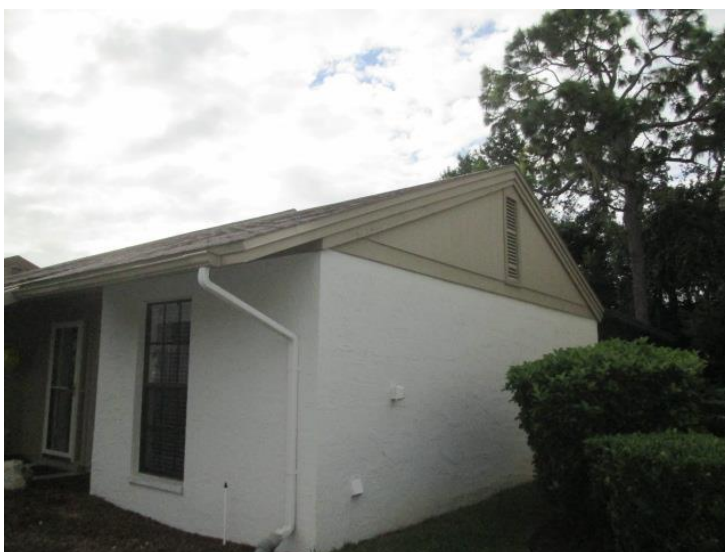
Roof Shape (Section 5)

| <b>5. <u>Roof Geometry:</u></b><br>Comments: | <b>Other Roof</b><br>Inspection verified a gable roof shape. |
