COMMERCIAL WINDSTORM MITIGATION INSPECTION REPORT (OIR-B1-1802)

Windrush Bay Condominium Association, Inc.

8 Windrush Bay Dr
Tarpon Springs, FL 34689

As of 10/5/2015

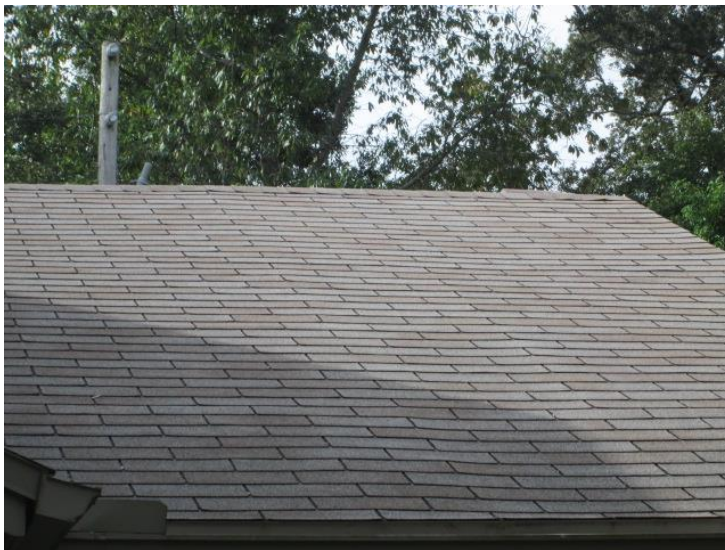
Roof Covering (Section 2)

Comments: | FBC Equivalent
The roof covering was replaced in 2003. The roof permit was confirmed and the permit number is 03-105. This roof was verified as meeting the building code requirements outlined on the mitigation affidavit. |

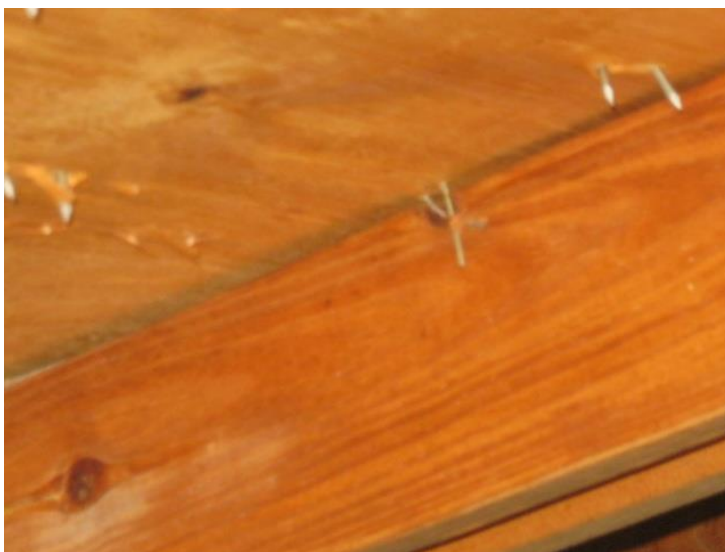
Roof Deck Attachment
(Section 3)

Comments: | Level A
Inspection verified 1/2" plywood roof deck attached with staples at a minimum of 6" on the edge & 12" in the field. |

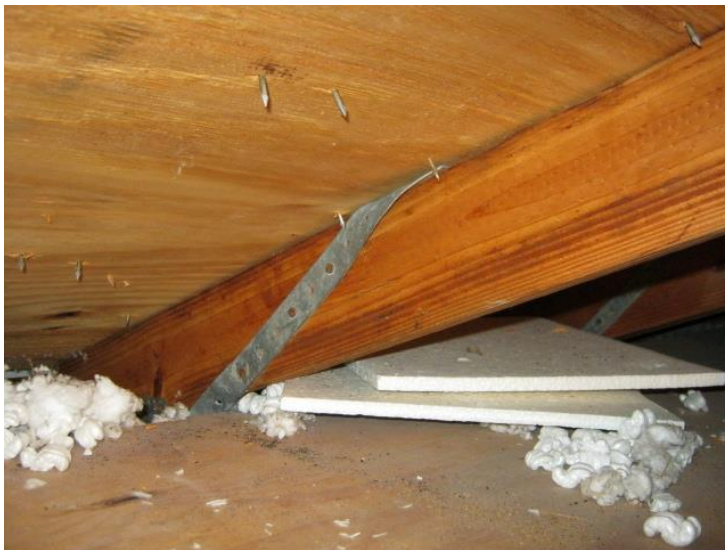
Roof to Wall Attachment (Section 4)

Comments: | Clips
Inspection verified embedded straps fastened with a minimum of three nails. |

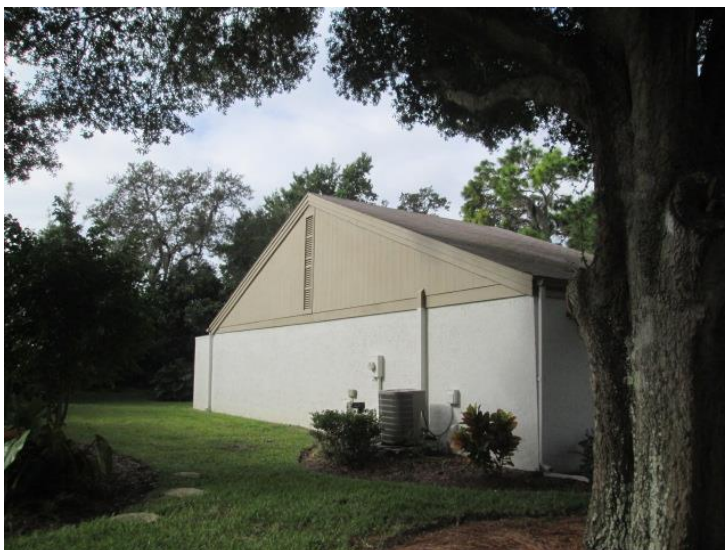
Roof Shape (Section 5)

Comments: | Other Roof
Inspection verified a gable roof shape. |
