# Windrush Bay Condo Association 509-516

## Wind Mitigation Inspection Report

By: Fair Wind Inspections Inc.

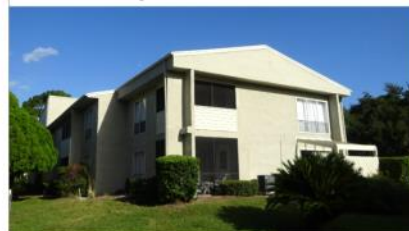
Geometry Picture

Roof Geometry: Non-Hip  
Total Non-Hip: N/A Total Perimeter: N/A  
Less Than 2:12: N/A Total Area: N/A

Gable end walls and/or non-hip features are greater than 10% of total perimeter

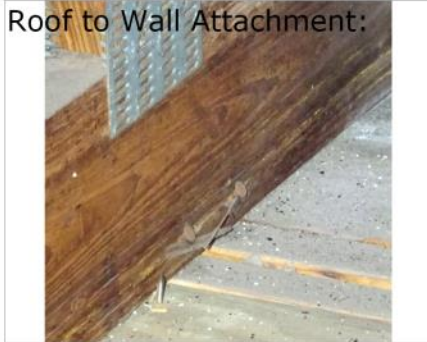
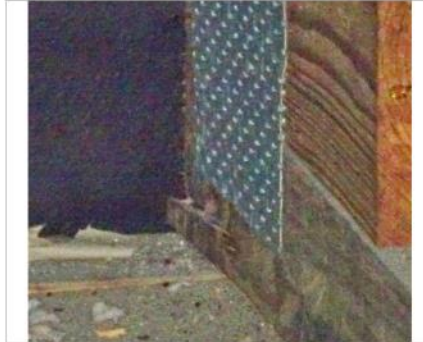
Roof to Wall Attachment:

- ☒ A. Toe Nails
  - ☒ Truss/rafter anchored to top plate of wall using nails driven at an angle through the truss/rafter and attached to the top plate of the wall, or
  - ☒ Metal connectors that do not meet the minimal conditions or requirements of B, C, or D

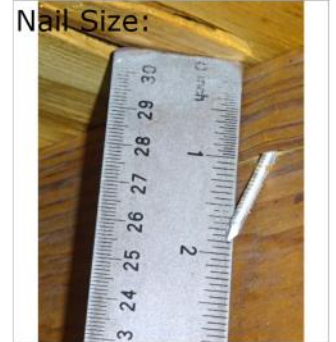
Nail Size:

Underside of roof is in good condition

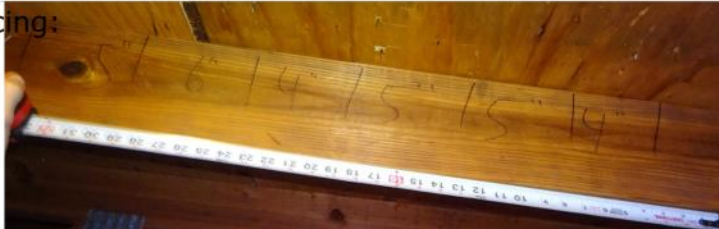
Nail Spacing:

- ☒ C. Plywood/OSB roof sheathing with a minimum thickness of 7/16" inch attached to the roof truss/rafter (spaced a maximum of 24" inches o.c.) by 8d common nails spaced a maximum of 6" inches in the field. -OR- Dimensional lumber/Tongue Groove decking with a minimum of 2 nails per board (or 1 nail per board if each board is equal to or less than 6 inches in width). -OR- Any system of screws, nails, adhesives, other deck fastening system or truss/rafter spacing that is shown to have an equivalent
