**COMMERCIAL WINDSTORM MITIGATION REPORT (OIR-B1-1802)**

Windrush Bay Condominium Association, Inc.

401-404 Windrush Bay Dr, Building A

As of 2/13/2020

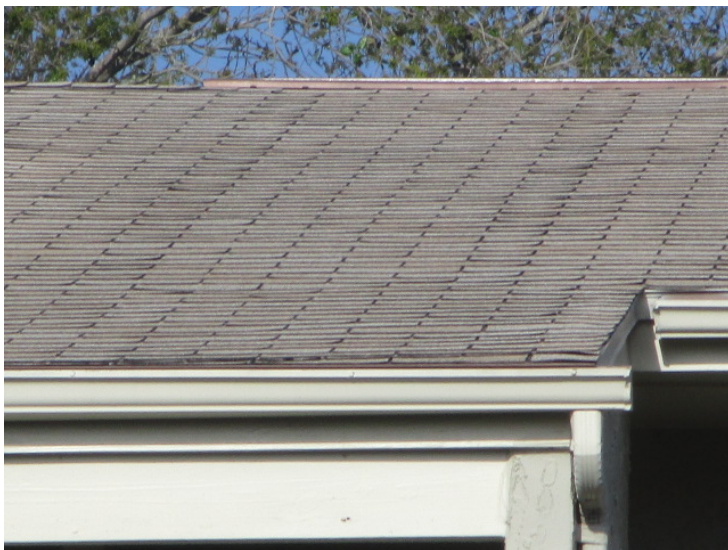
Roof Construction

- 3. Roof Deck Attachment:**        **Level A**  
Comments:                                      Inspection verified 1/2" plywood roof deck attached with staples at a minimum of 6" on the edge & 12" in the field.

- 4. Roof to Wall Attachment:**        **Clips**  
Comments:                                      Inspection verified hurricane clips fastened with a minimum of three nails.
