COMMERCIAL WINDSTORM MITIGATION REPORT (OIR-B1-1802)

Windrush Bay Condominium Association, Inc.

405-412 Windrush Bay Dr, Building B

As of 2/13/2020
FPAT File# MUD2013974

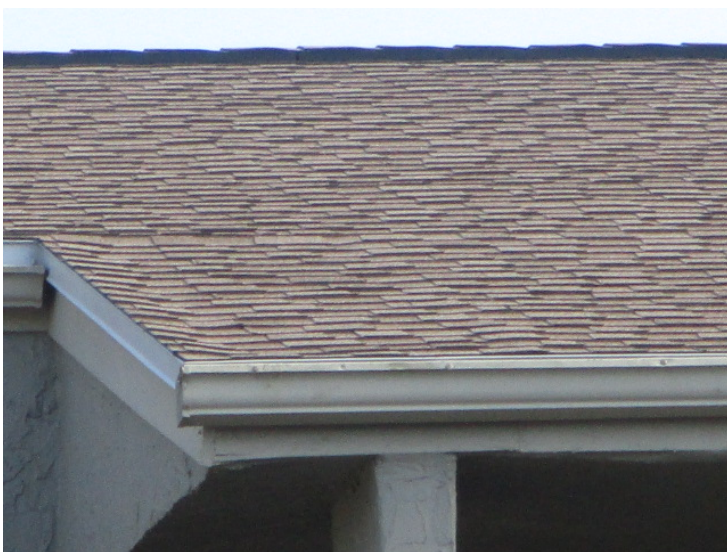
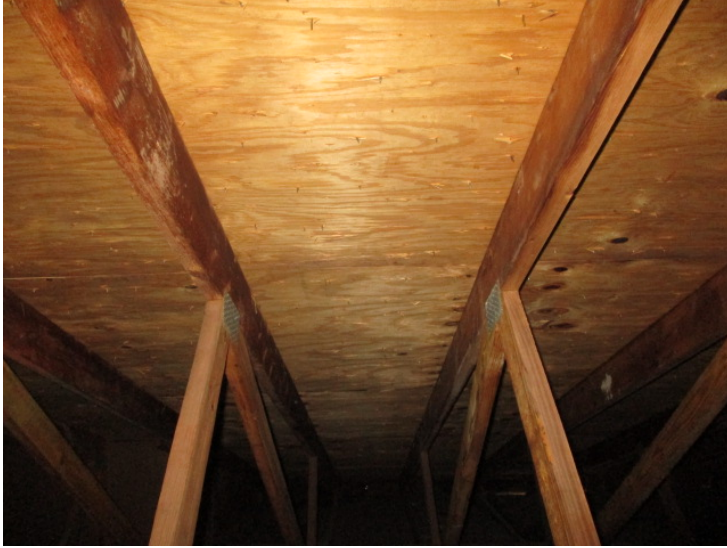
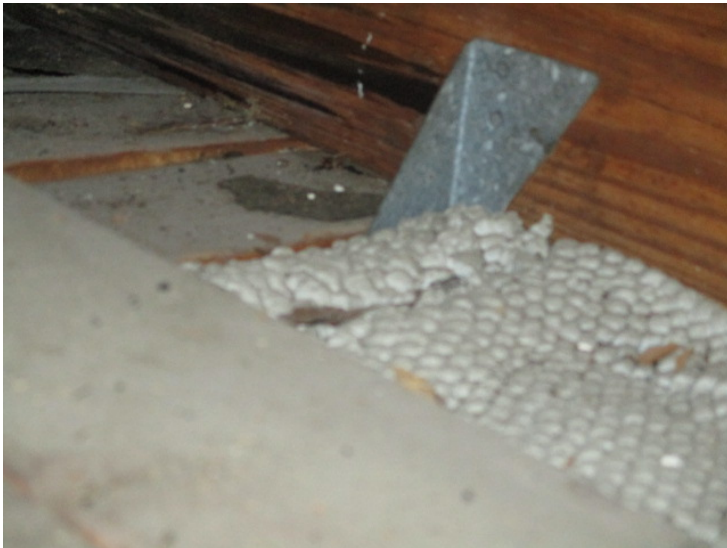
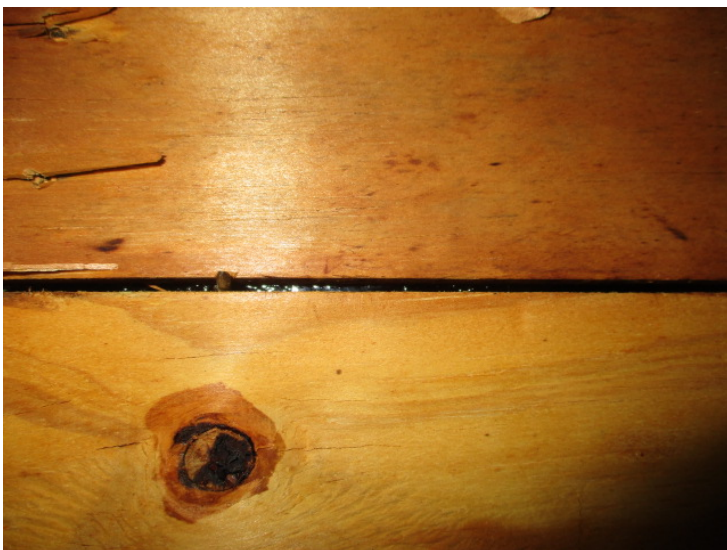
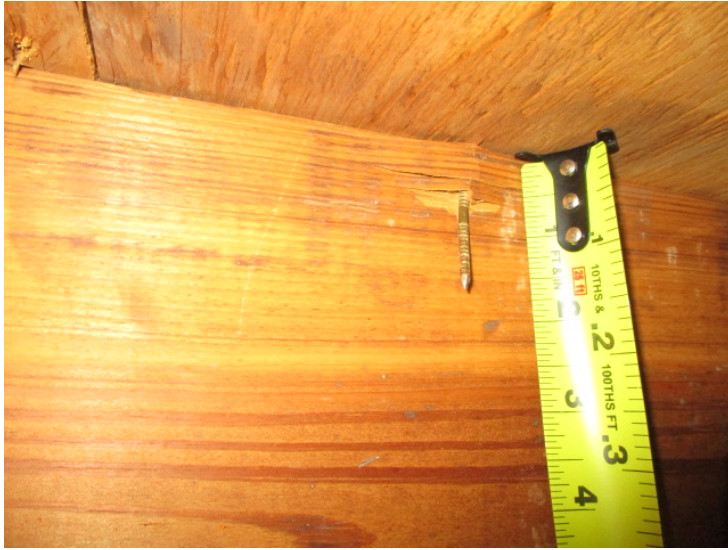
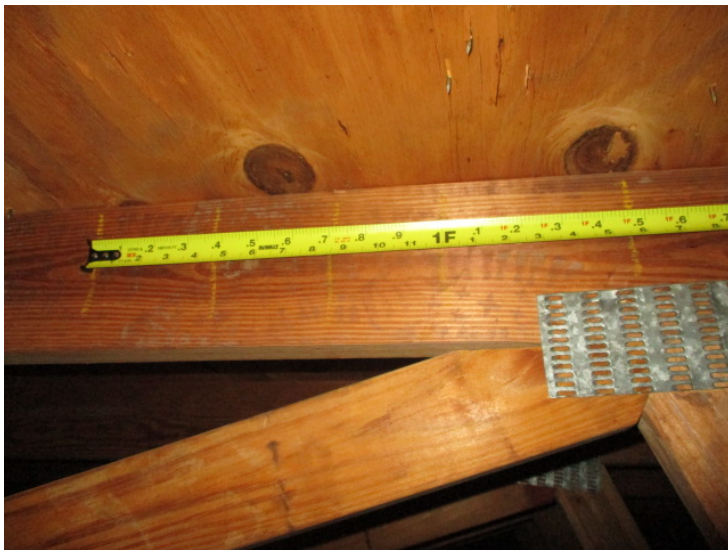
Roof Construction

- 3. Roof Deck Attachment:** **Level C**
Comments: Inspection verified 1/2" plywood roof deck attached with 8d nails at a minimum 6" on the edge & 6" in the field.

- 4. Roof to Wall Attachment:** **Clips**
Comments: Inspection verified hurricane clips fastened with a minimum of three nails.
- 5. Roof Geometry:** **Other Roof**
Comments: Inspection verified a gable roof shape.

- 6. SWR:** **Yes**
Comments: SWR was verified at time of inspection. The Secondary Water Resistance verified is a self-adhering peel and stick.
- 7. Opening Protection:** **None or Some Glazed Openings**
Comments: Inspection verified no opening protection.
