COMMERCIAL WINDSTORM MITIGATION REPORT (OIR-B1-1802)

Windrush Bay Condominium Association, Inc.

413-420 Windrush Bay Dr, Building C

As of 2/13/2020

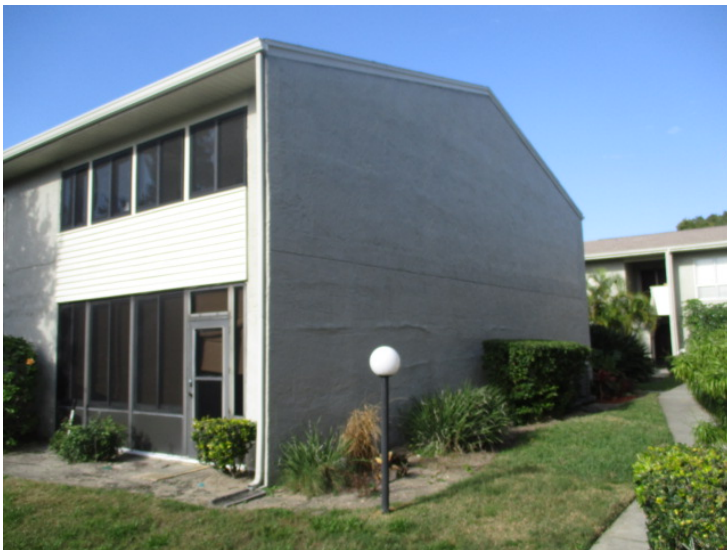
Exterior Elevation

- 4. Roof to Wall Attachment:** **Clips**
Comments: Inspection verified hurricane clips fastened with a minimum of three nails.
- 5. Roof Geometry:** **Other Roof**
Comments: Inspection verified a gable roof shape.

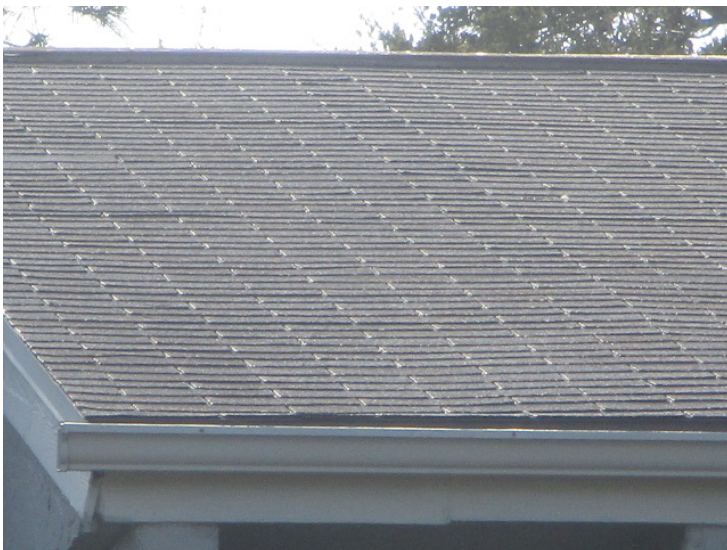
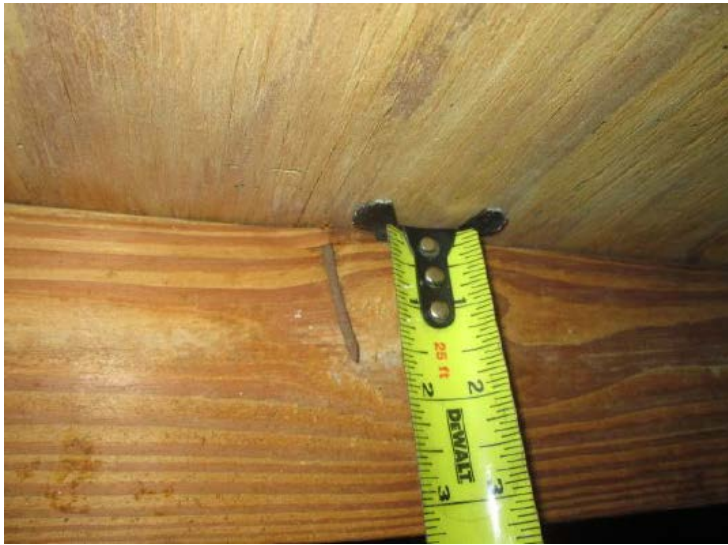
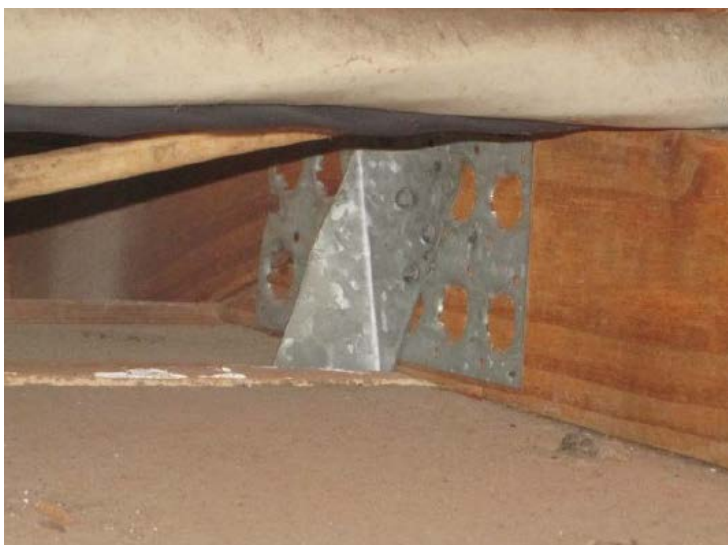
Roof Construction

- 3. Roof Deck Attachment:** **Level A**
Comments: Inspection verified 1/2" plywood roof deck attached with 6d nails at a minimum of 6" on the edge & 12" in the field.
