COMMERCIAL WINDSTORM MITIGATION REPORT (OIR-B1-1802)

Windrush Bay Condominium Association, Inc.

501-508 Windrush Bay Dr, Building E

As of 2/13/2020

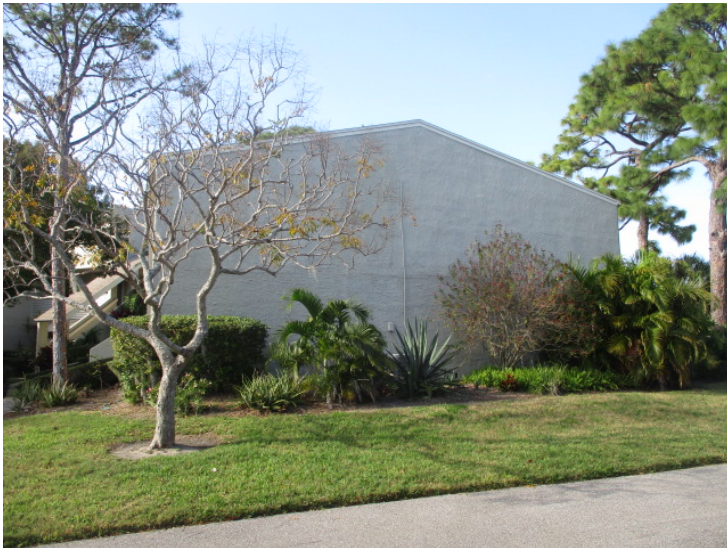
Exterior Elevation

- 4. Roof to Wall Attachment:** **Clips**
Comments: Inspection verified hurricane clips fastened with a minimum of three nails.
- 5. Roof Geometry:** **Other Roof**
Comments: Inspection verified a gable roof shape.

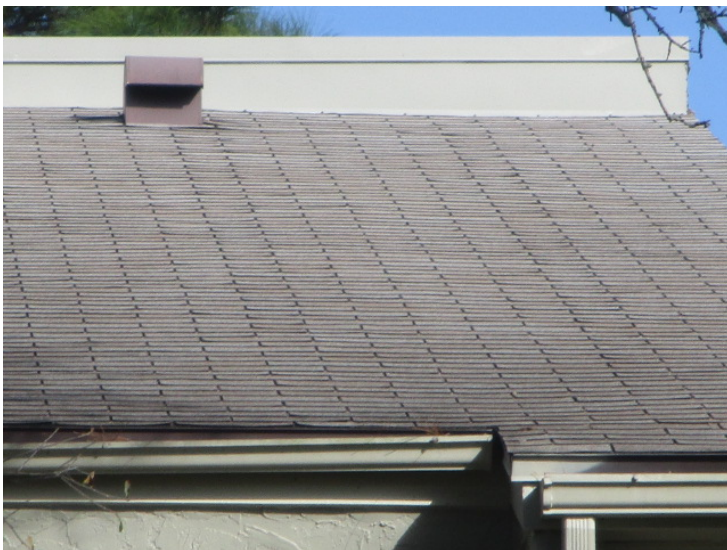
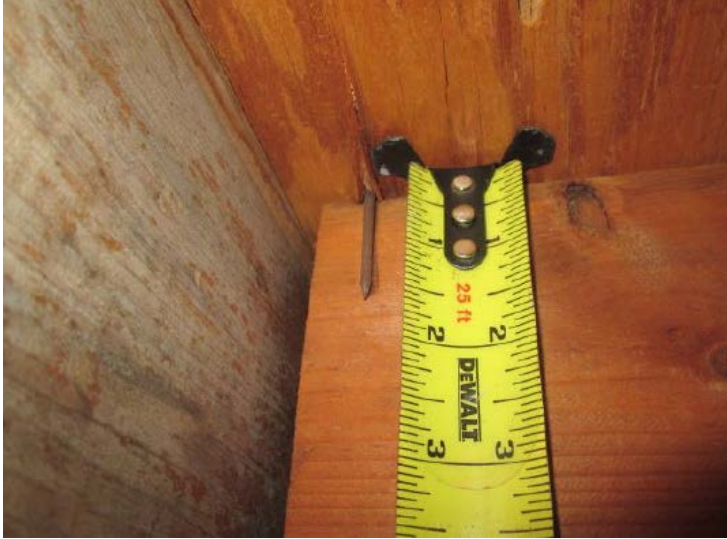
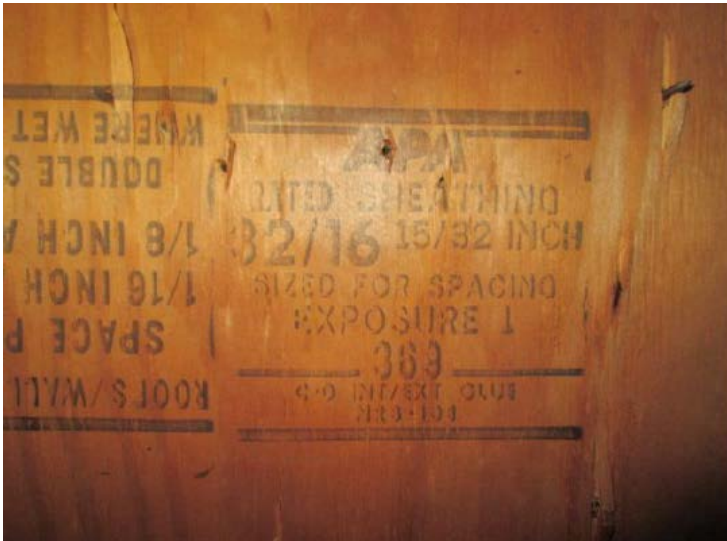
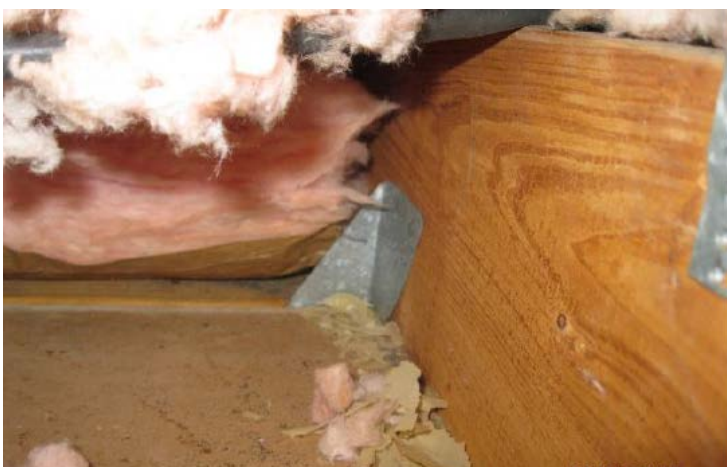
Roof Construction

- 3. Roof Deck Attachment:** **Level A**
Comments: Inspection verified 1/2" plywood roof deck attached with 6d nails at a minimum of 6" on the edge & 12" in the field.

- 6. SWR:** **No**
Comments: Inspection verified no secondary water resistance.
- 7. Opening Protection:** **None or Some Glazed Openings**
Comments: Inspection verified no opening protection.
