## COMMERCIAL WINDSTORM MITIGATION REPORT (OIR-B1-1802)

Windrush Bay Condominium Association, Inc.

509-516 Windrush Bay Dr, Building F

As of 2/13/2020  
FPAT File# MUD2013974

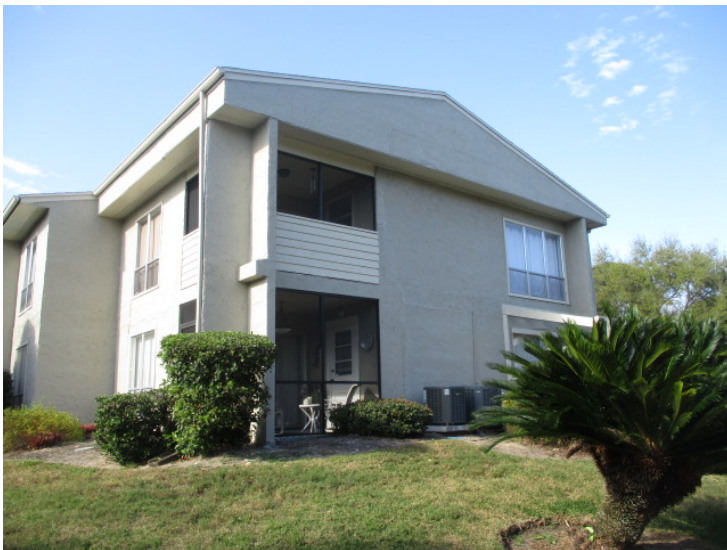
Exterior Elevation

- 5. Roof Geometry:**                      **Other Roof**  
Comments:                                      Inspection verified a gable roof shape.
- 6. SWR:**                                      **No**  
Comments:                                      Inspection verified no secondary water resistance.

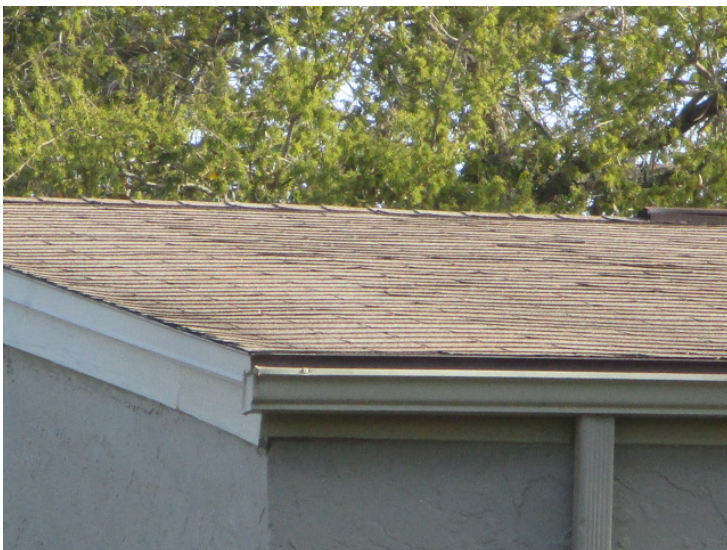
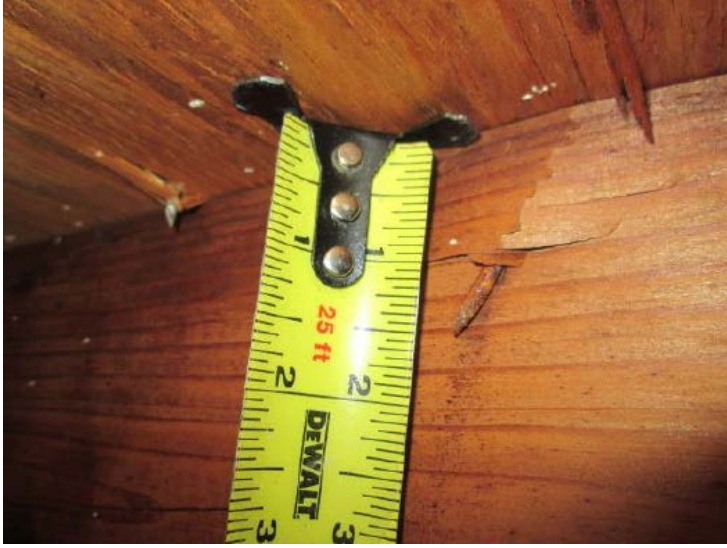
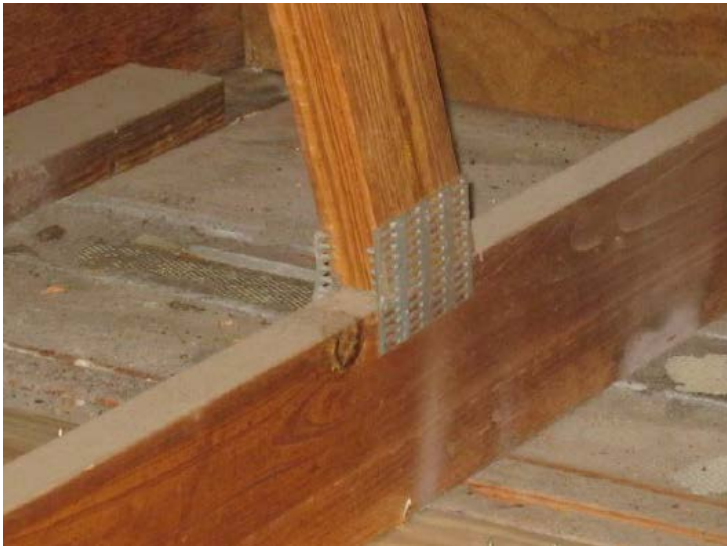
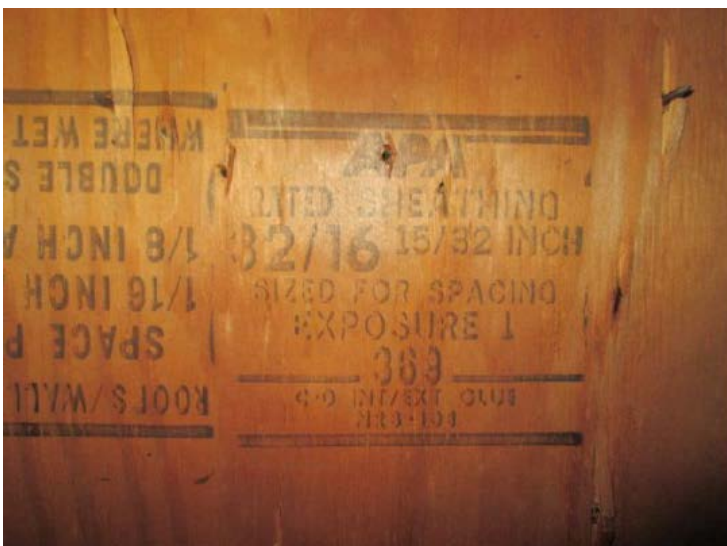
Roof Construction

- 3. Roof Deck Attachment:**        **Level A**  
Comments:                                      Inspection verified 1/2" plywood roof deck attached with 6d nails at a minimum of 6" on the edge & 12" in the field.

- 4. Roof to Wall Attachment:**        **Toe Nails**  
Comments:                                      Toe nails were verified during our attic inspection as the roof wall connection.
