COMMERCIAL WINDSTORM MITIGATION REPORT (OIR-B1-1802)

Windrush Bay Condominium Association, Inc.

601-608 Windrush Bay Dr, Building G

As of 2/13/2020

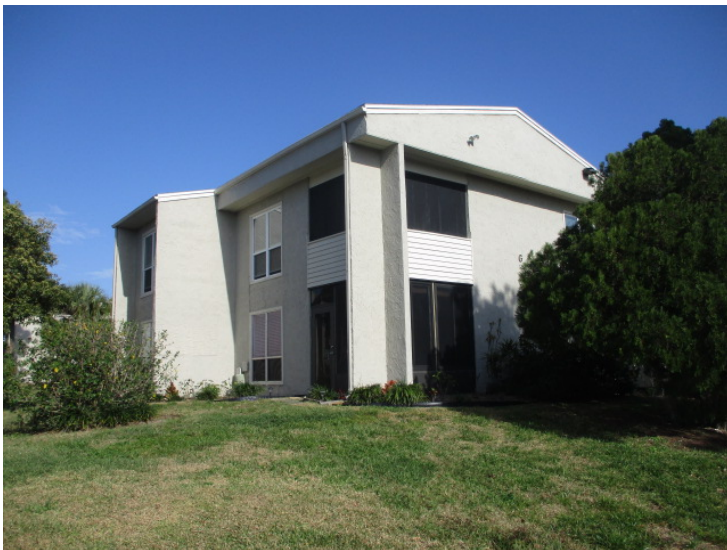
Exterior Elevation

- 4. Roof to Wall Attachment:** **Clips**
Comments: Inspection verified hurricane clips fastened with a minimum of three nails.
- 5. Roof Geometry:** **Other Roof**
Comments: Inspection verified a gable roof shape.

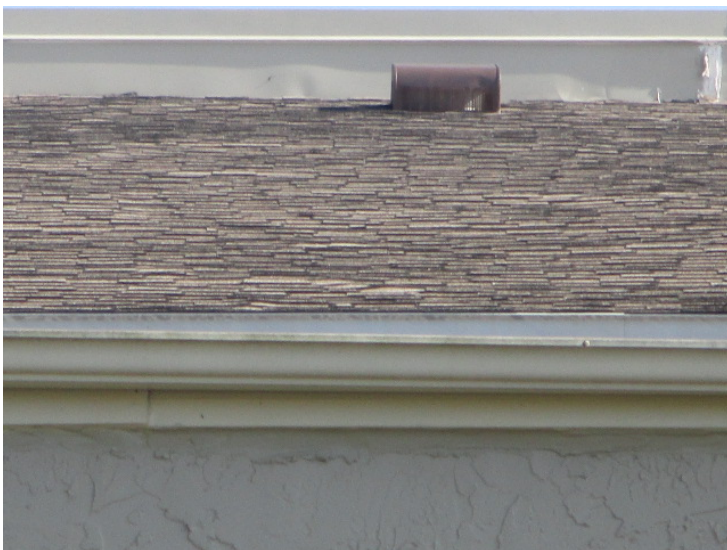
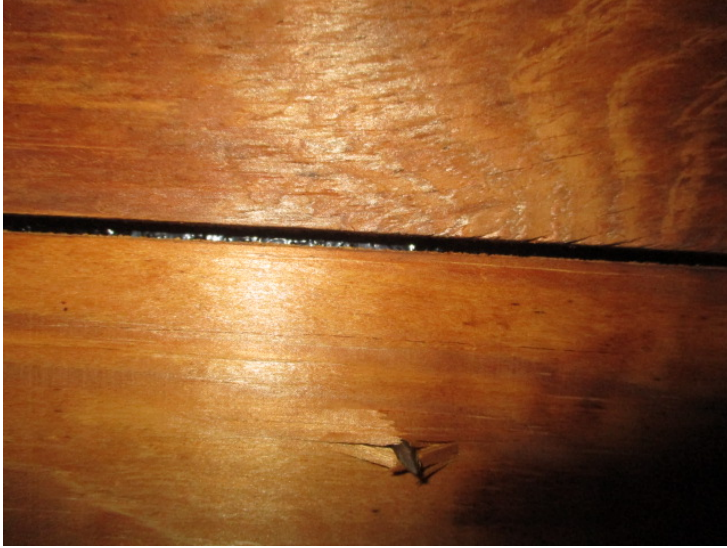
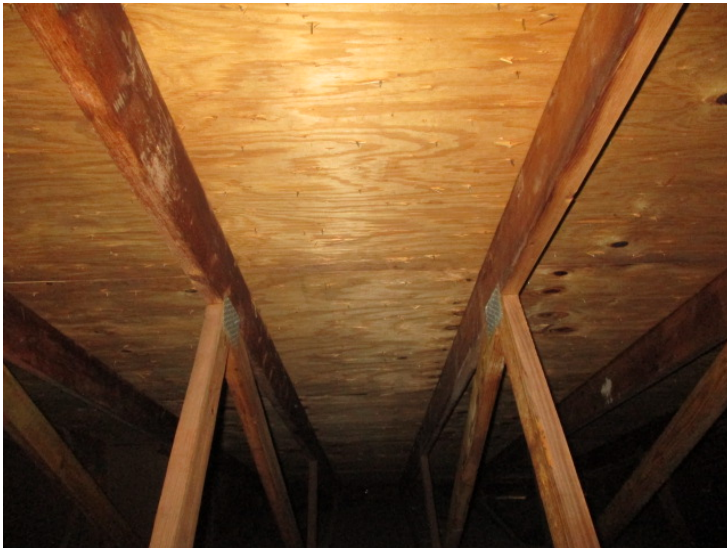
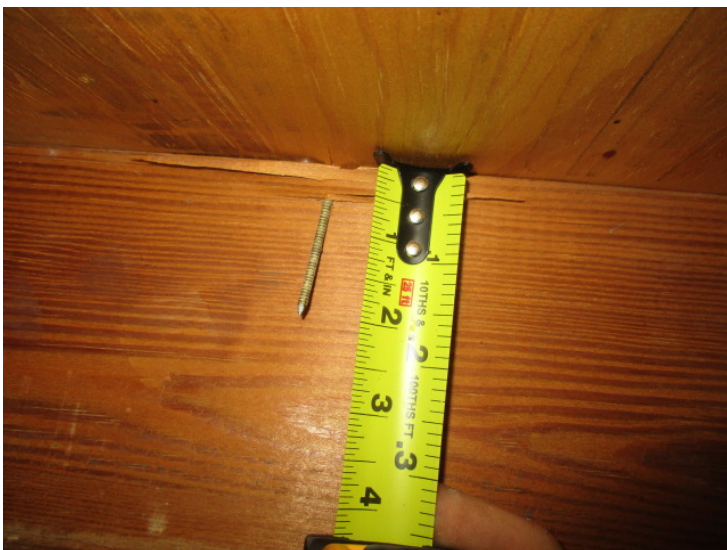
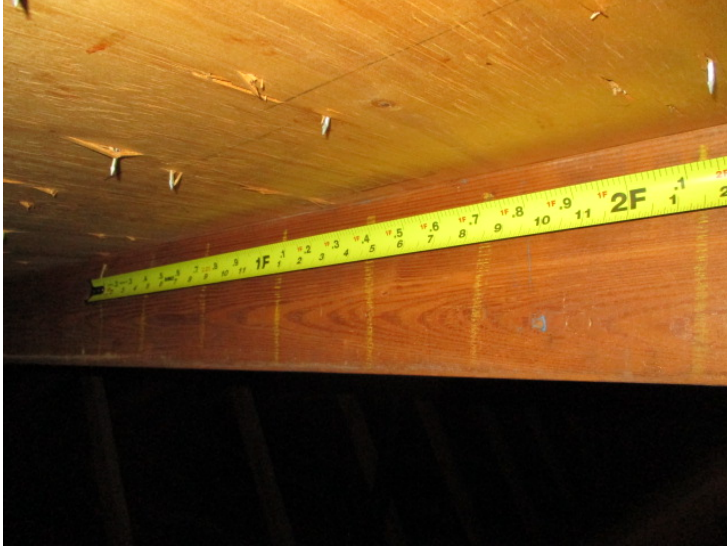
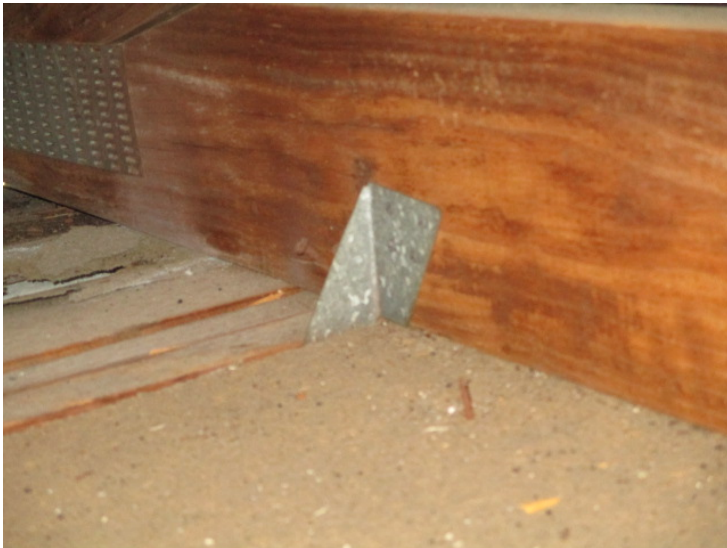
Roof Construction

- 3. Roof Deck Attachment:** **Level C**
Comments: Inspection verified 1/2" plywood roof deck attached with 8d nails at a minimum 6" on the edge & 6" in the field.

- 6. SWR:** **Yes**
Comments: SWR was verified at time of inspection. The Secondary Water Resistance verified is a self-adhering peel and stick.
- 7. Opening Protection:** **None or Some Glazed Openings**
Comments: Inspection verified no opening protection.
