COMMERCIAL WINDSTORM MITIGATION REPORT (OIR-B1-1802)

Windrush Bay Condominium Association, Inc.

609-616 Windrush Bay Dr, Building H

As of 2/13/2020

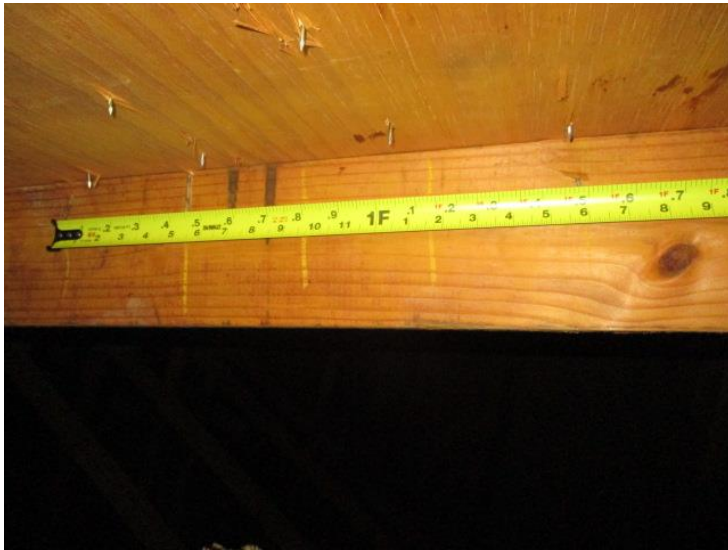
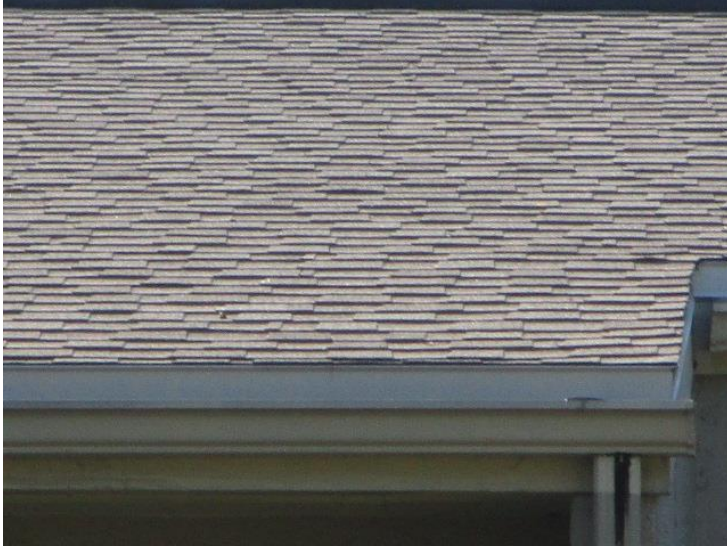
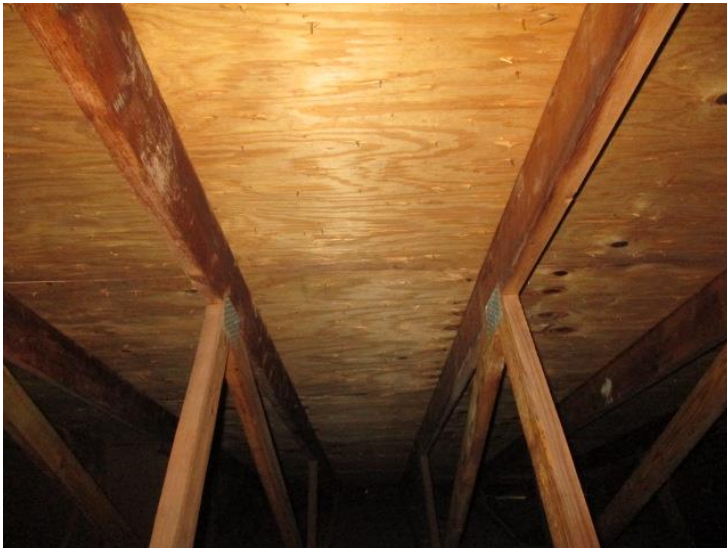
Roof Construction

3. **Roof Deck Attachment:** **Level C**
Comments: Inspection verified 1/2" plywood roof deck attached with 8d nails at a minimum 6" on the edge & 6" in the field.

4. **Roof to Wall Attachment:** **Clips**
Comments: Inspection verified hurricane clips fastened with a minimum of three nails.
5. **Roof Geometry:** **Other Roof**
Comments: Inspection verified a gable roof shape.

6. **SWR:** **Yes**
Comments: SWR was verified at time of inspection. The Secondary Water Resistance verified is a self-adhering peel and stick.
7. **Opening Protection:** **None or Some Glazed Openings**
Comments: Inspection verified no opening protection.
