COMMERCIAL WINDSTORM MITIGATION REPORT (OIR-B1-1802)

Windrush Bay Condominium Association, Inc.

617-620 Windrush Bay Dr, Building J

As of 2/13/2020
FPAT File# MUD2013974

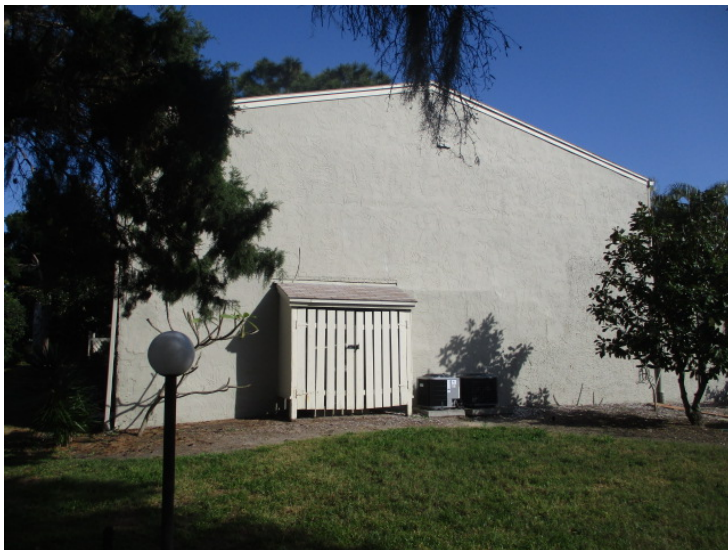
Exterior Elevation

- 4. Roof to Wall Attachment:** **Clips**
Comments: Inspection verified hurricane clips fastened with a minimum of three nails.
- 5. Roof Geometry:** **Other Roof**
Comments: Inspection verified a gable roof shape.

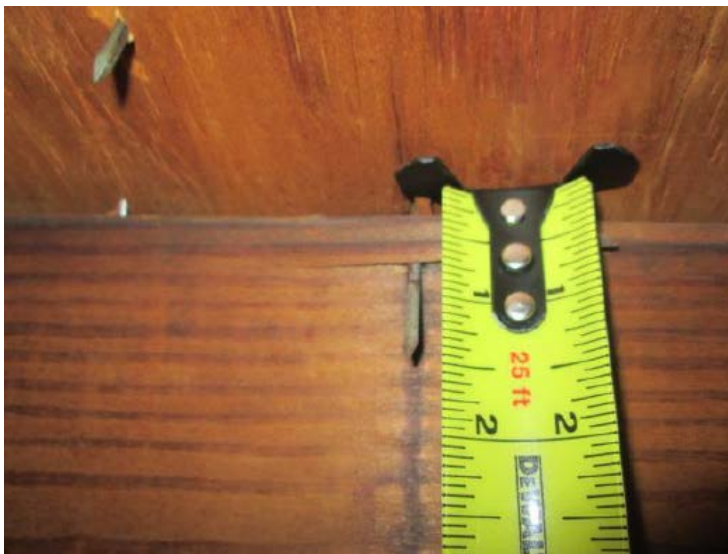
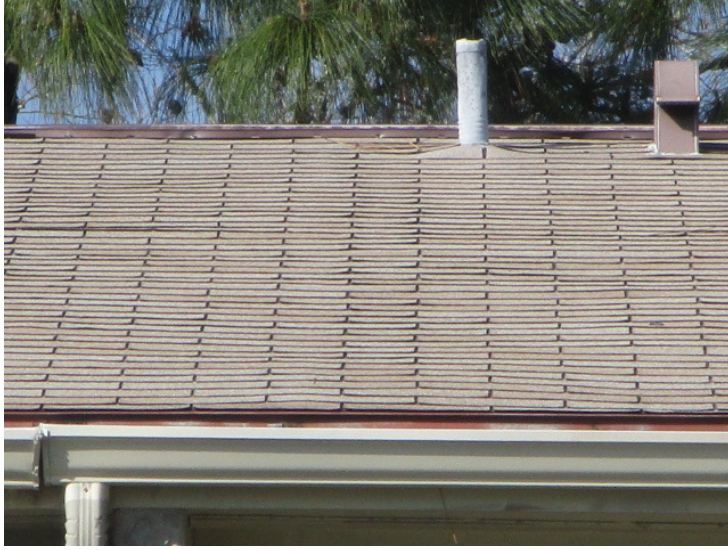
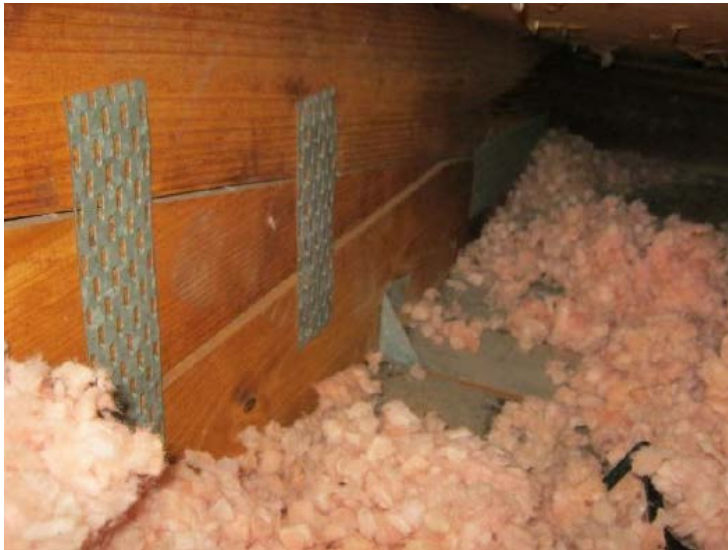
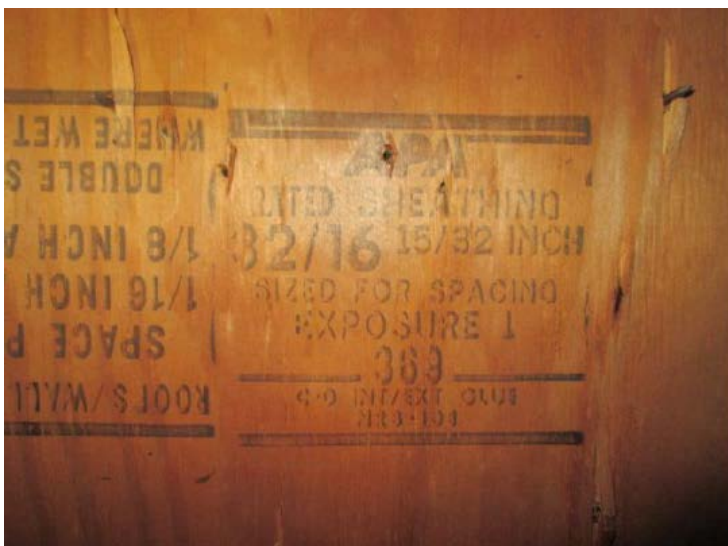
Roof Construction

- 3. Roof Deck Attachment:** **Level A**
Comments: Inspection verified 1/2" plywood roof deck attached with 6d nails at a minimum of 6" on the edge & 12" in the field.

- 6. SWR:** **No**
Comments: Inspection verified no secondary water resistance.
- 7. Opening Protection:** **None or Some Glazed Openings**
Comments: Inspection verified no opening protection.
