COMMERCIAL WINDSTORM MITIGATION REPORT (OIR-B1-1802)

Windrush Bay Condominium Association, Inc.

621-628 Windrush Bay Dr, Building K

As of 2/13/2020

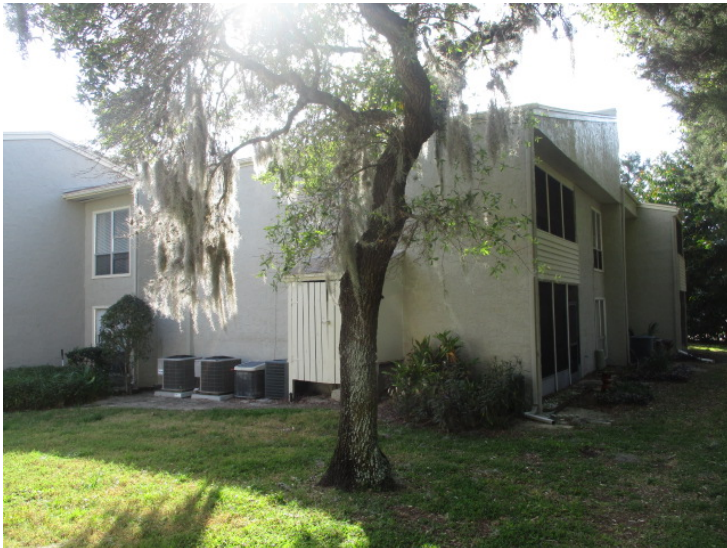
Exterior Elevation

- 4. Roof to Wall Attachment:** **Clips**
Comments: Inspection verified hurricane clips fastened with a minimum of three nails.
- 5. Roof Geometry:** **Other Roof**
Comments: Inspection verified a gable roof shape.

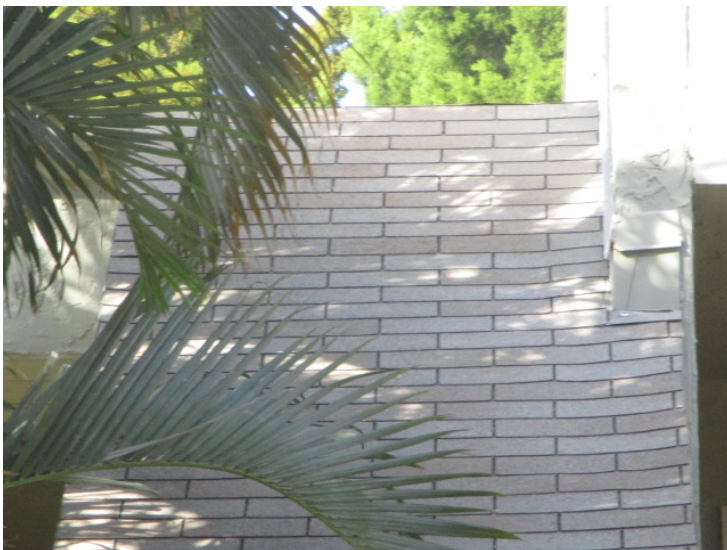
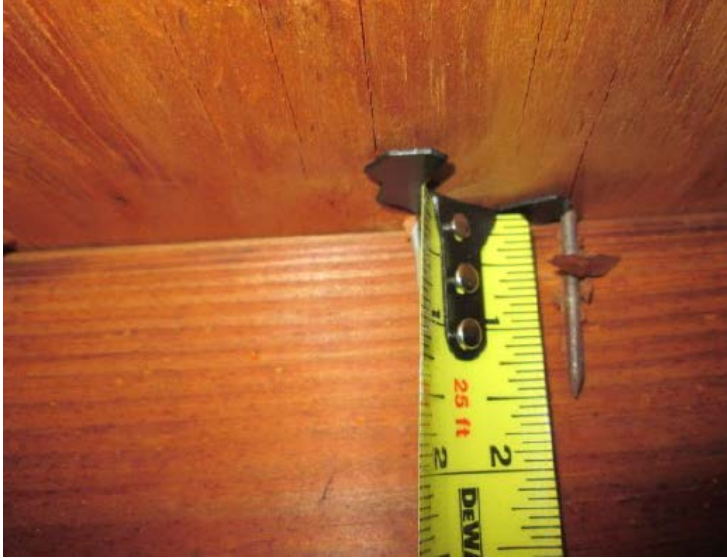
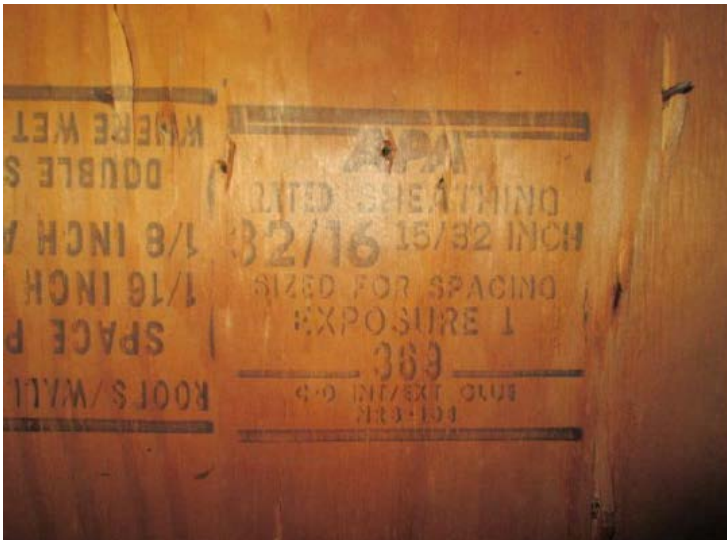
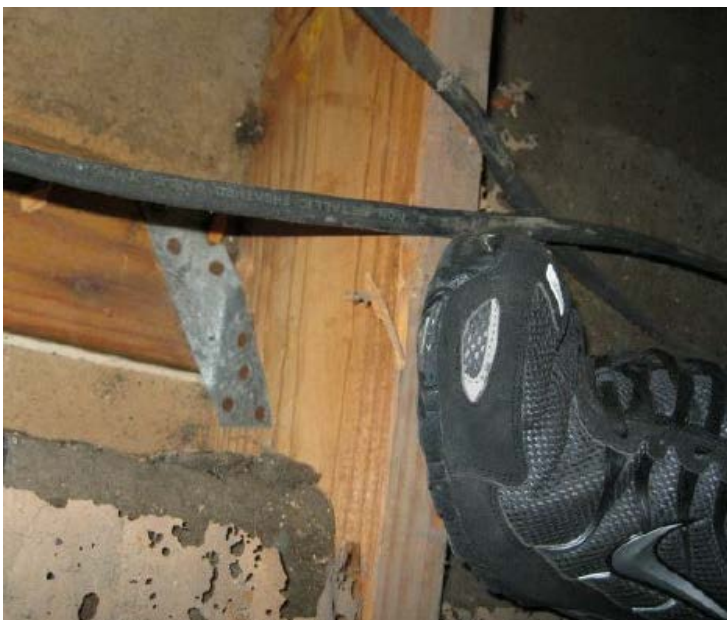
Roof Construction

- 3. Roof Deck Attachment:** **Level A**
Comments: Inspection verified 1/2" plywood roof deck attached with 6d nails at a minimum of 6" on the edge & 12" in the field.

- 6. SWR:** **No**
Comments: Inspection verified no secondary water resistance.
- 7. Opening Protection:** **None or Some Glazed Openings**
Comments: Inspection verified no opening protection.
