COMMERCIAL WINDSTORM MITIGATION REPORT (OIR-B1-1802)

Windrush Bay Condominium Association, Inc.

629-636 Windrush Bay Dr, Building L

As of 2/13/2020

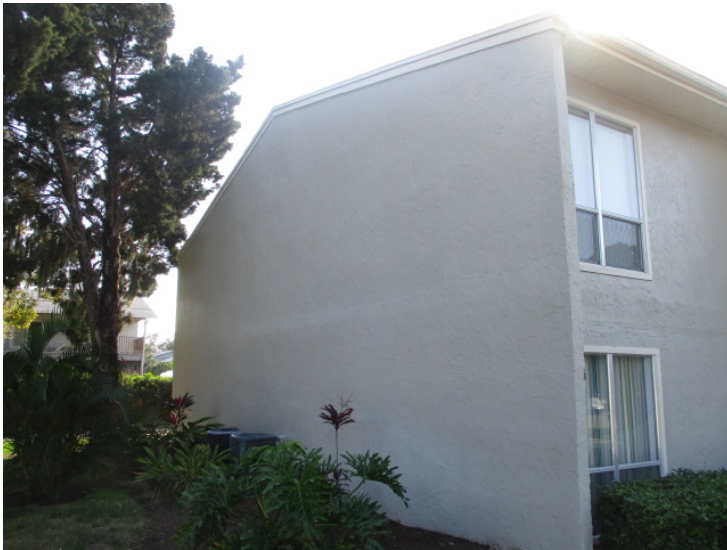
Exterior Elevation

- 4. Roof to Wall Attachment:** **Toe Nails**
Comments: Toe nails were verified during our attic inspection as the roof wall connection.
- 5. Roof Geometry:** **Other Roof**
Comments: Inspection verified a gable roof shape.

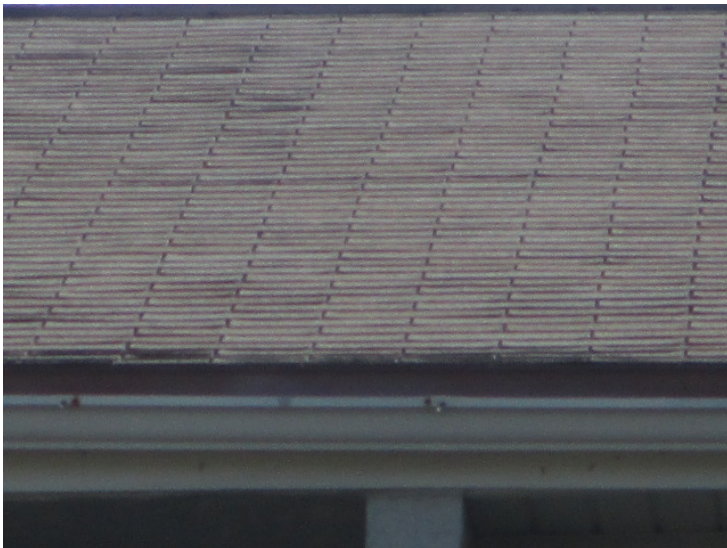
Roof Construction

- 3. Roof Deck Attachment:** **Level A**
Comments: Inspection verified 1/2" plywood roof deck attached with 6d nails at a minimum of 6" on the edge & 12" in the field.

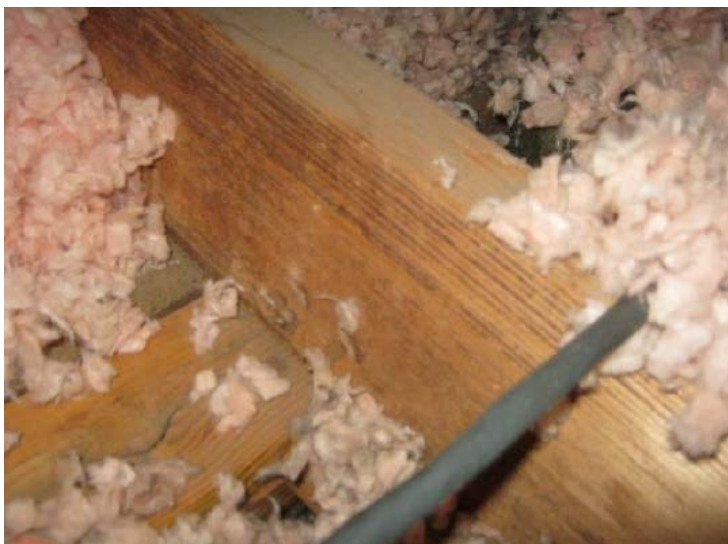
Roof Construction

- 6. SWR:** **No**
Comments: Inspection verified no secondary water resistance.
- 7. Opening Protection:** **None or Some Glazed Openings**
Comments: Inspection verified no opening protection.
