COMMERCIAL WINDSTORM MITIGATION REPORT (OIR-B1-1802)

Windrush Bay Condominium Association, Inc.

645-648 Windrush Bay Dr, Building N

As of 2/13/2020

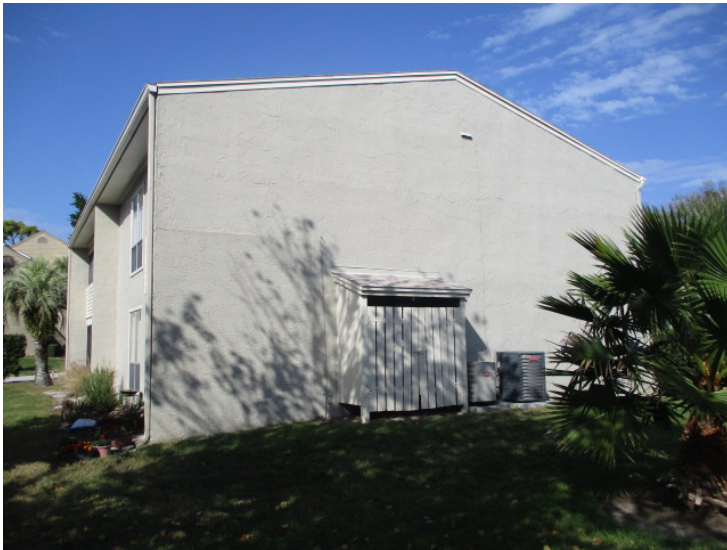
Exterior Elevation

- 4. Roof to Wall Attachment:** **Clips**
Comments: Inspection verified hurricane clips fastened with a minimum of three nails.
- 5. Roof Geometry:** **Other Roof**
Comments: Inspection verified a gable roof shape.

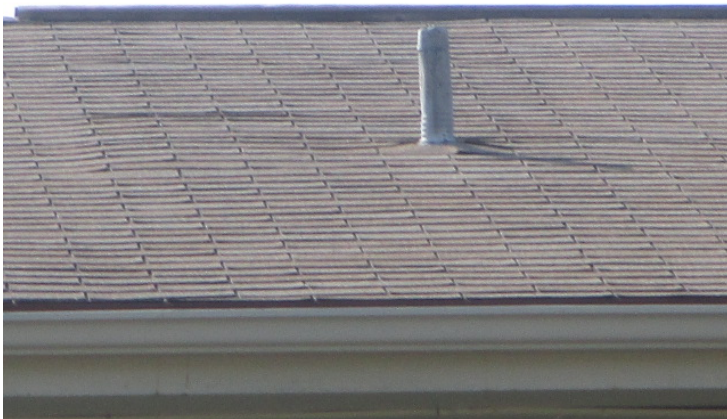
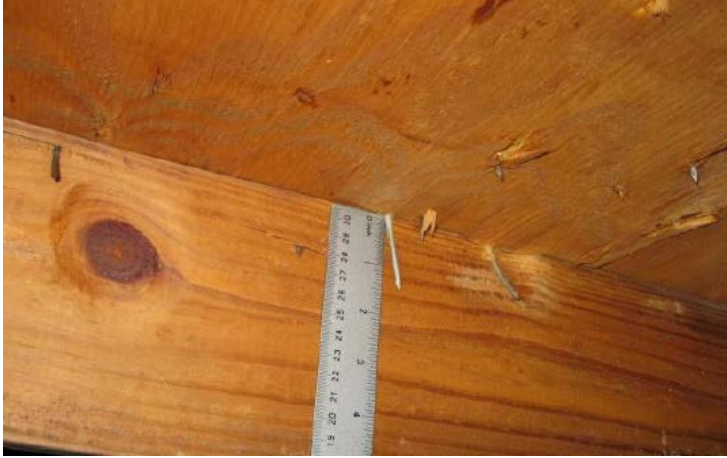
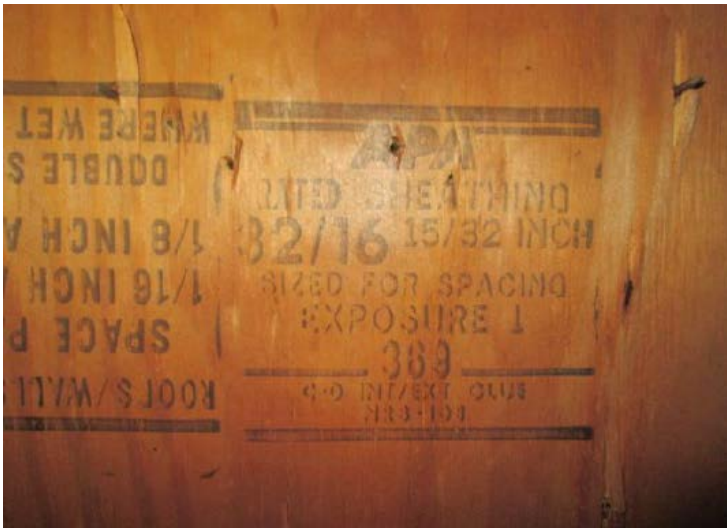
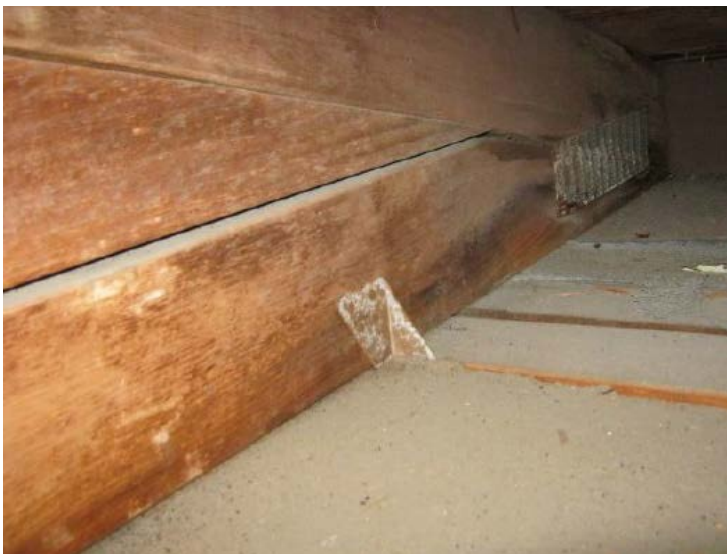
Roof Construction

- 3. Roof Deck Attachment:** **Level A**
Comments: Inspection verified 1/2" plywood roof deck attached with 6d nails at a minimum of 6" on the edge & 12" in the field.

- 6. SWR:** **No**
Comments: Inspection verified no secondary water resistance.
- 7. Opening Protection:** **None or Some Glazed Openings**
Comments: Inspection verified no opening protection.
