COMMERCIAL WINDSTORM MITIGATION REPORT (OIR-B1-1802)

Windrush Bay Condominium Association, Inc.

649-656 Windrush Bay Dr, Building O

As of 2/13/2020

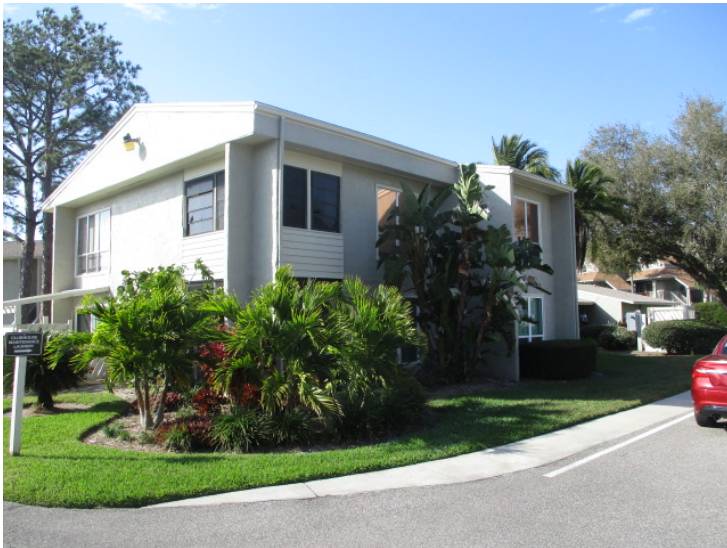
Exterior Elevation

- 4. Roof to Wall Attachment:** **Clips**
Comments: Inspection verified hurricane clips fastened with a minimum of three nails.
- 5. Roof Geometry:** **Other Roof**
Comments: Inspection verified a gable roof shape.

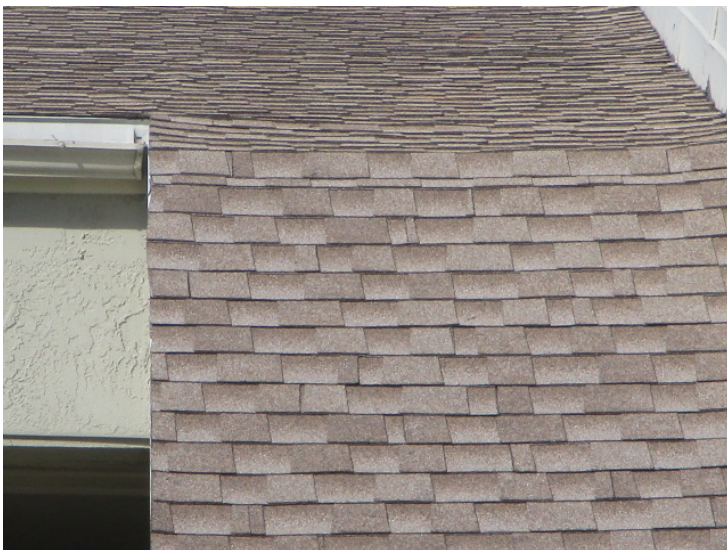
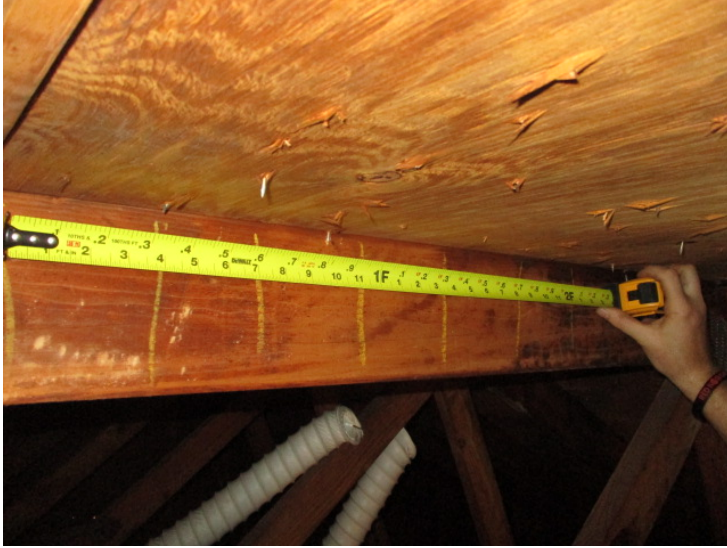
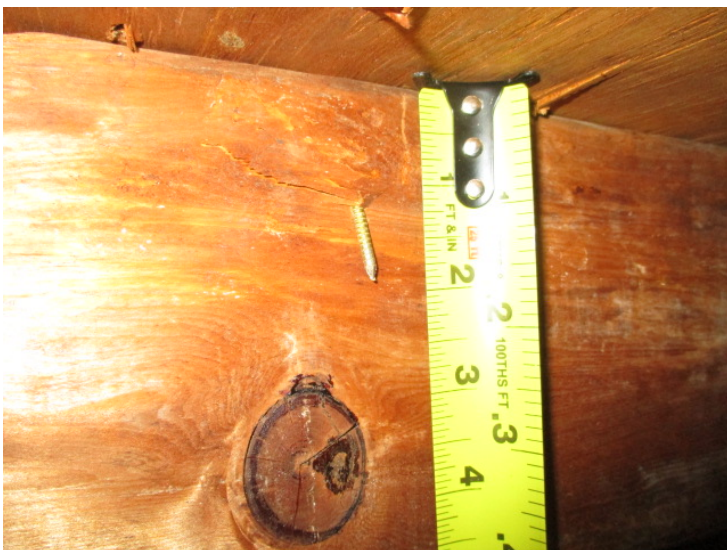
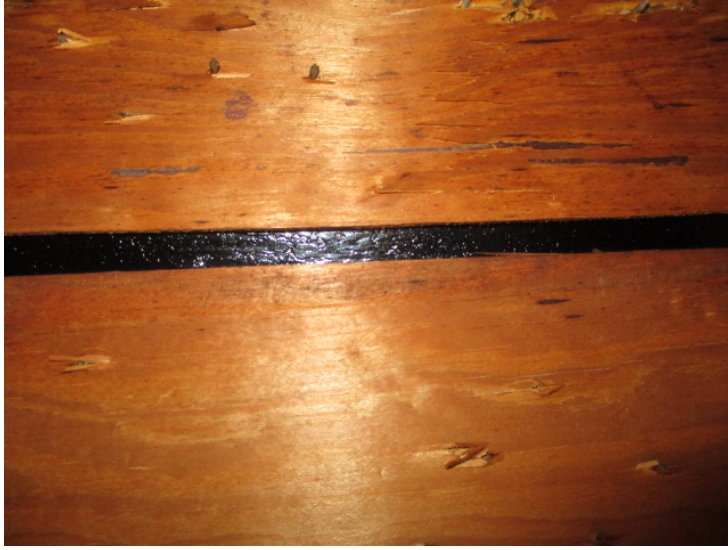
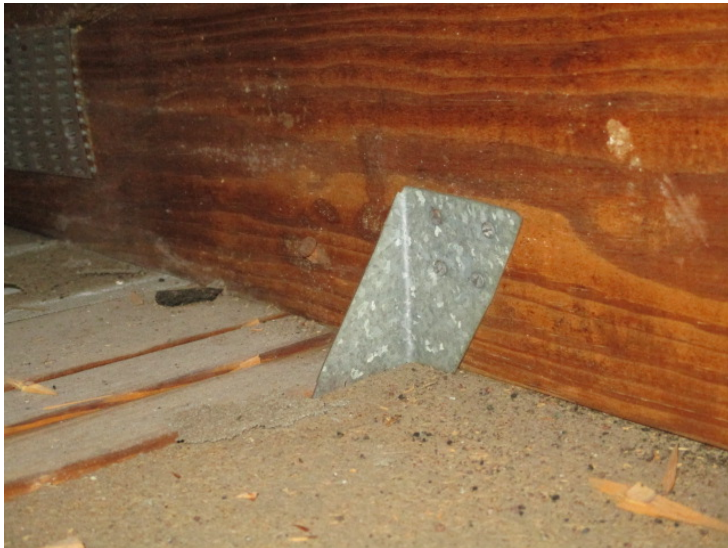
Roof Construction

- 3. Roof Deck Attachment:** **Level C**
Comments: Inspection verified 1/2" plywood roof deck attached with 8d nails at a minimum 6" on the edge & 6" in the field.

- 6. SWR:** **Yes**
Comments: SWR was verified at time of inspection. The Secondary Water Resistance verified is a self-adhering peel and stick.
- 7. Opening Protection:** **None or Some Glazed Openings**
Comments: Inspection verified no opening protection.
