COMMERCIAL WINDSTORM MITIGATION REPORT (OIR-B1-1802)

Windrush Bay Condominium Association, Inc.

1 Windrush Bay Dr

As of 2/13/2020

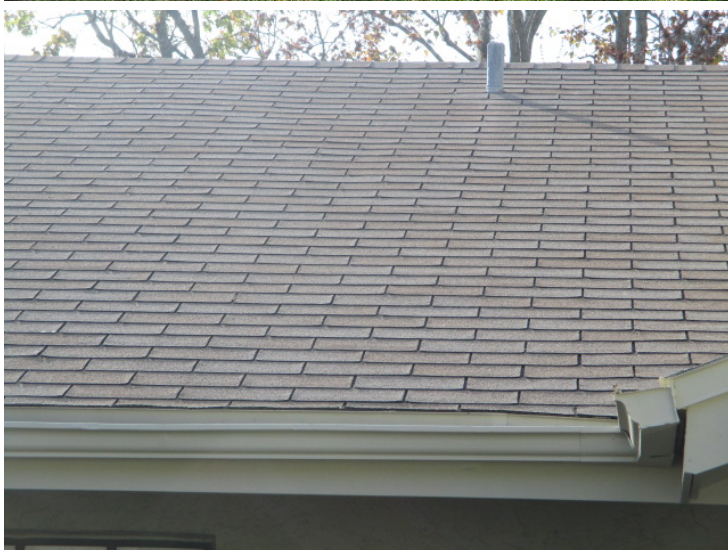
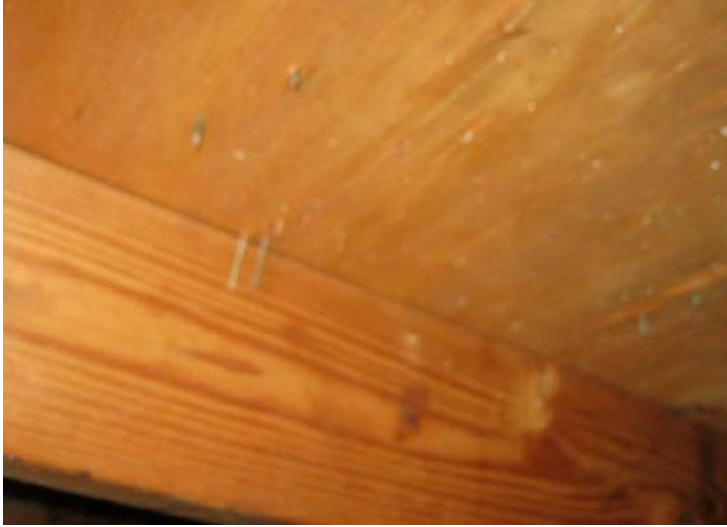
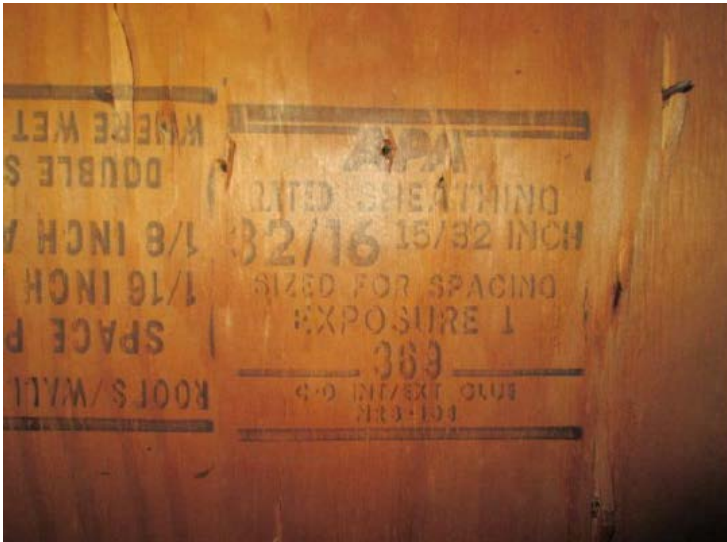
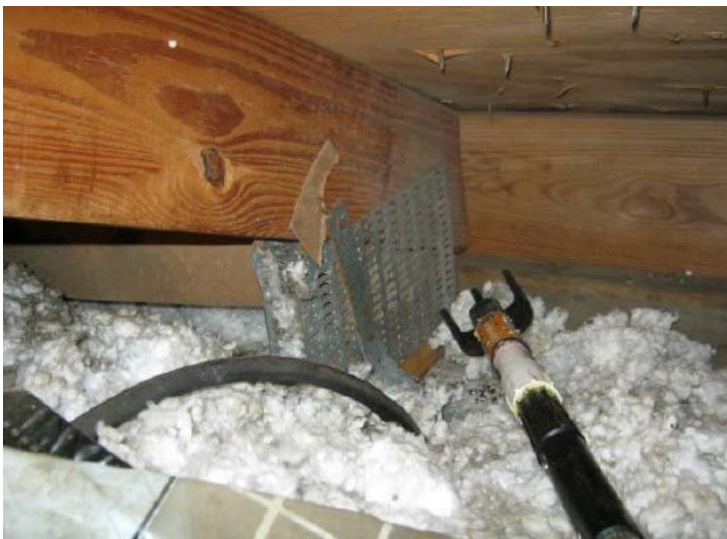
Roof Construction

- 3. Roof Deck Attachment:** **Level A**
Comments: Inspection verified 1/2" plywood roof deck attached with staples at a minimum of 6" on the edge & 12" in the field.

- 4. Roof to Wall Attachment:** **Clips**
Comments: Inspection verified embedded straps fastened with a minimum of three nails.
- 5. Roof Geometry:** **Other Roof**
Comments: Inspection verified a gable roof shape.
