COMMERCIAL WINDSTORM MITIGATION REPORT (OIR-B1-1802)

Windrush Bay Condominium Association, Inc.

10 Windrush Bay Dr
Tarpon Springs, FL 34689

As of 2/13/2020
FPAT File# MUD2013974

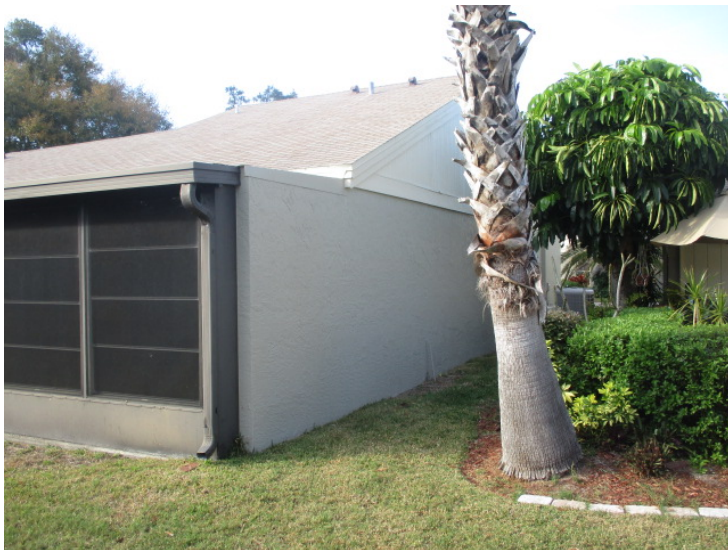
Exterior Elevation

- 4. Roof to Wall Attachment:** **Clips**
Comments: Inspection verified embedded straps fastened with a minimum of three nails.
- 5. Roof Geometry:** **Other Roof**
Comments: Inspection verified a gable roof shape.

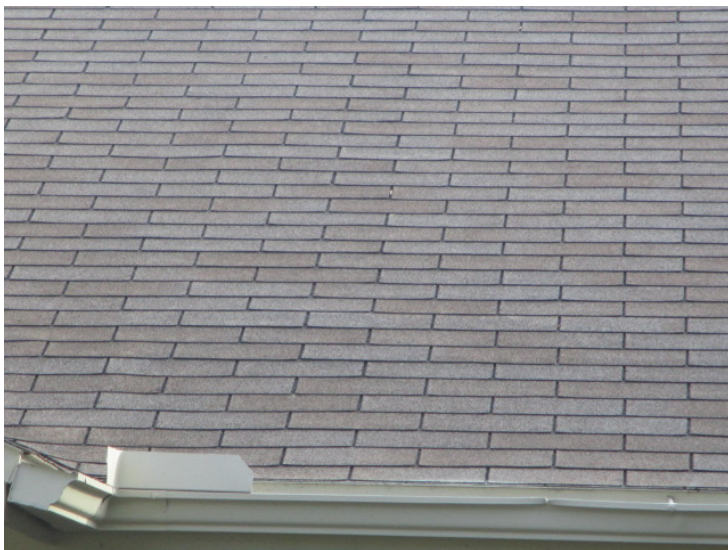
Roof Construction

- 3. Roof Deck Attachment:** **Level A**
Comments: Inspection verified 1/2" plywood roof deck attached with staples at a minimum of 6" on the edge & 12" in the field.

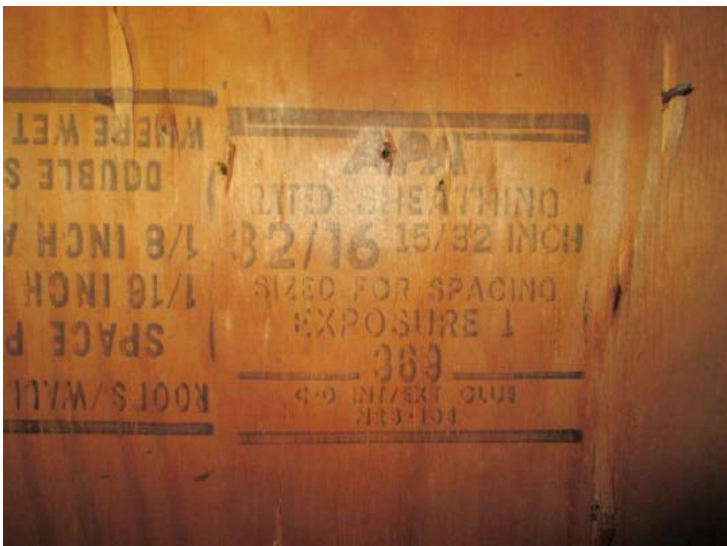
Roof Construction

- 6. SWR:** **No**
Comments: Inspection verified no secondary water resistance.
- 7. Opening Protection:** **None or Some Glazed Openings**
Comments: Inspection verified no opening protection.
