COMMERCIAL WINDSTORM MITIGATION REPORT (OIR-B1-1802)

Windrush Bay Condominium Association, Inc.

11 Windrush Bay Dr
Tarpon Springs, FL 34689

As of 2/13/2020
FPAT File# MUD2013974

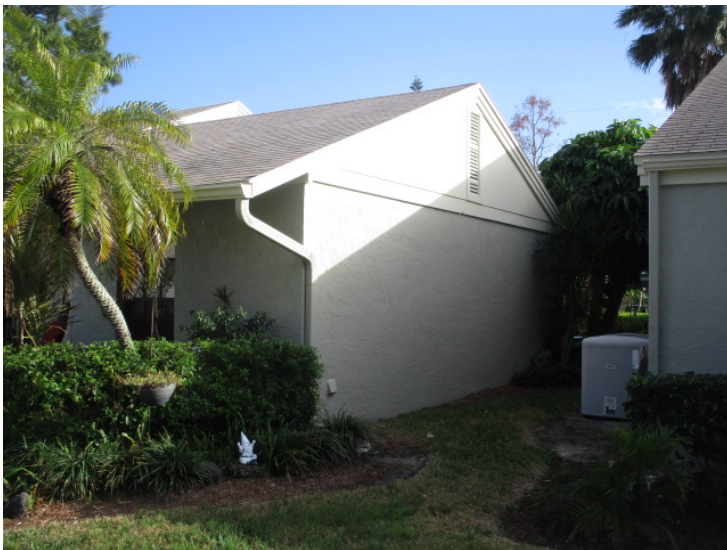
Exterior Elevation

- 4. Roof to Wall Attachment:** **Clips**
Comments: Inspection verified embedded straps fastened with a minimum of three nails.
- 5. Roof Geometry:** **Other Roof**
Comments: Inspection verified a gable roof shape.

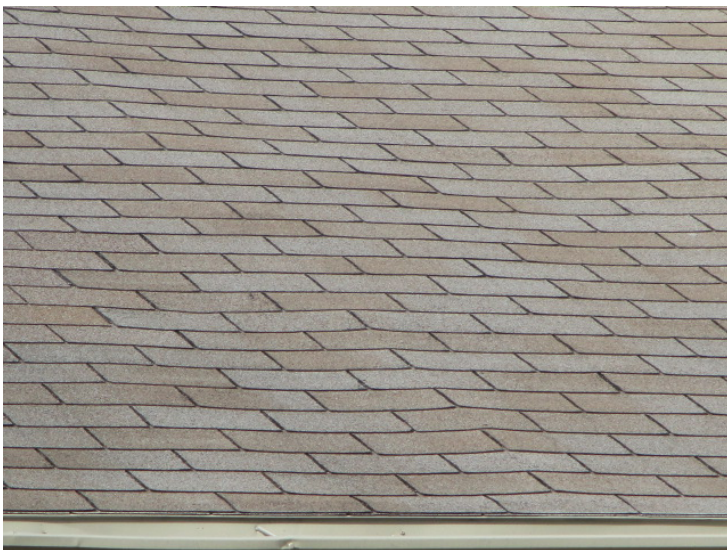
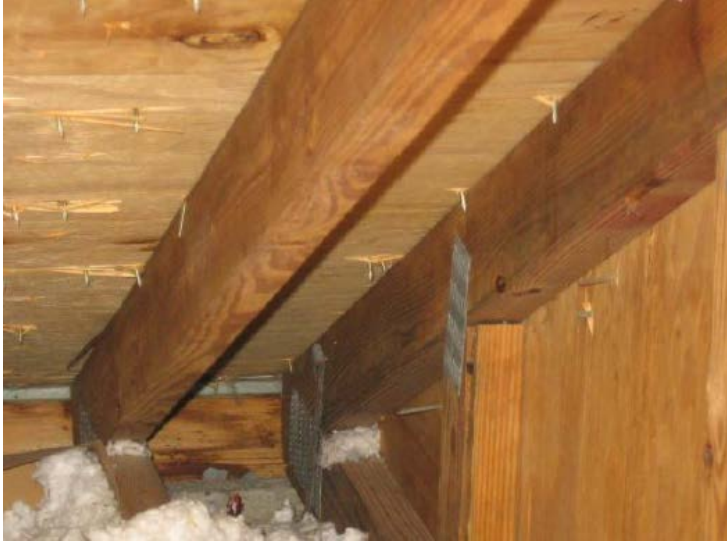
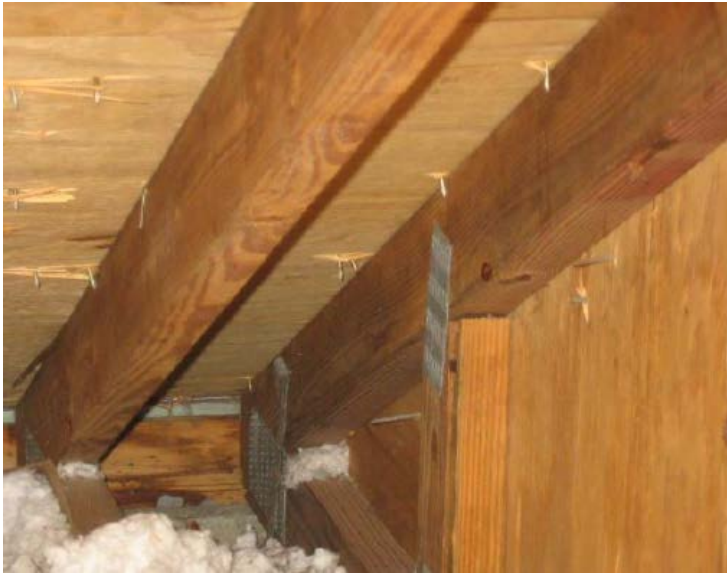
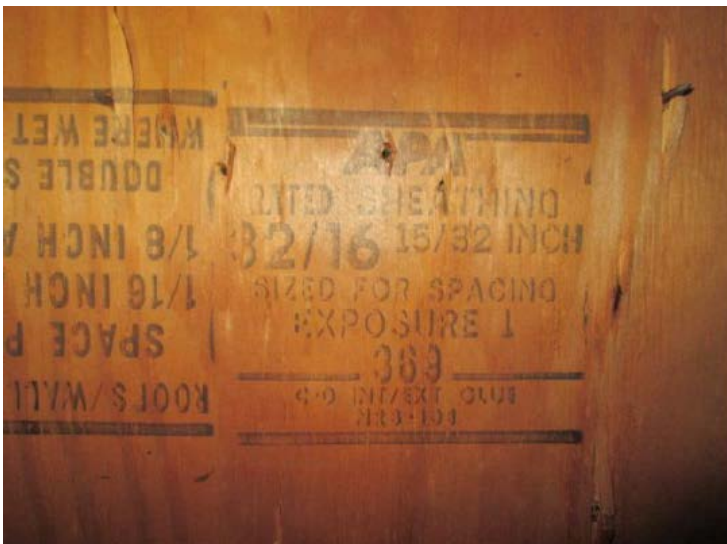
Roof Construction

- 3. Roof Deck Attachment:** **Level A**
Comments: Inspection verified 1/2" plywood roof deck attached with staples at a minimum of 6" on the edge & 12" in the field.
