COMMERCIAL WINDSTORM MITIGATION REPORT (OIR-B1-1802)

Windrush Bay Condominium Association, Inc.

12 Windrush Bay Dr
Tarpon Springs, FL 34689

As of 2/13/2020
FPAT File# MUD2013974

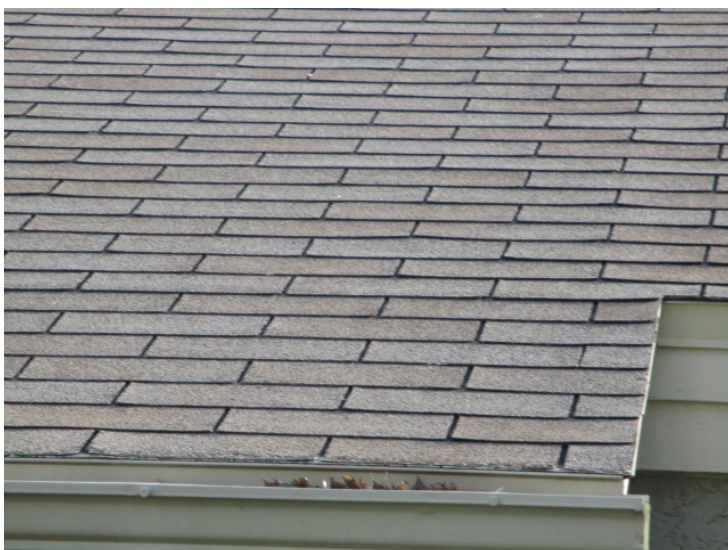
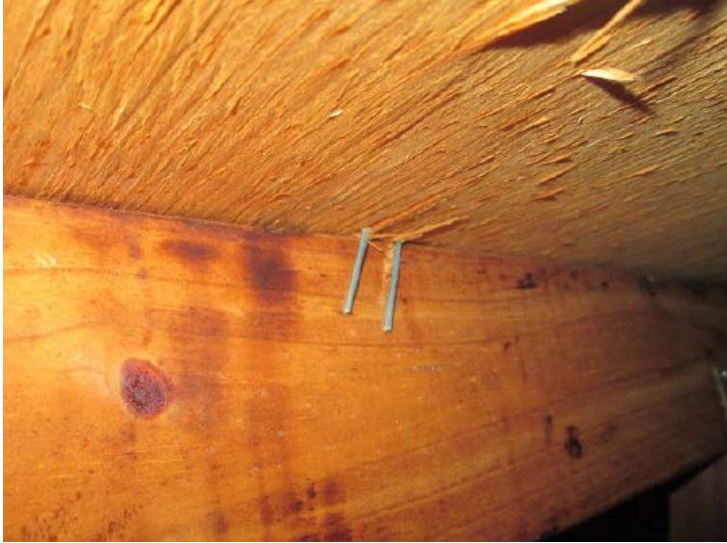
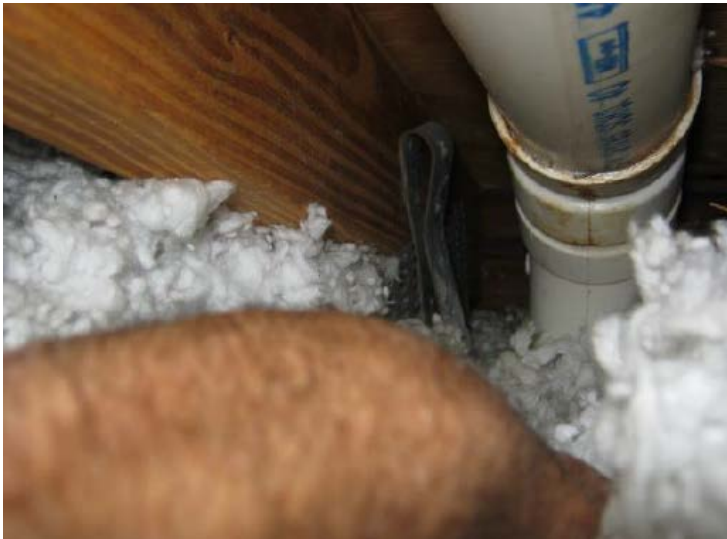
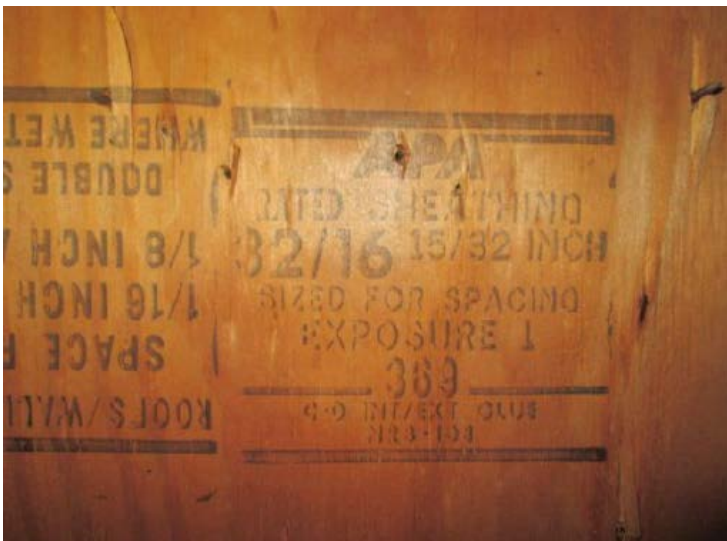
Roof Construction

- 3. Roof Deck Attachment:** **Level A**
Comments: Inspection verified 1/2" plywood roof deck attached with staples at a minimum of 6" on the edge & 12" in the field.

- 4. Roof to Wall Attachment:** **Clips**
Comments: Inspection verified embedded straps fastened with a minimum of three nails.
- 5. Roof Geometry:** **Other Roof**
Comments: Inspection verified a gable roof shape.
