COMMERCIAL WINDSTORM MITIGATION REPORT (OIR-B1-1802)

Windrush Bay Condominium Association, Inc.

13 Windrush Bay Dr
Tarpon Springs, FL 34689

As of 2/13/2020
FPAT File# MUD2013974

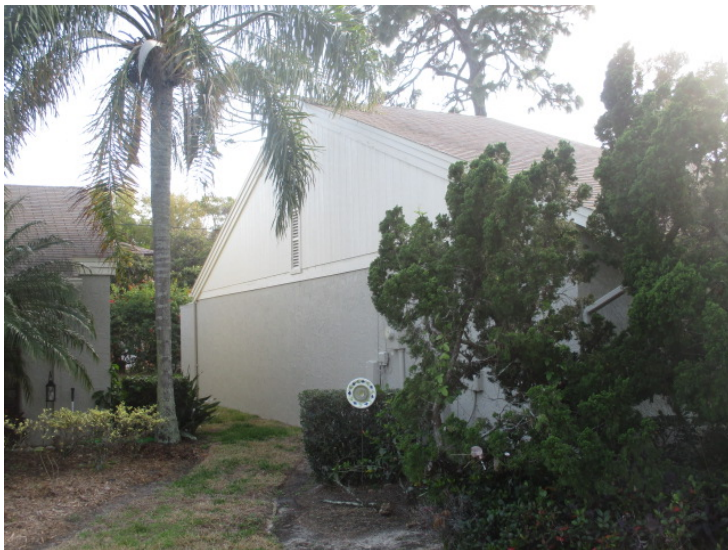
Exterior Elevation

- 4. Roof to Wall Attachment:** **Clips**
Comments: Inspection verified embedded straps fastened with a minimum of three nails.
- 5. Roof Geometry:** **Other Roof**
Comments: Inspection verified a gable roof shape.

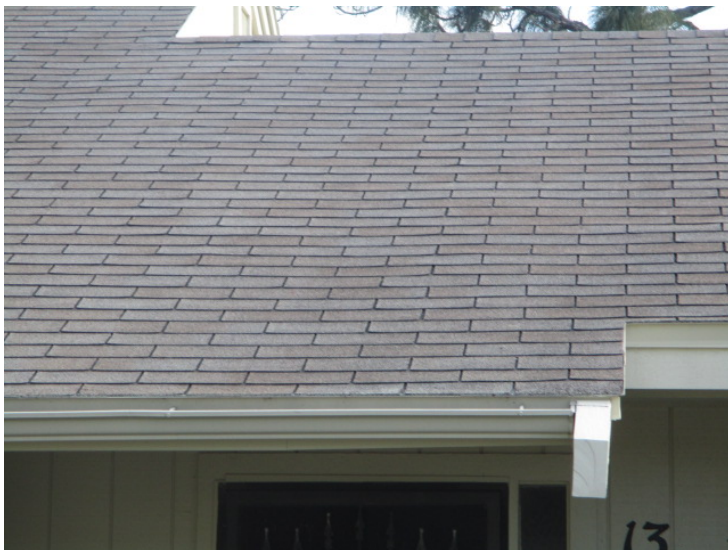
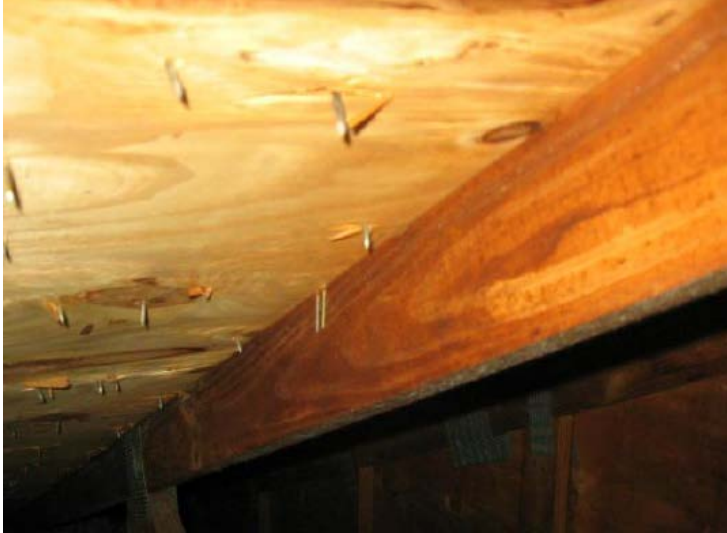
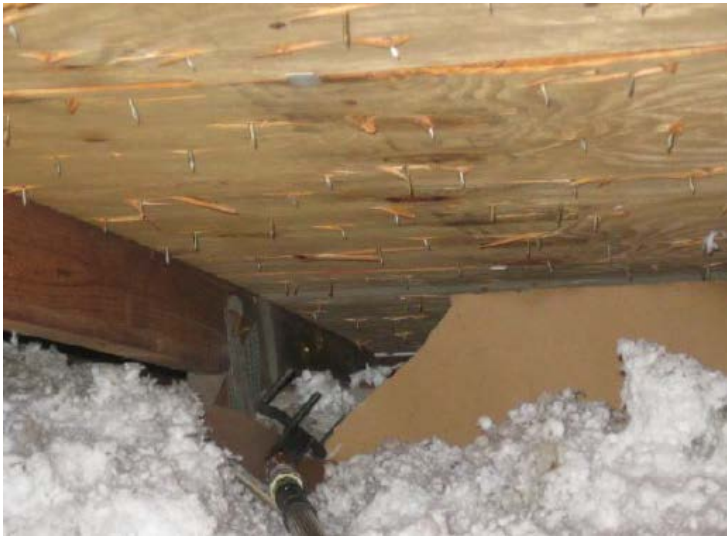
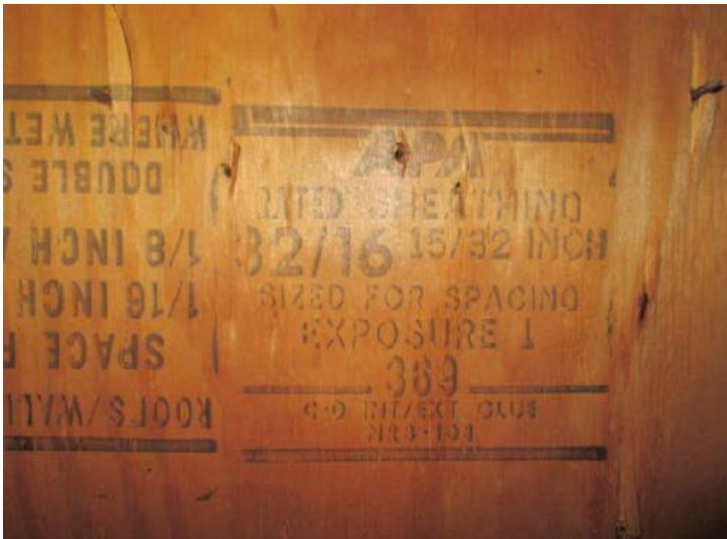
Roof Construction

- 3. Roof Deck Attachment:** **Level A**
Comments: Inspection verified 1/2" plywood roof deck attached with staples at a minimum of 6" on the edge & 12" in the field.
