COMMERCIAL WINDSTORM MITIGATION REPORT (OIR-B1-1802)

Windrush Bay Condominium Association, Inc.

14 Windrush Bay Dr
Tarpon Springs, FL 34689

As of 2/13/2020
FPAT File# MUD2013974

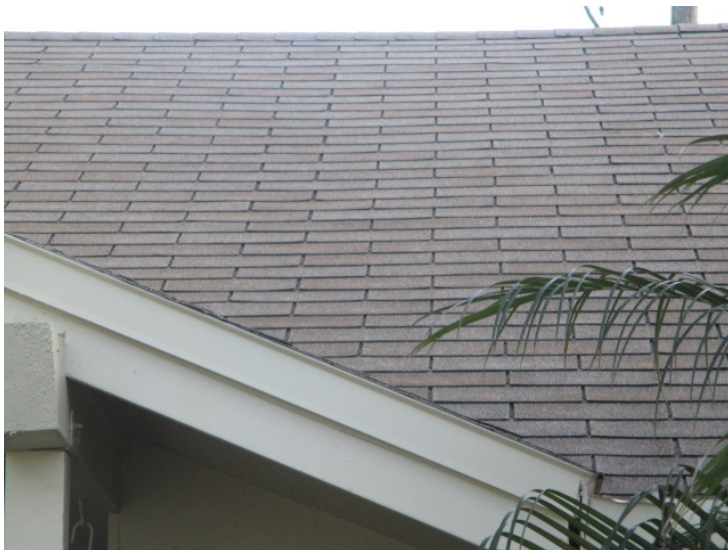
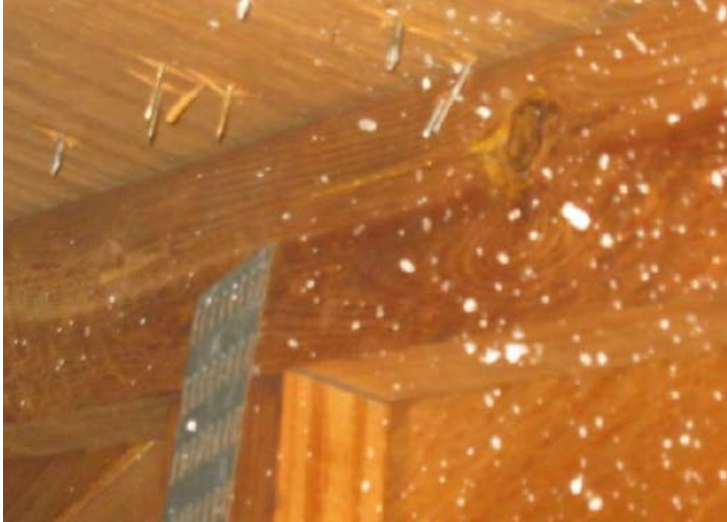
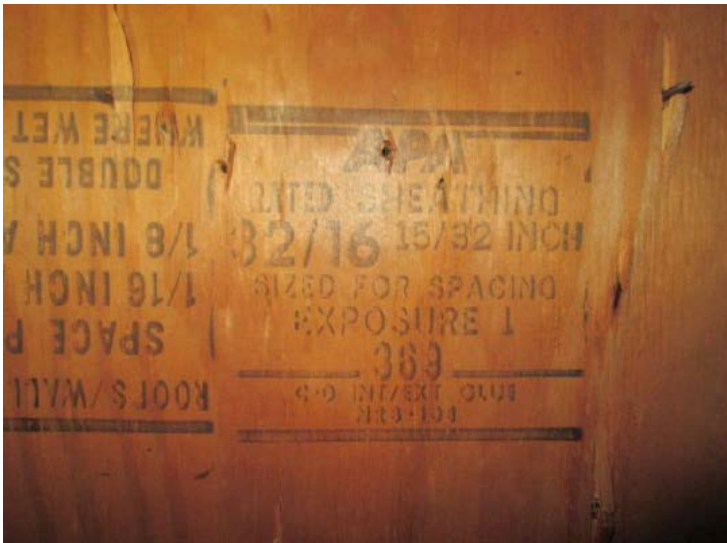
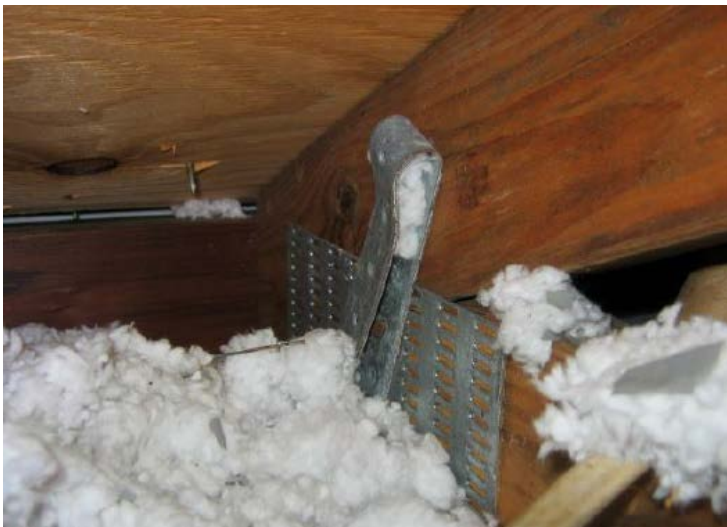
Roof Construction

- 3. Roof Deck Attachment:** **Level A**
Comments: Inspection verified 1/2" plywood roof deck attached with staples at a minimum of 6" on the edge & 12" in the field.

- 4. Roof to Wall Attachment:** **Clips**
Comments: Inspection verified embedded straps fastened with a minimum of three nails.
- 5. Roof Geometry:** **Other Roof**
Comments: Inspection verified a gable roof shape.
