COMMERCIAL WINDSTORM MITIGATION REPORT (OIR-B1-1802)

Windrush Bay Condominium Association, Inc.

15 Windrush Bay Dr
Tarpon Springs, FL 34689

As of 2/13/2020
FPAT File# MUD2013974

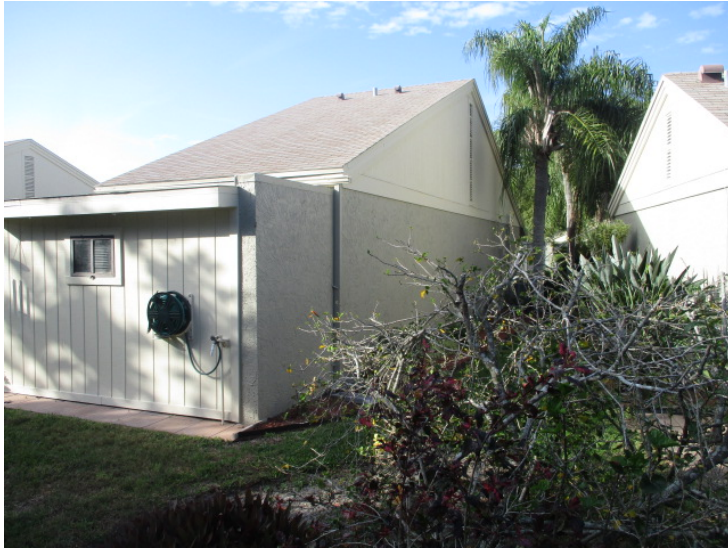
Exterior Elevation

- 4. Roof to Wall Attachment:** **Clips**
Comments: Inspection verified embedded straps fastened with a minimum of three nails.
- 5. Roof Geometry:** **Other Roof**
Comments: Inspection verified a gable roof shape.

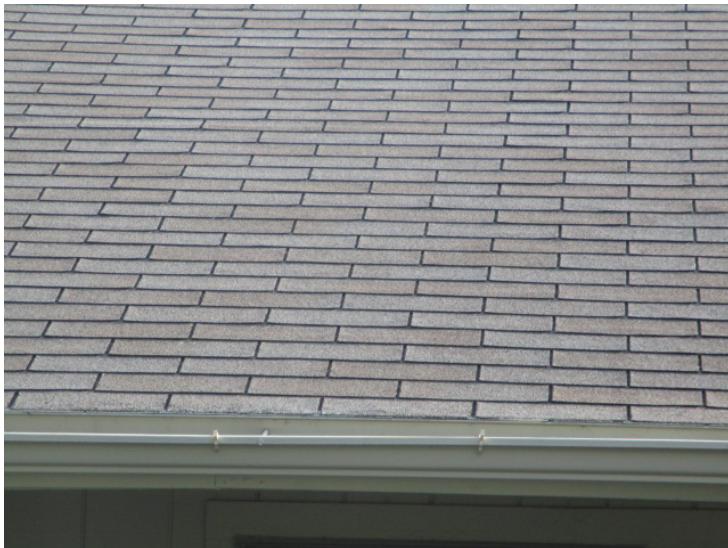
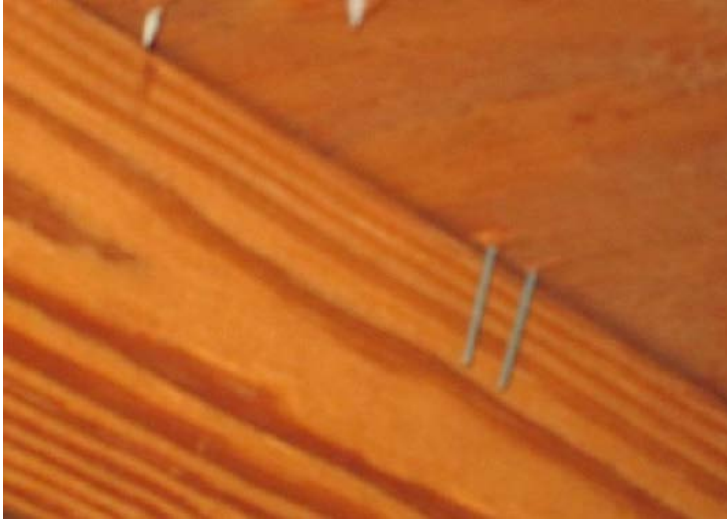
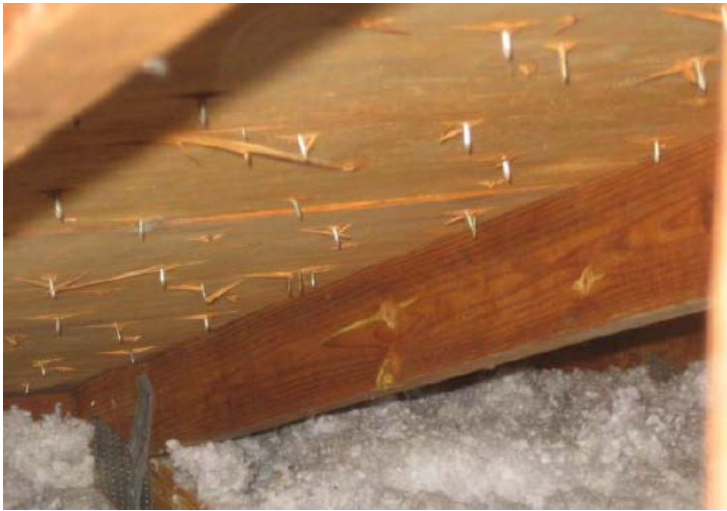
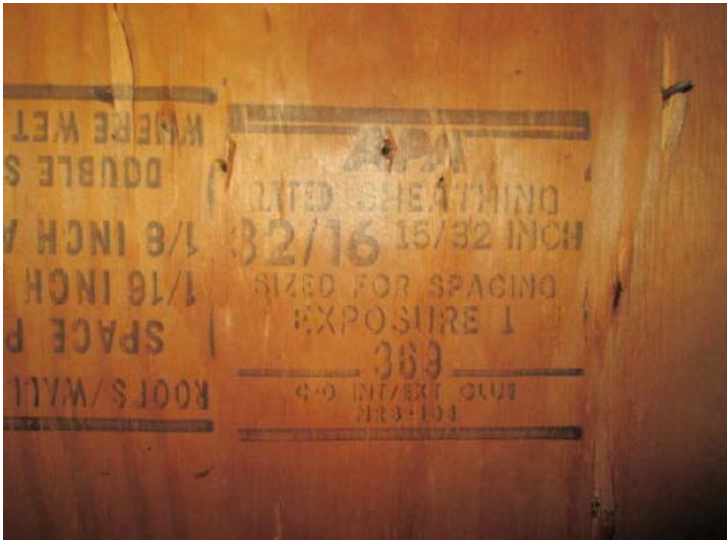
Roof Construction

- 3. Roof Deck Attachment:** **Level A**
Comments: Inspection verified 1/2" plywood roof deck attached with staples at a minimum of 6" on the edge & 12" in the field.

- 6. SWR:** **No**
Comments: Inspection verified no secondary water resistance.
- 7. Opening Protection:** **None or Some Glazed Openings**
Comments: Inspection verified no opening protection.
