COMMERCIAL WINDSTORM MITIGATION REPORT (OIR-B1-1802)

Windrush Bay Condominium Association, Inc.

16 Windrush Bay Dr
Tarpon Springs, FL 34689

As of 2/13/2020
FPAT File# MUD2013974

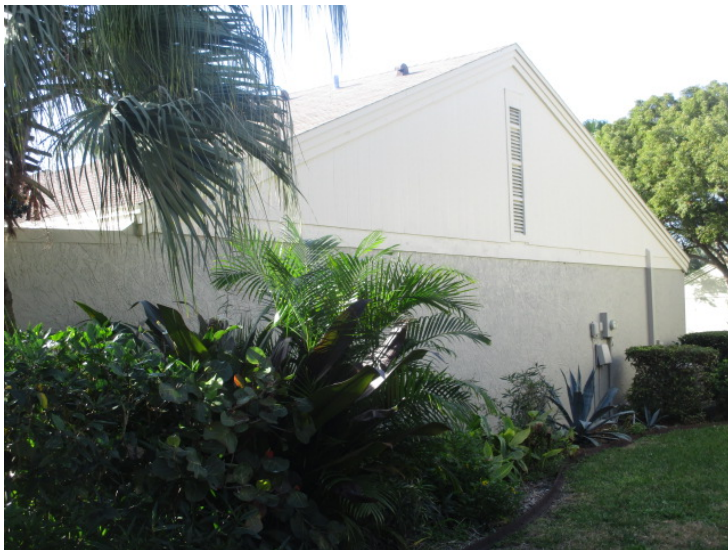
Exterior Elevation

- 4. Roof to Wall Attachment:** **Clips**
Comments: Inspection verified embedded straps fastened with a minimum of three nails.
- 5. Roof Geometry:** **Other Roof**
Comments: Inspection verified a gable roof shape.

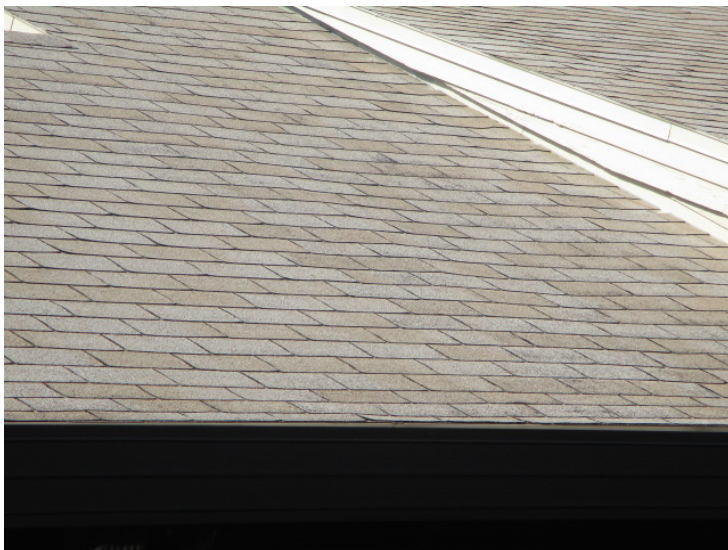
Roof Construction

- 3. Roof Deck Attachment:** **Level A**
Comments: Inspection verified 1/2" plywood roof deck attached with staples at a minimum of 6" on the edge & 12" in the field.
