COMMERCIAL WINDSTORM MITIGATION REPORT (OIR-B1-1802)

Windrush Bay Condominium Association, Inc.

17 Windrush Bay Dr
Tarpon Springs, FL 34689

As of 2/13/2020
FPAT File# MUD2013974

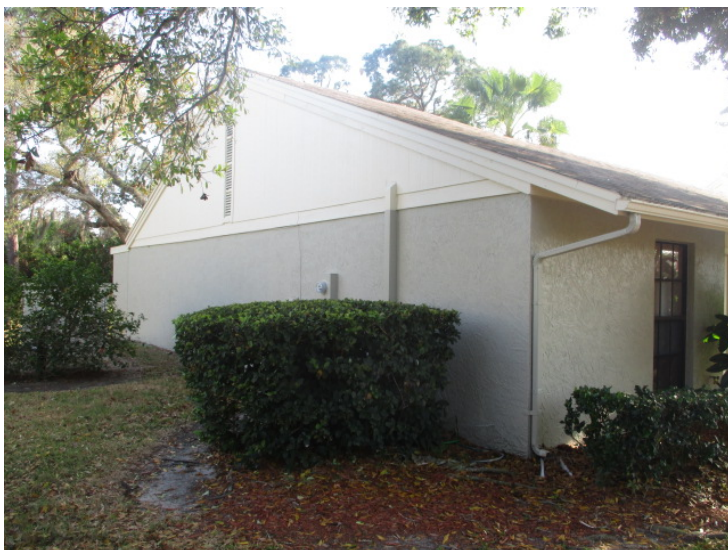
Exterior Elevation

- 4. Roof to Wall Attachment:** **Clips**
Comments: Inspection verified embedded straps fastened with a minimum of three nails.
- 5. Roof Geometry:** **Other Roof**
Comments: Inspection verified a gable roof shape.

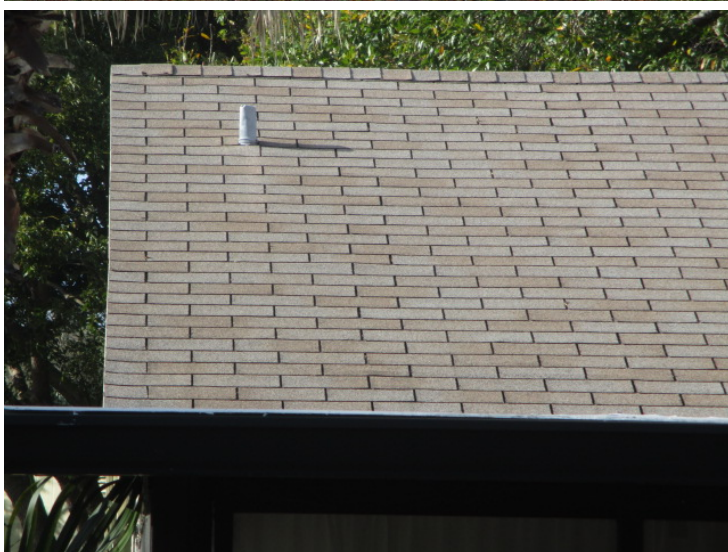
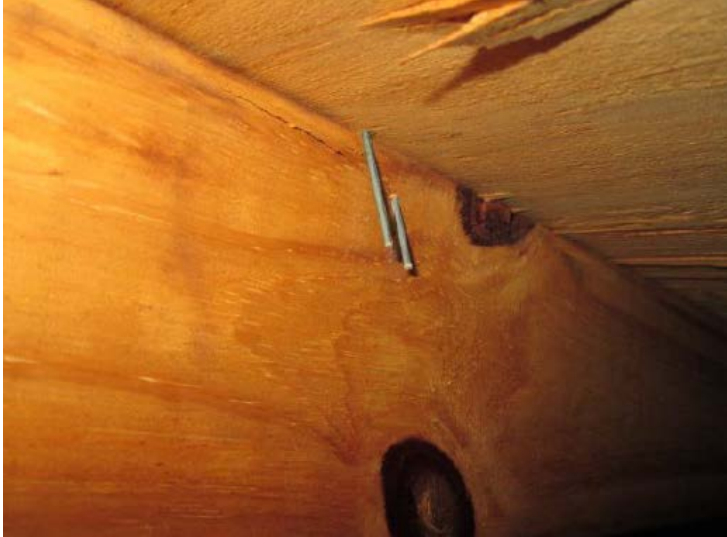
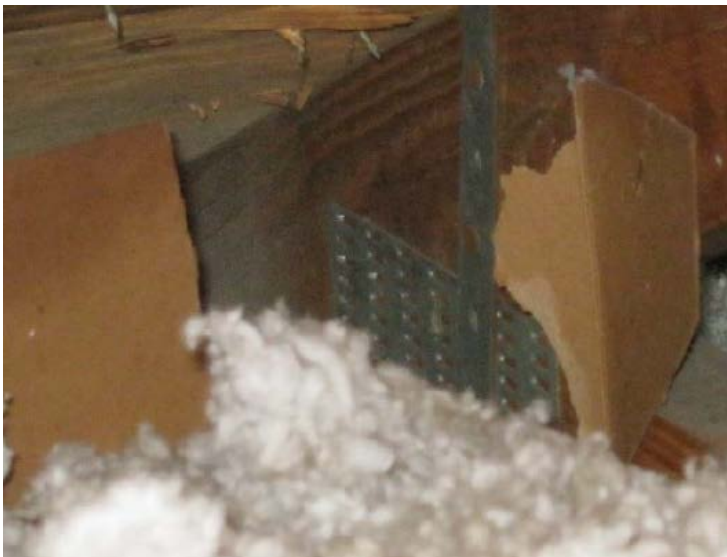
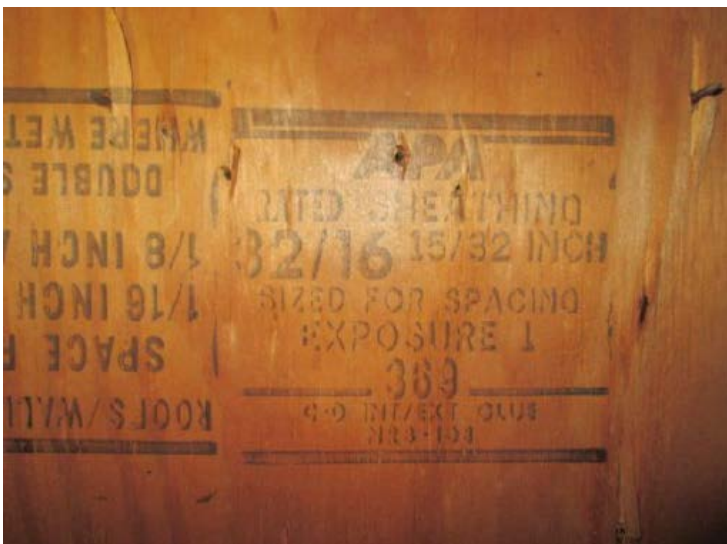
Roof Construction

- 3. Roof Deck Attachment:** **Level A**
Comments: Inspection verified 1/2" plywood roof deck attached with staples at a minimum of 6" on the edge & 12" in the field.
