COMMERCIAL WINDSTORM MITIGATION REPORT (OIR-B1-1802)

Windrush Bay Condominium Association, Inc.

18 Windrush Bay Dr  
Tarpon Springs, FL 34689

As of 2/13/2020  
FPAT File# MUD2013974

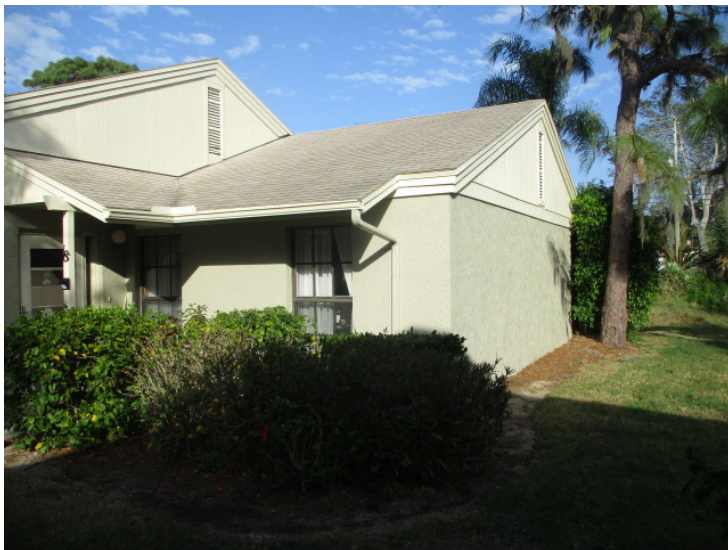
Exterior Elevation

- 5. Roof Geometry:**                      **Other Roof**  
Comments:                                      Inspection verified a gable roof shape.
- 6. SWR:**                                      **No**  
Comments:                                      Inspection verified no secondary water resistance.

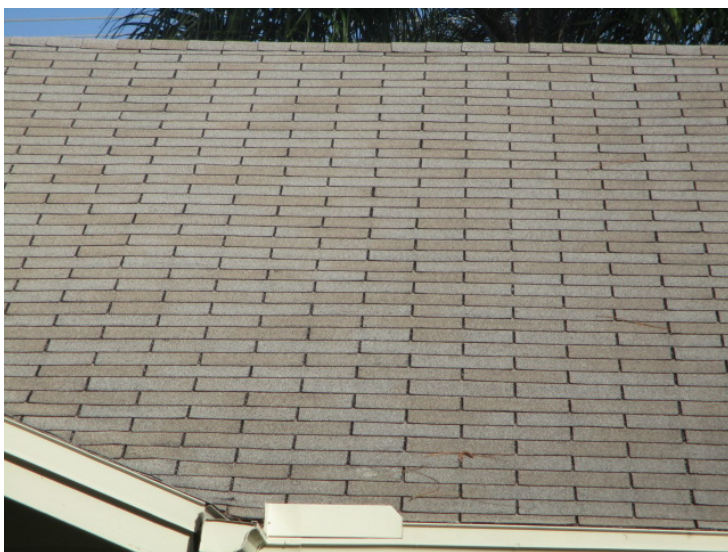
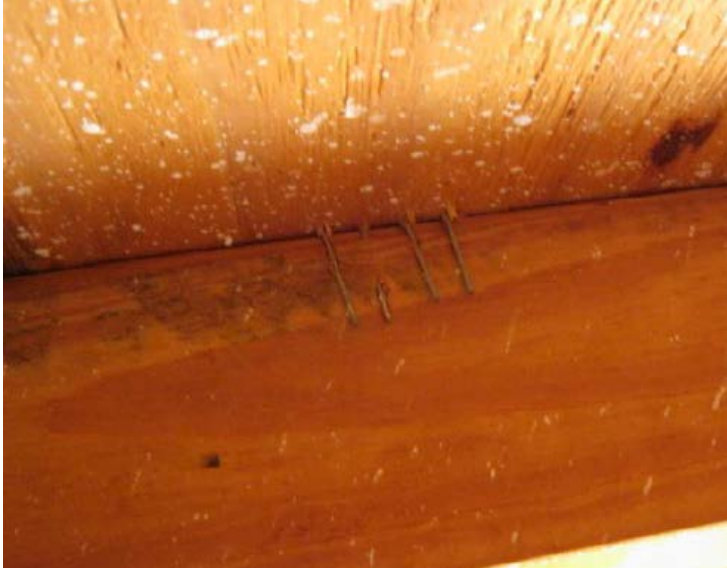
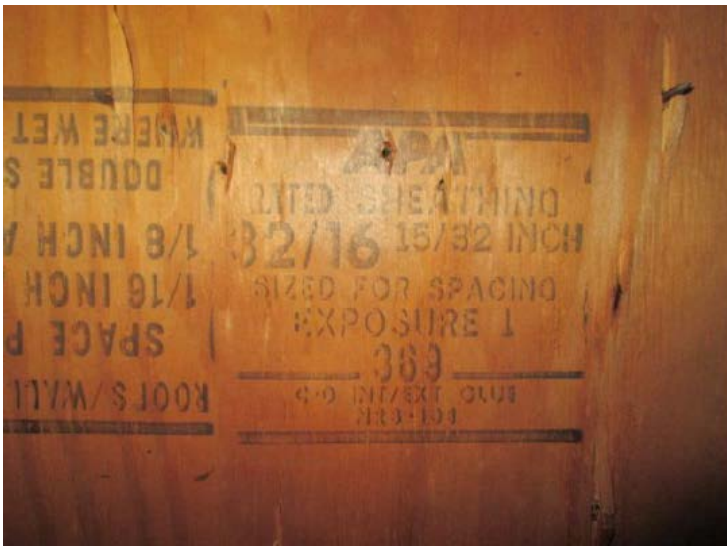
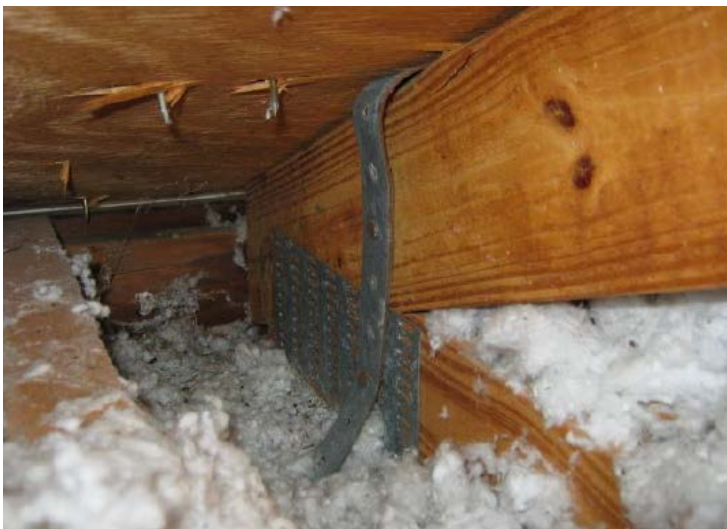
Roof Construction

- 3. Roof Deck Attachment:**        **Level A**  
Comments:                                      Inspection verified 1/2" plywood roof deck attached with staples at a minimum of 6" on the edge & 12" in the field.

- 4. Roof to Wall Attachment:**        **Clips**  
Comments:                                      Inspection verified embedded straps fastened with a minimum of three nails.
