COMMERCIAL WINDSTORM MITIGATION REPORT (OIR-B1-1802)

Windrush Bay Condominium Association, Inc.

19 Windrush Bay Dr
Tarpon Springs, FL 34689

As of 2/13/2020
FPAT File# MUD2013974

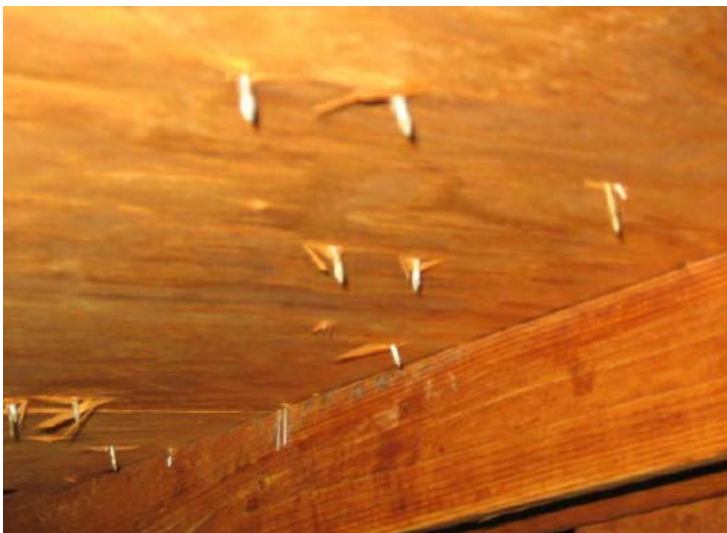
Roof Construction

- 3. Roof Deck Attachment:** **Level A**
Comments: Inspection verified 1/2" plywood roof deck attached with staples at a minimum of 6" on the edge & 12" in the field.

- 4. Roof to Wall Attachment:** **Clips**
Comments: Inspection verified embedded straps fastened with a minimum of three nails.
- 5. Roof Geometry:** **Other Roof**
Comments: Inspection verified a gable roof shape.
