## COMMERCIAL WINDSTORM MITIGATION REPORT (OIR-B1-1802)

Windrush Bay Condominium Association, Inc.

2 Windrush Bay Dr

As of 2/13/2020

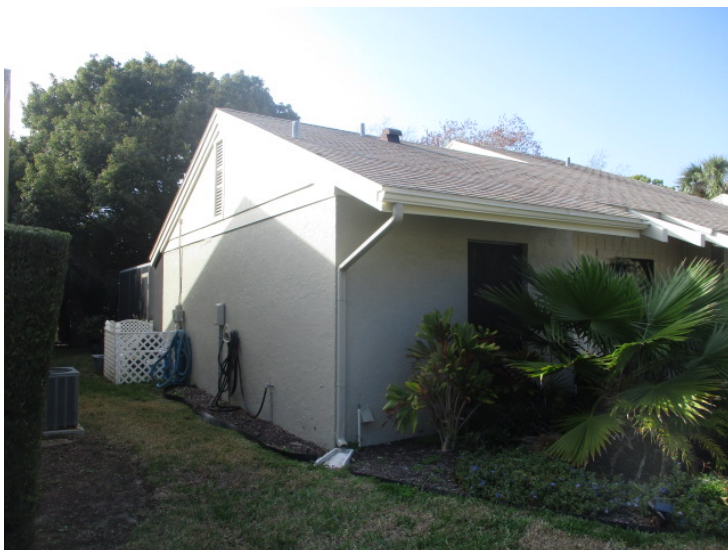
Exterior Elevation

- 5. Roof Geometry:**                      **Other Roof**  
Comments:                                      Inspection verified a gable roof shape.
- 6. SWR:**                                      **No**  
Comments:                                      Inspection verified no secondary water resistance.

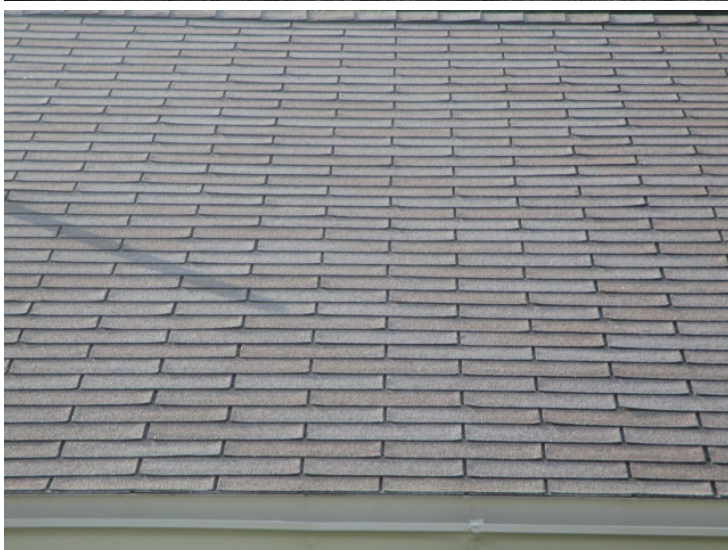
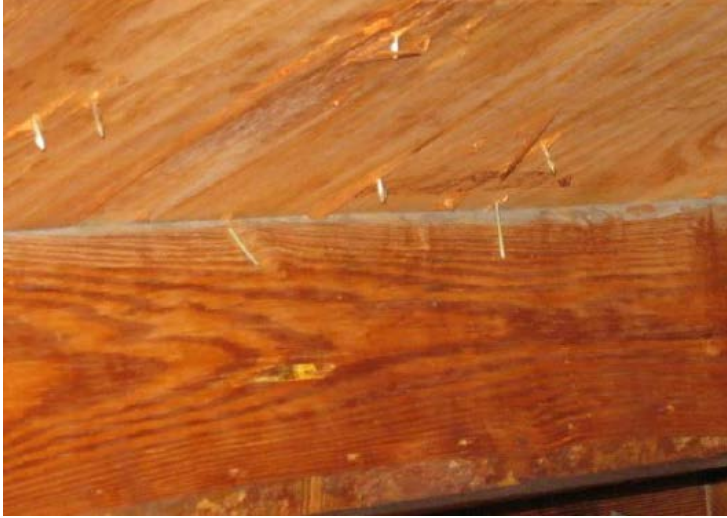
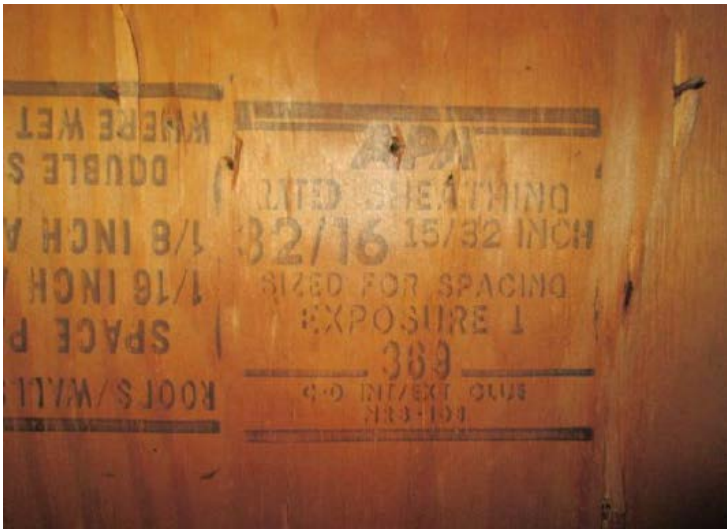
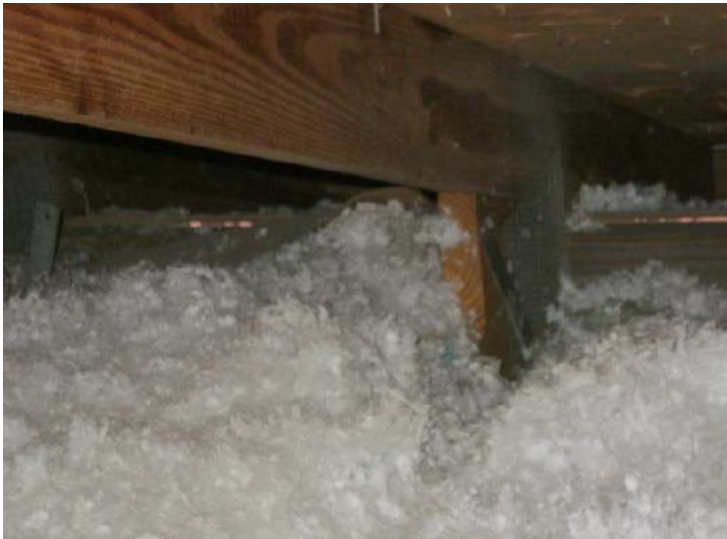
Roof Construction

- 3. Roof Deck Attachment:**        **Level A**  
Comments:                                      Inspection verified 1/2" plywood roof deck attached with staples at a minimum of 6" on the edge & 12" in the field.

- 4. Roof to Wall Attachment:**        **Clips**  
Comments:                                      Inspection verified embedded straps fastened with a minimum of three nails.
