COMMERCIAL WINDSTORM MITIGATION REPORT (OIR-B1-1802)

Windrush Bay Condominium Association, Inc.

20 Windrush Bay Dr

As of 2/13/2020

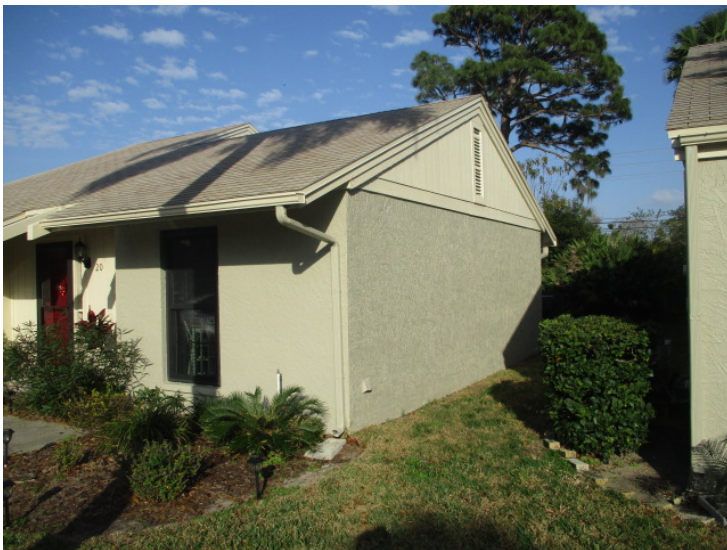
Exterior Elevation

- 4. Roof to Wall Attachment:** **Clips**
Comments: Inspection verified embedded straps fastened with a minimum of three nails.
- 5. Roof Geometry:** **Other Roof**
Comments: Inspection verified a gable roof shape.

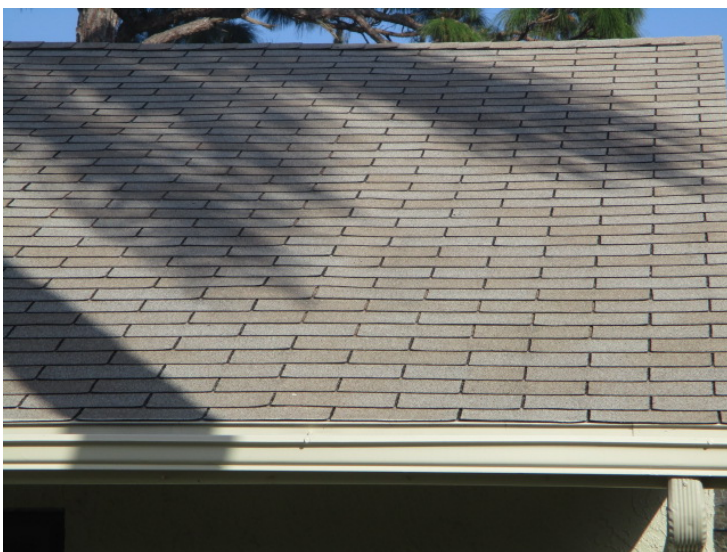
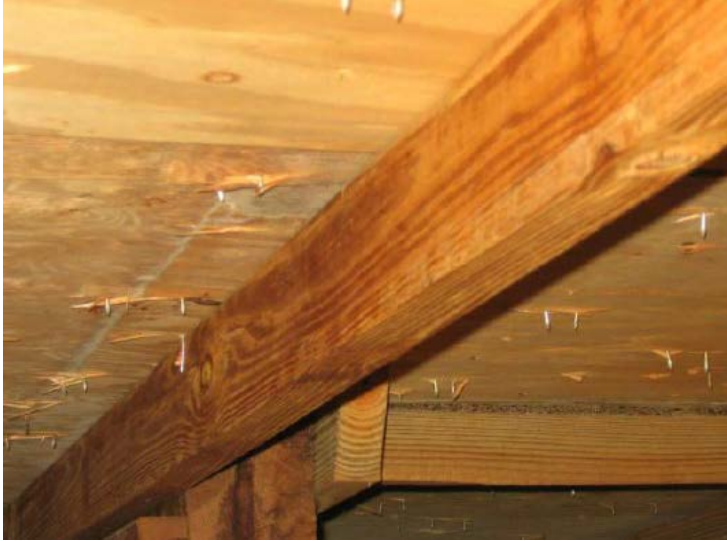
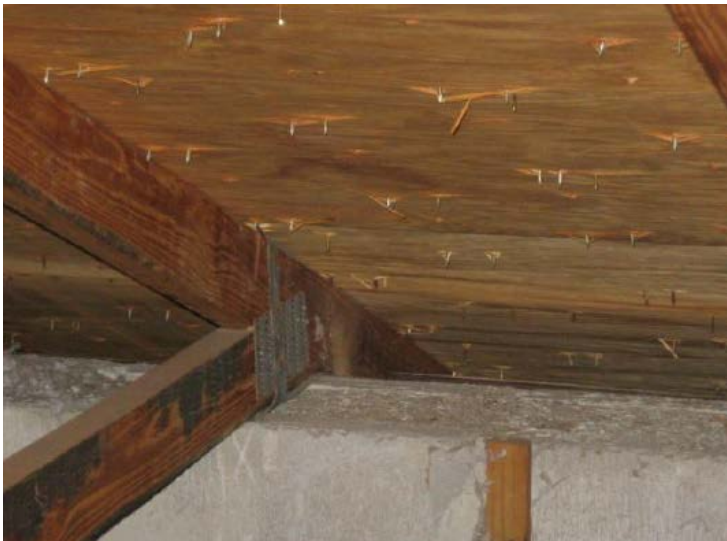
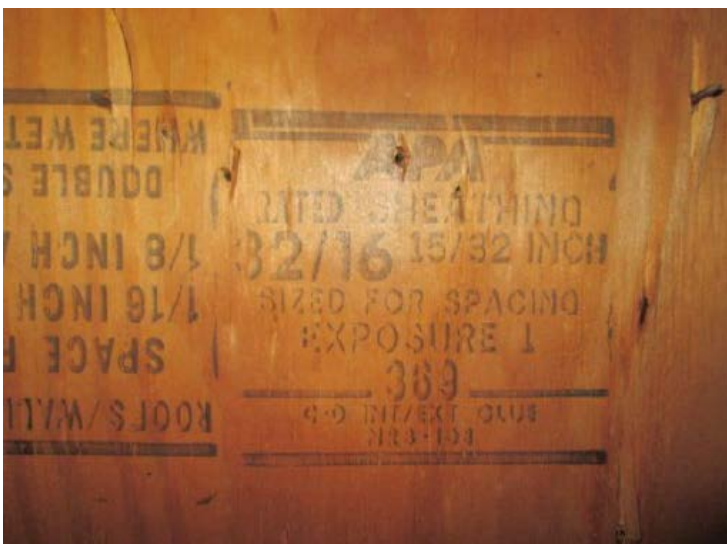
Roof Construction

- 3. Roof Deck Attachment:** **Level A**
Comments: Inspection verified 1/2" plywood roof deck attached with staples at a minimum of 6" on the edge & 12" in the field.
