COMMERCIAL WINDSTORM MITIGATION REPORT (OIR-B1-1802)

Windrush Bay Condominium Association, Inc.

22 Windrush Bay Dr

Tarpon Springs, FL 34689

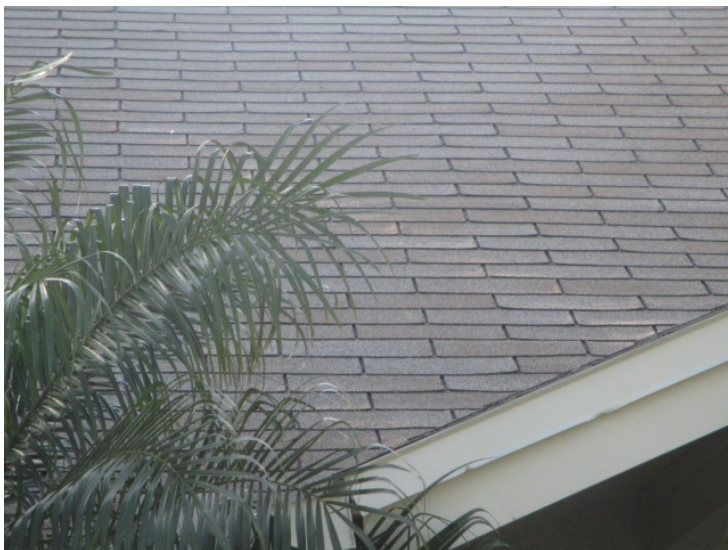
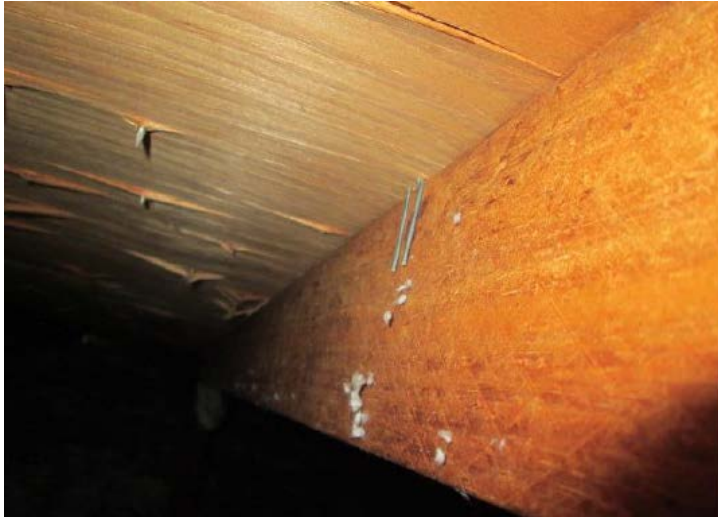
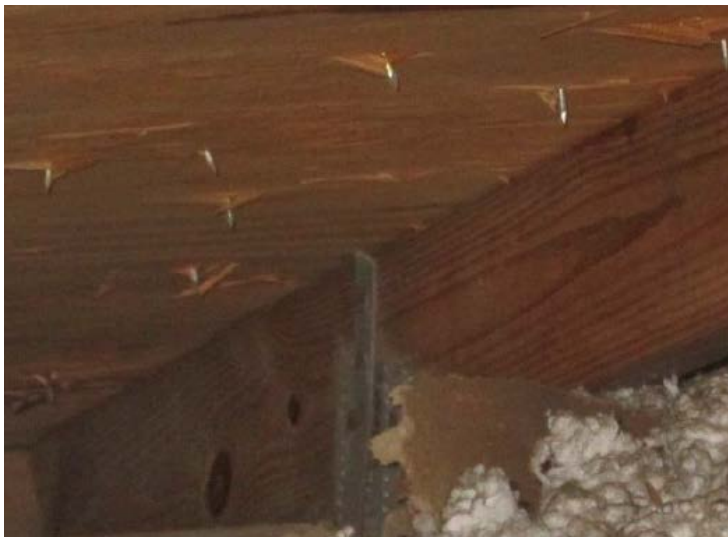
Roof Construction

- 3. Roof Deck Attachment:** **Level A**
Comments: Inspection verified 1/2" plywood roof deck attached with staples at a minimum of 6" on the edge & 12" in the field.

- 4. Roof to Wall Attachment:** **Clips**
Comments: Inspection verified embedded straps fastened with a minimum of three nails.
- 5. Roof Geometry:** **Other Roof**
Comments: Inspection verified a gable roof shape.
